PRE-DEMOLITION ASBESTOS INSPECTION AND RBM IDENTIFICATION REPORT

Water Treatment Plant
2166 Apple Valley Rd
Lyons, Colorado 80540

April 12, 2016

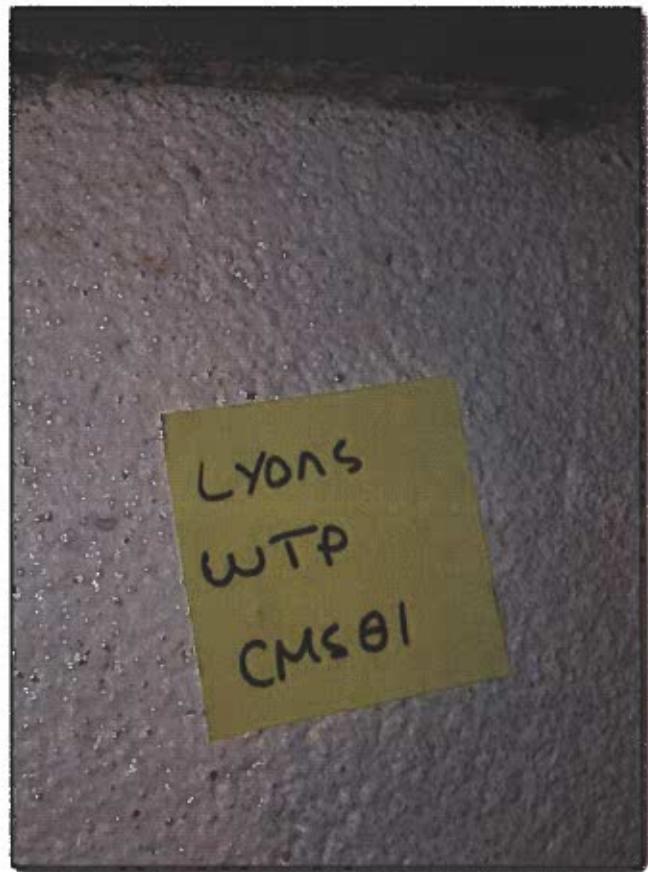
CMS01

- White concrete masonry sealant (CMS01)
- Grey concrete masonry sealant associated with exterior (CMS02)

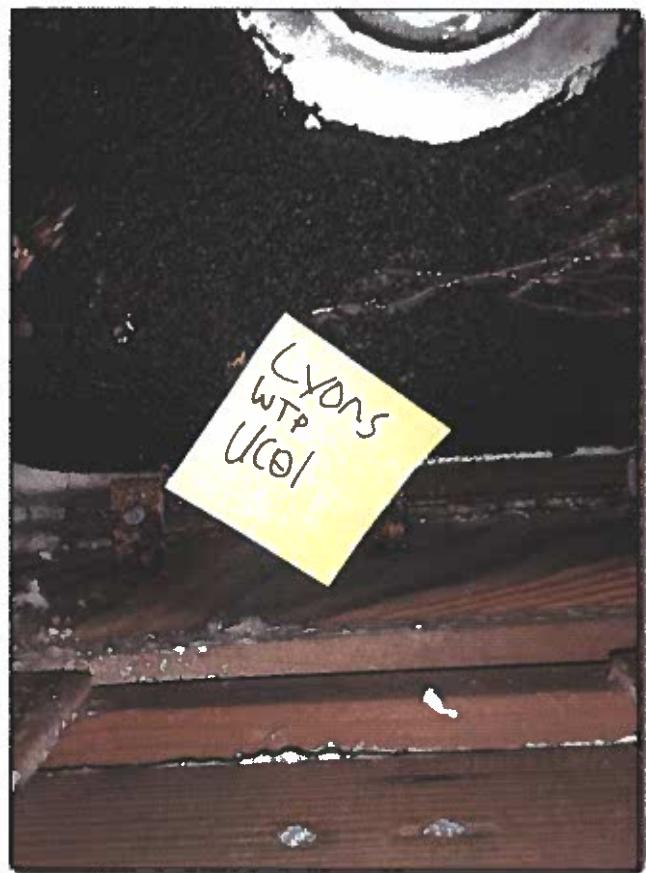
UC01

- Black sink undercoating (UC01)

The following RACMs have been identified in the building that require removal prior to demolition of the structure:

- Black sink undercoating (UC01)

Regulation. The proper removal and handling of these materials is addressed through the preparation of a written abatement scope of work/specification document. This document is used to identify the specific locations of RACM within the scope of work to be removed by the abatement contractor. All ACM is subject to OSHA Construction Industry Standard for Asbestos (29 CFR Part 1926.1101). Based on the laboratory analytical results, RACM listed in this report should be removed by a Certified Abatement Contractor prior to conducting any demolition activities associated with the RACM mentioned above.
