MEMO

TO: Town of Lyons, Colorado
FROM: Werner Water Engineering
DATE: 3-10-2025
SUBJECT: Lyons Ute Highway Stream Stabilization Project

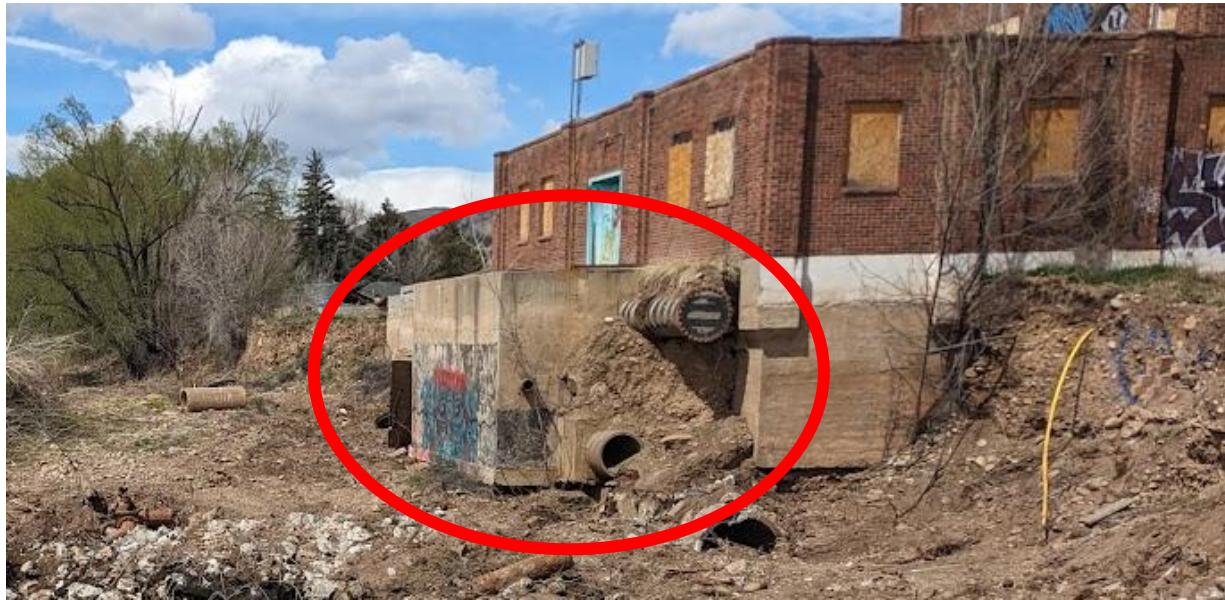
The scope work for debris removal in the project was significantly larger than was expected. There were substantial quantities of sub-surface concrete that were removed. The only demolition and debris removal that was a variation from the permitted plan was the removal of the concrete piece connected to the building circled in Figure 1.

Figure 1 Section of building that was removed.

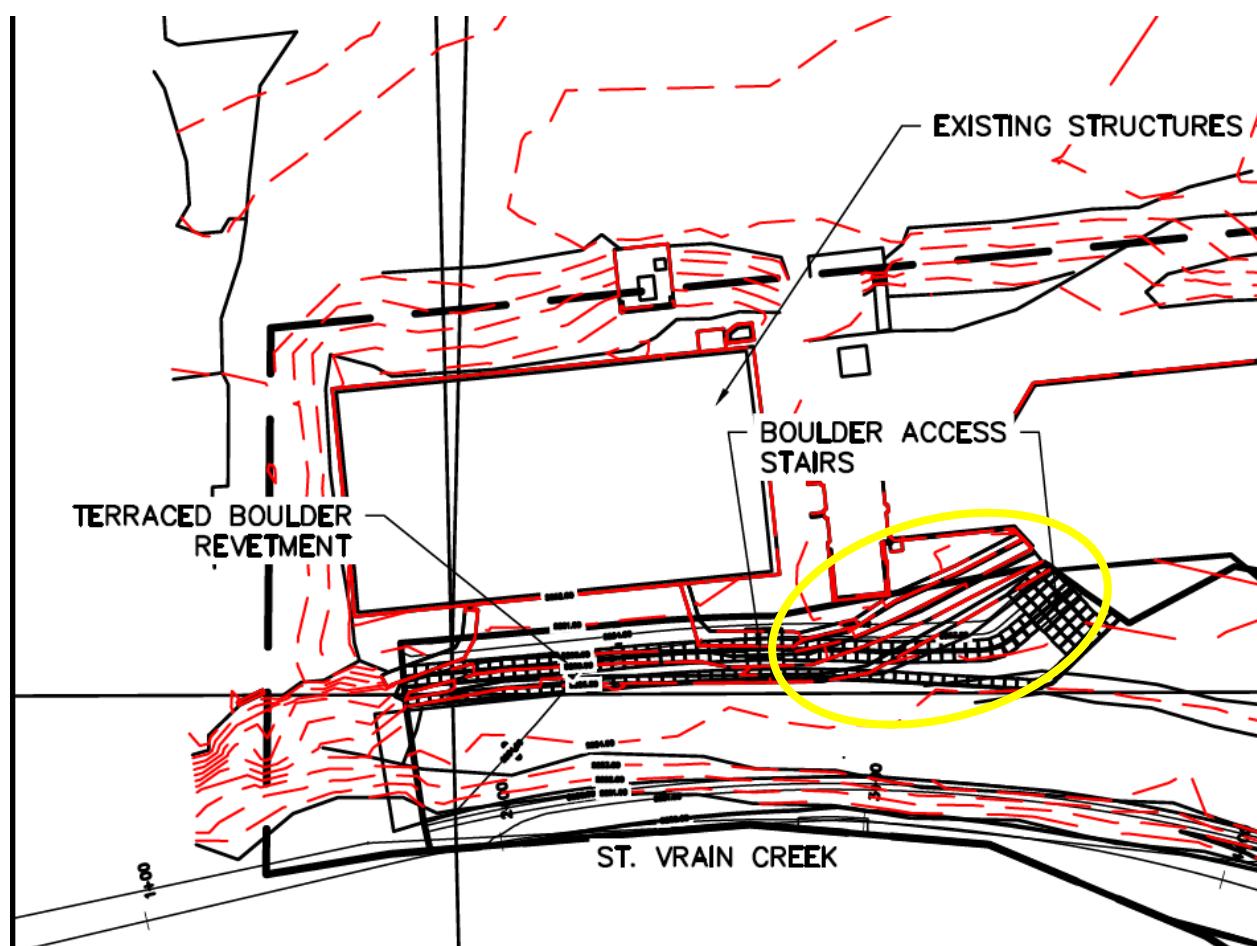
The upstream terraced boulder revetment was modified in two ways. The downstream extend of the terracing was tied into the existing concrete tank wall closer to the north than the proposed plan. The existing surface the proposed plan was developed from had an incorrect breakline so this modification was to line the terracing up with the existing conditions more appropriately. This area is highlighted in yellow in Figure 2.

Figure 2 Terraced boulder revetment as-built

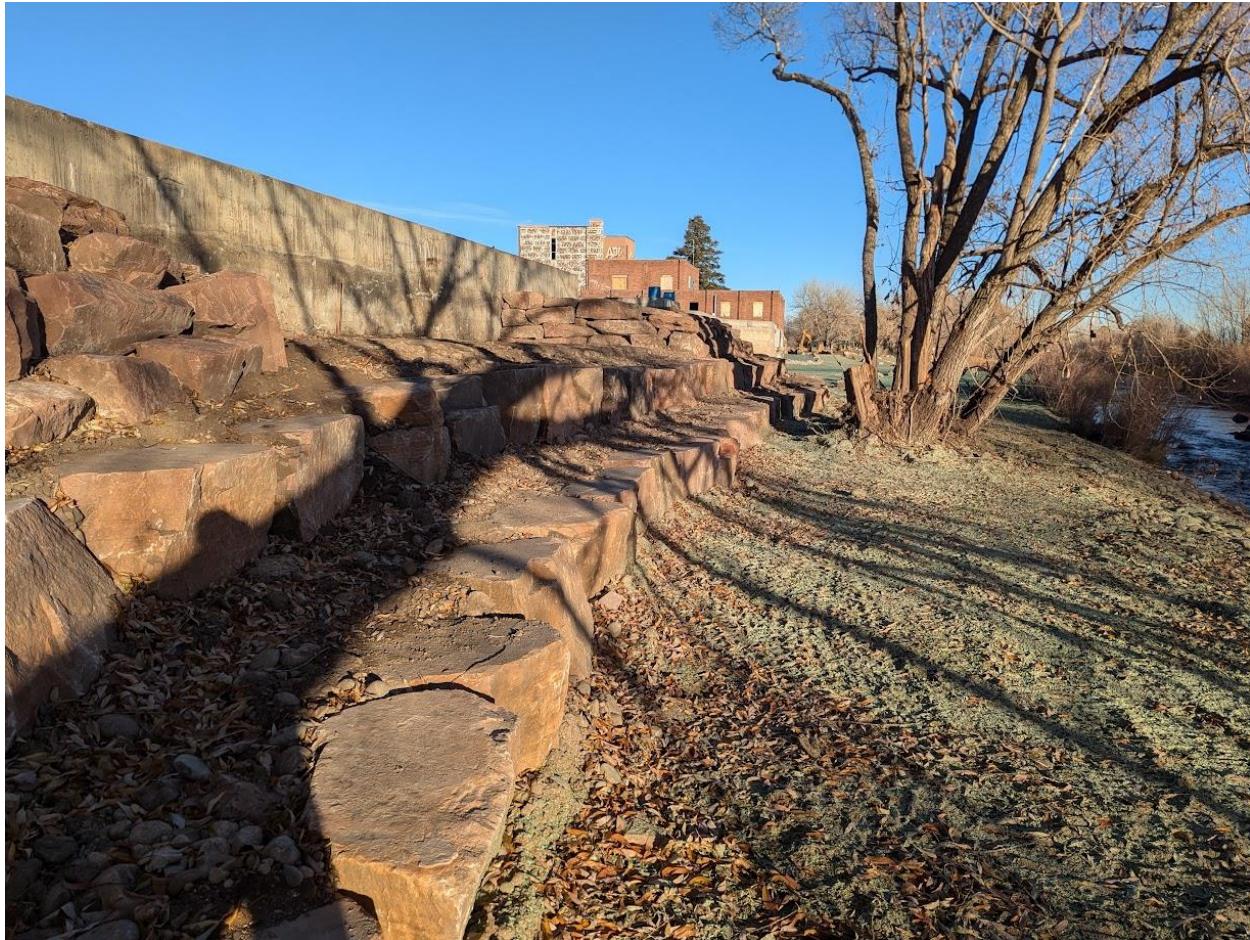
The other deviation from the proposed plan in the terraced boulder revetment was the upper row of boulders was wrapped back to tie into the wall of the existing structure. The final elevation in this recessed area was set to be above 5261 so it would be above the modeled BFE. The final constructed terraced boulder revetment is shown in Figure 3.

Figure 3 Final terraced boulder revetment with recessed upper row.

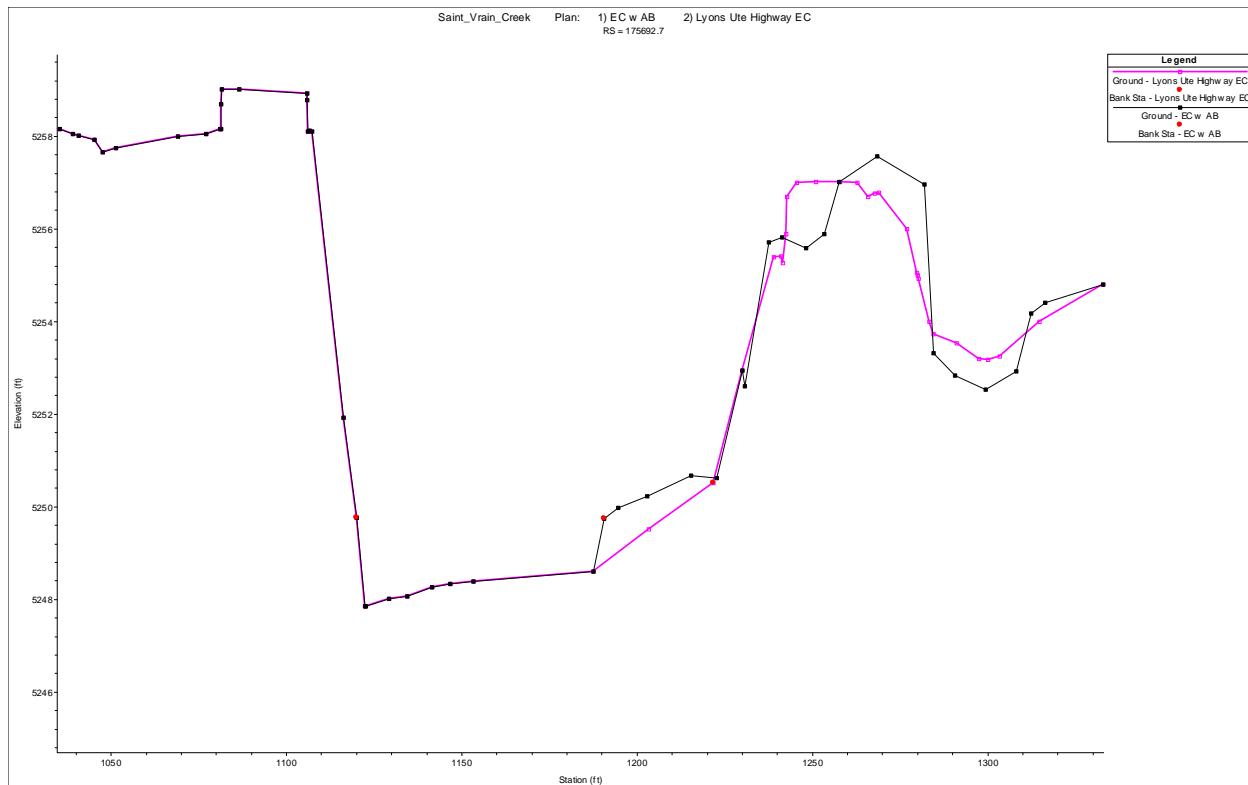
The hydraulic model in this reach is very sensitive to changes. This was true in the as-built conditions, as well as the permitted design. Cross section 175692.7 was the most sensitive and the as-built survey resulted in a difference in the right overbank area that was beyond the grading limits of the project. A new existing conditions plan was created to account for this difference in pre-disturbance conditions. The survey used for the design was collected in 2017 and natural changes occurred in the right over bank, primarily being the deposition

of material on the floodplain bench. The differences in the as-built surveyed cross section compared to the existing conditions cross section used in the design are shown in Figure 4. The more recent survey is the black line.

Figure 4 Comparison of Existing Condition model to survey data in right overbank.

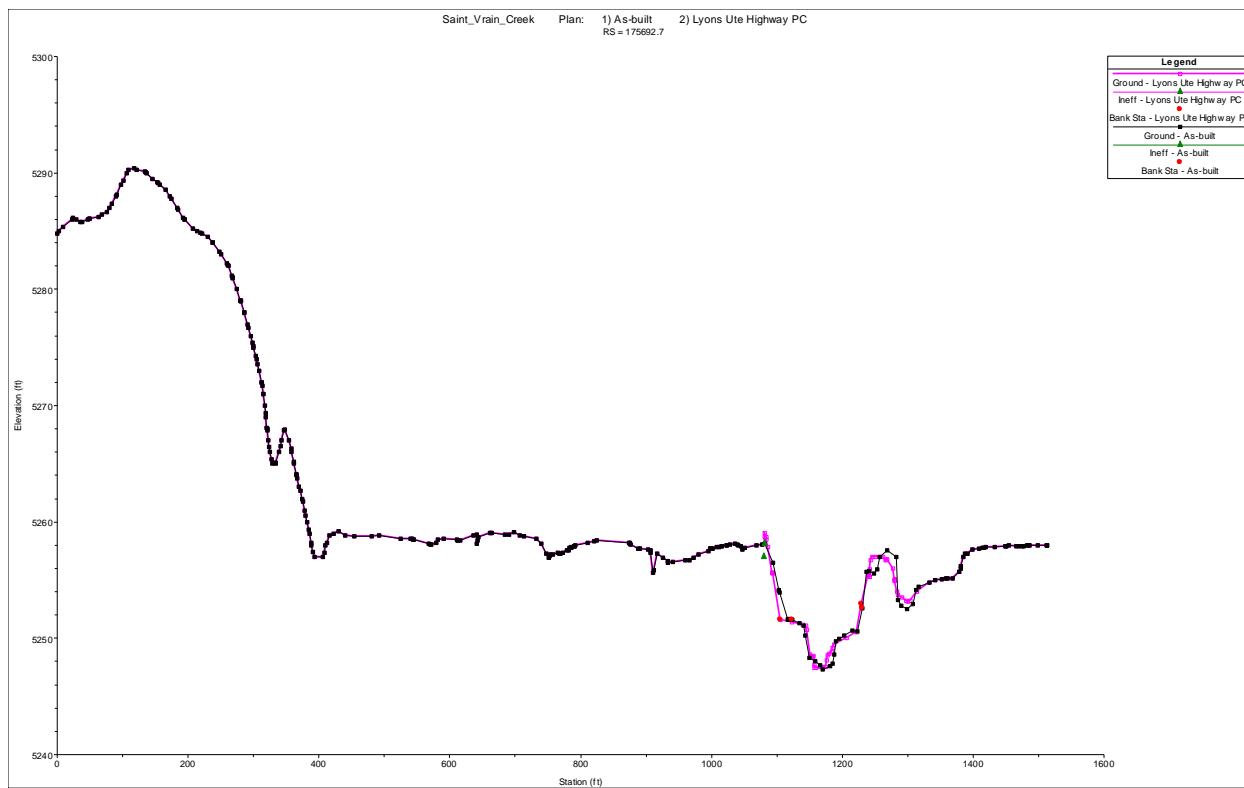
Figure 5 Cross Section 175692.7 as-built compared to proposed.

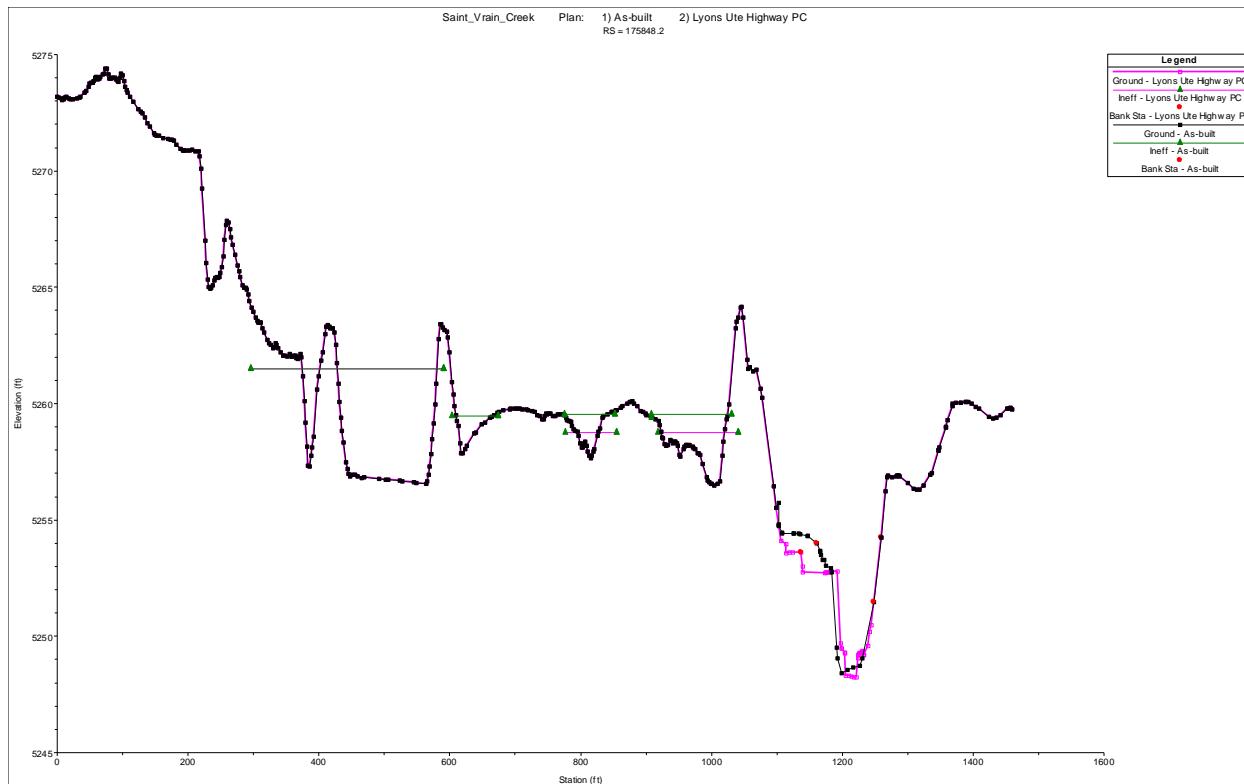
The floodplain bench that was modified is obvious in Figure 6. The toe of the slope on the left bank in Figure 7 was moved slightly north to tie the grading into the existing streambank upstream of the property as well and the peak in the center of the channel was existing material that had deposited and was not placed by the project. That deposit of material is on the adjacent property and could not be impacted by the project as there was no agreement with the landowner for any work to occur on their property.

Figure 6 Cross Section 175848.2 as-built compared to proposed.

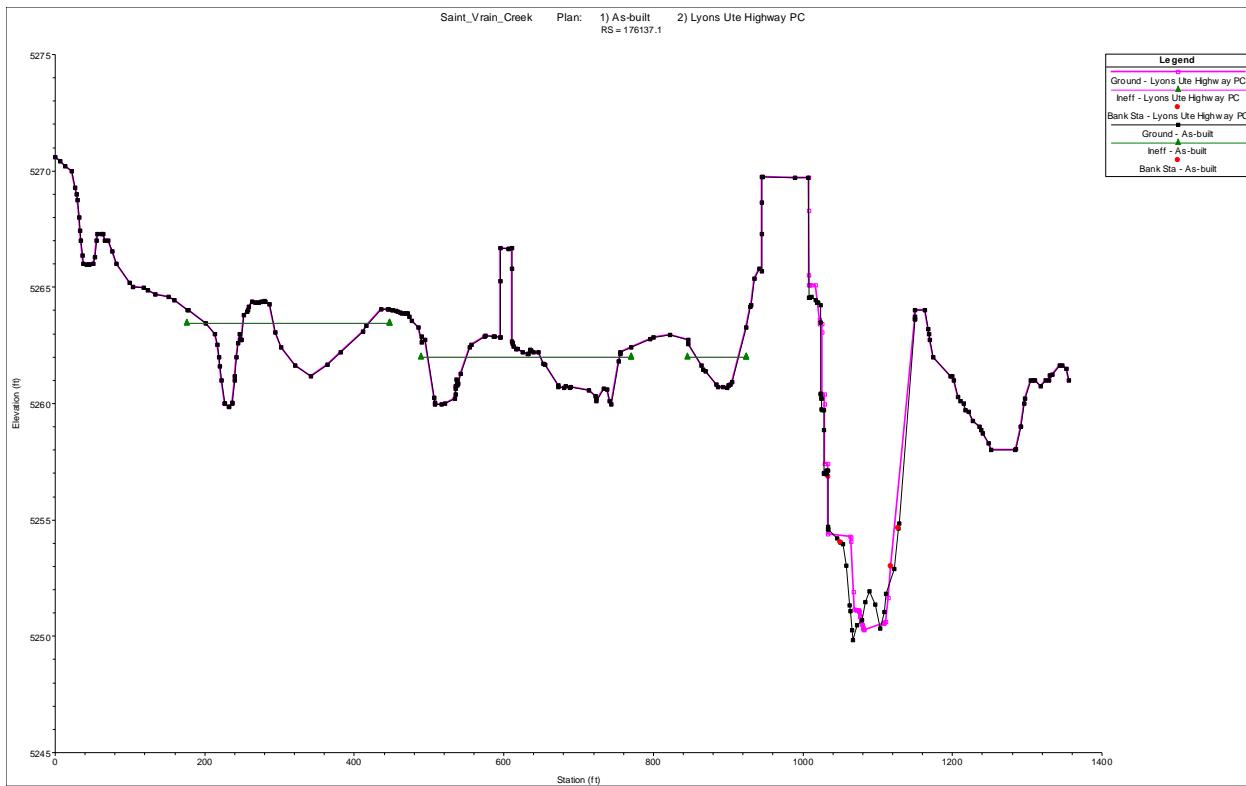
Figure 7 Cross Section 176137.1 as-built compared to proposed.
