Flagstone Culvert Investigation

Final Report
July 16, 2025

Town Of Lyons
432 5th Ave
P.O Box 49
Lyons, Colorado 80540

Town Project Number: 24-CULVERT-01
Martin/Martin, Inc. Project Number: 25.0203.S.01

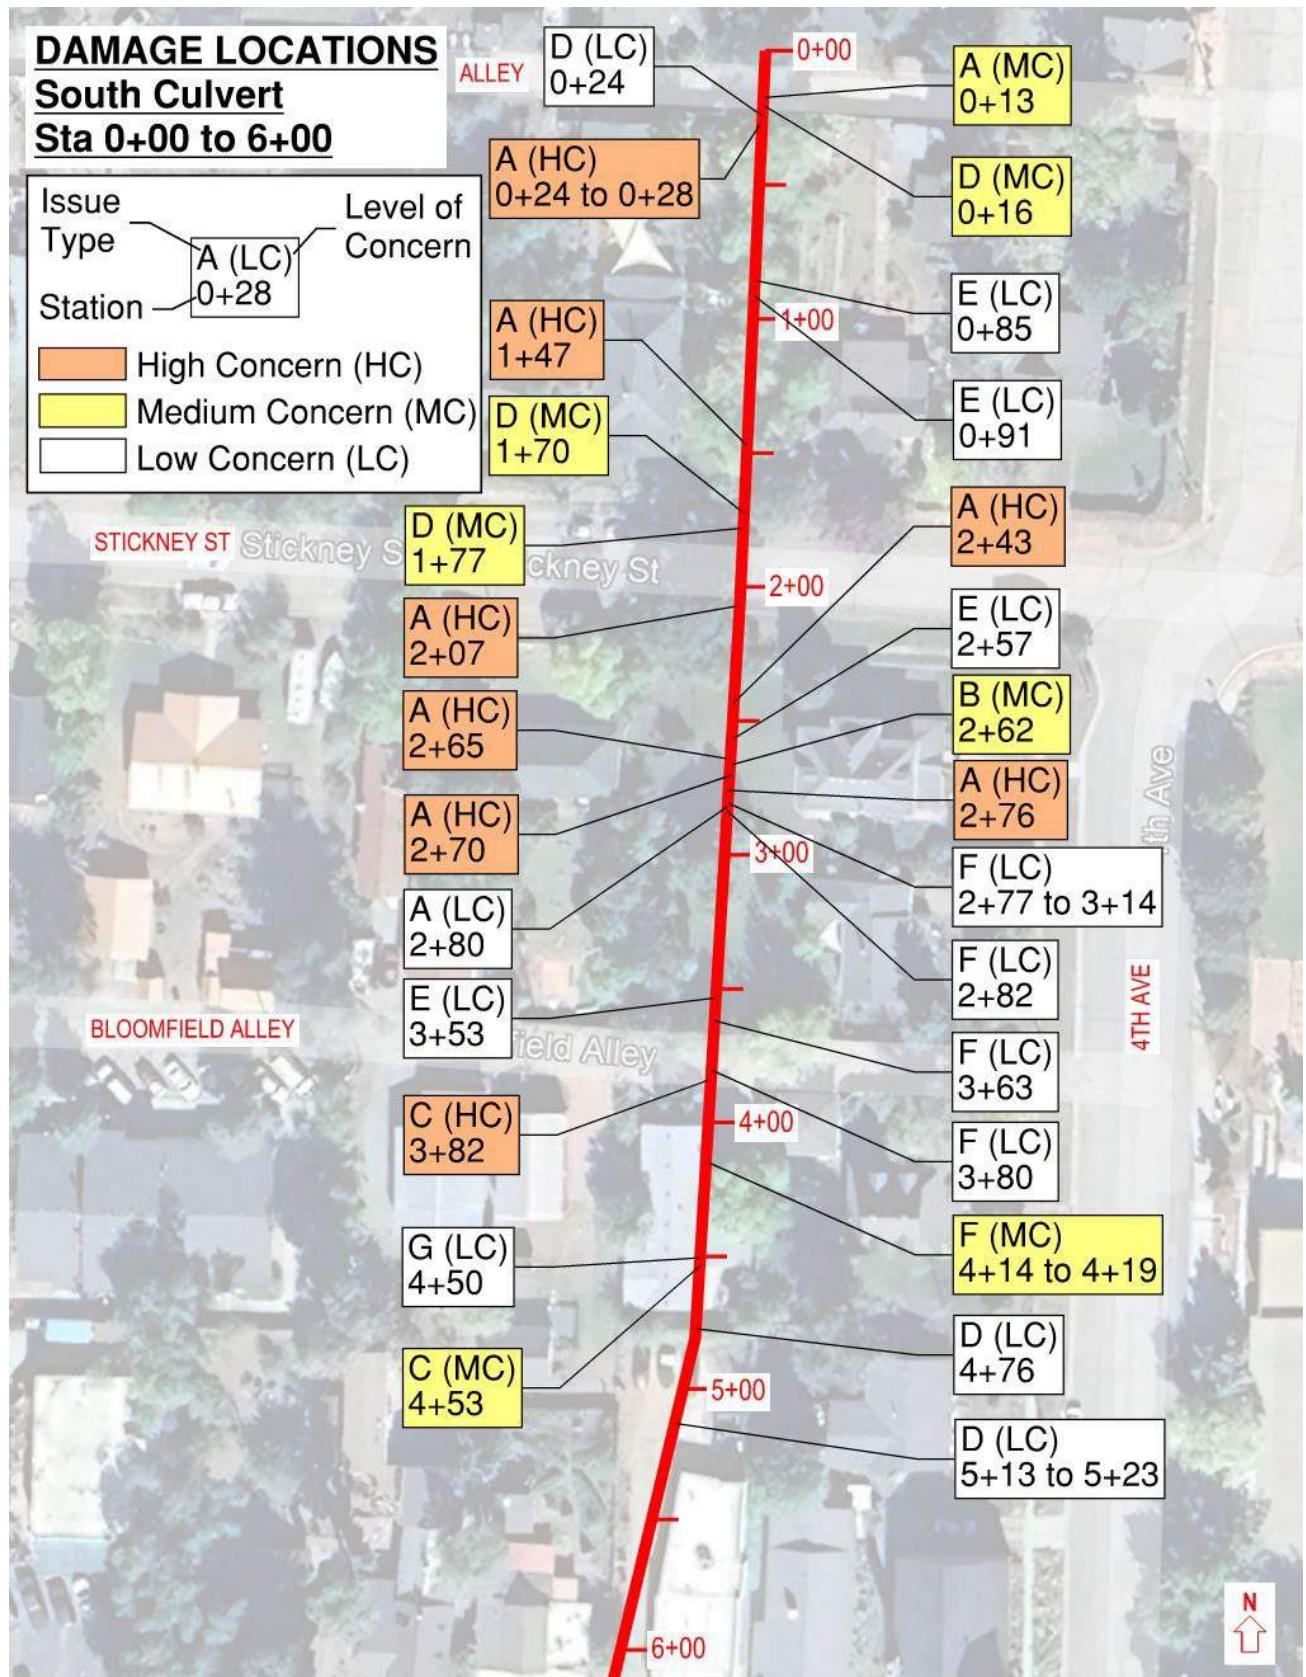
Figure 12: South Culvert Map of Damaged/Deteriorated Areas Stations (S)0+00 to (S)6+00

Table 1 describes typical conditions of deterioration and damage observed throughout the culverts. Reference Figure 12 though Figure 14 for mapped locations of each issue and their "level of concern," and APPENDIX C for associated photos.

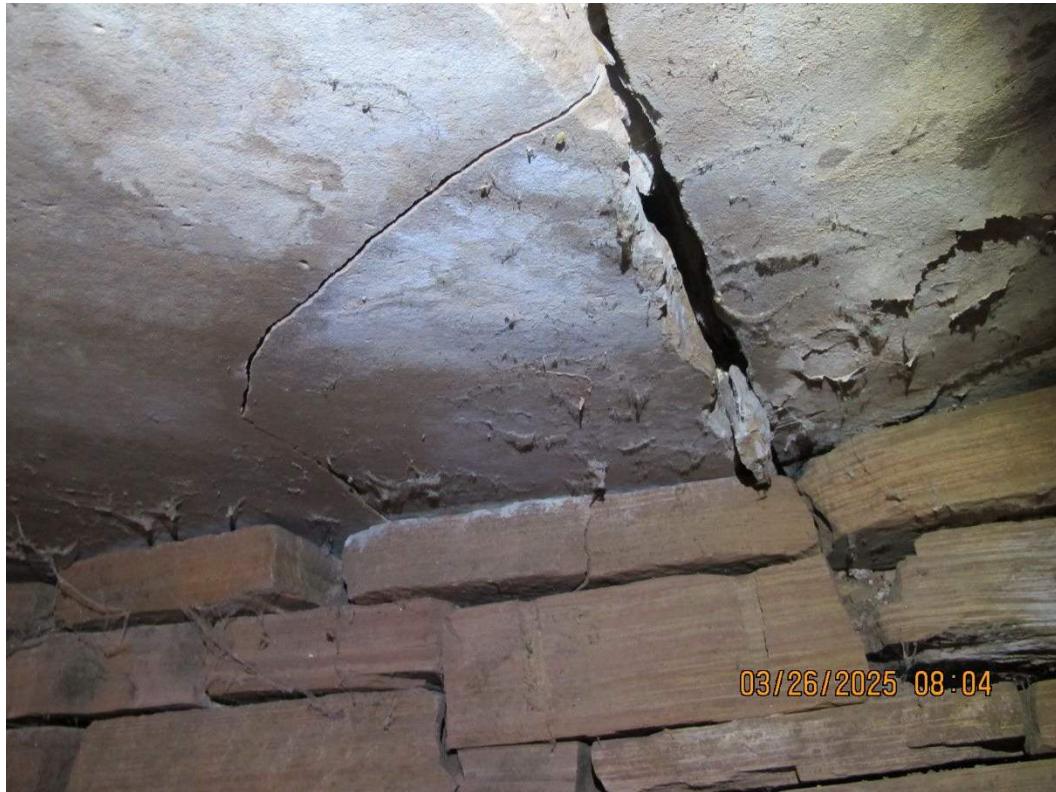
Photo C.1 South Culvert Station (S)0+13

| <u>Map Keynote</u> | <u>Description</u> |
|---|---|
| A | Flagstone Lid Fracture (Photo C.1 to Photo C.14) – Several flagstone lid members (lid construction Type C1) throughout the culvert have fractured or cracked, many of which have deflected to varying degrees exposing the soil above the culvert. Typically, the cracks are parallel to the culvert (perpendicular to the flagstone span direction) or have occurred at the corner of a flagstone. The damage is likely due to loads imposed above the top of the culvert lid, either by vehicular traffic or excessive soil / pavement / flagstones installed since original construction. |

| Deterioration Type: A – Flagstone Lid Fracture (accessible from above) | | | |
|--|--|---|---|
| 1 | <ul style="list-style-type: none"> ▪ Excavate damaged culvert lid. ▪ Remove and replace-in-kind with Lyons Red Sandstone up to 12" thick. ▪ Backfill and replace landscaping/paving. | \$20,000 to \$30,000 per location | No change. |
| 2 | <ul style="list-style-type: none"> ▪ Excavate damaged culvert lid. ▪ Remove lid and replace with a reinforced precast concrete panel between 6" and 8" thick. ▪ Backfill and replace landscaping/paving. | \$21,000 to \$31,000 per location | No change. |
| 3 | <ul style="list-style-type: none"> ▪ Excavate damaged culvert lid. ▪ Remove lid and replace with a reinforced cast-in-place concrete slab between 6" and 8" thick. ▪ Backfill and replace landscaping/paving. | \$19,000 to \$29,000 per location | No Change. |

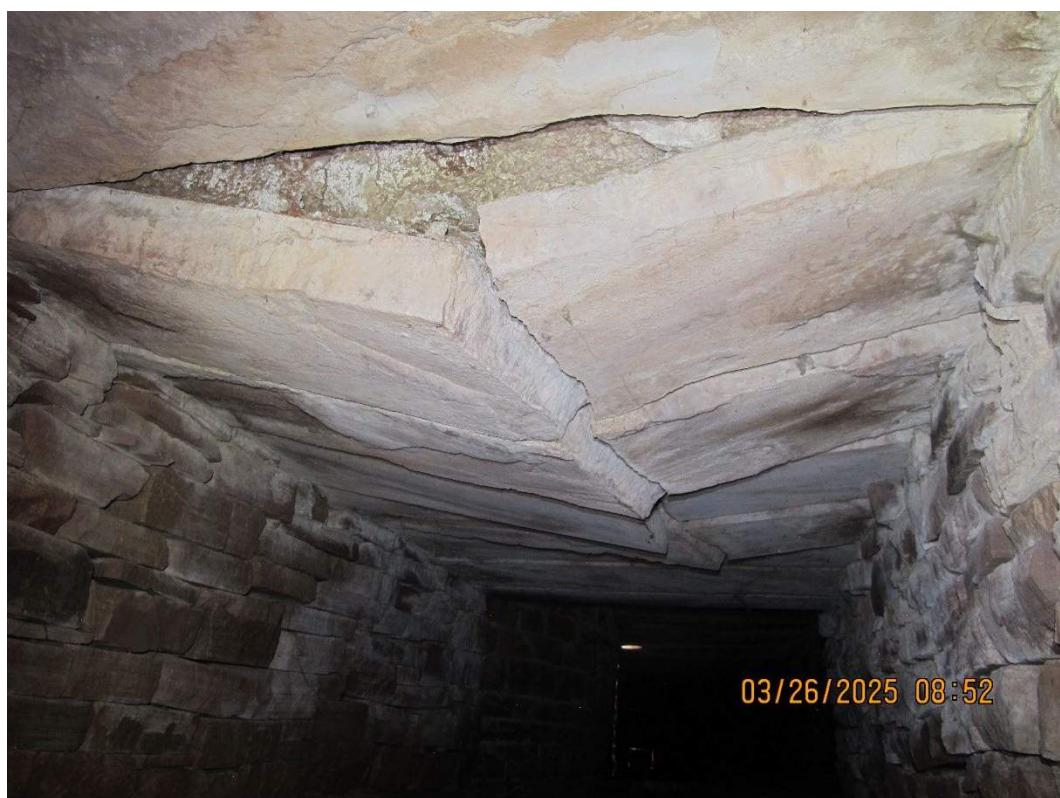
Photo C.4: South Culvert Station (S)1+47

- Fractured and failed flagstone lids at Stations (S)0+24 to (S)0+28, (S)1+47, (S)2+07, (S)2+43, (S)2+65, (S)2+70, (S)2+76, (S)6+16, and (S)7+15.
- Deteriorated steel framing supporting lids at Stations (S)7+04 to (S)7+07.
- Deteriorated concrete lids at Station (S)3+82.

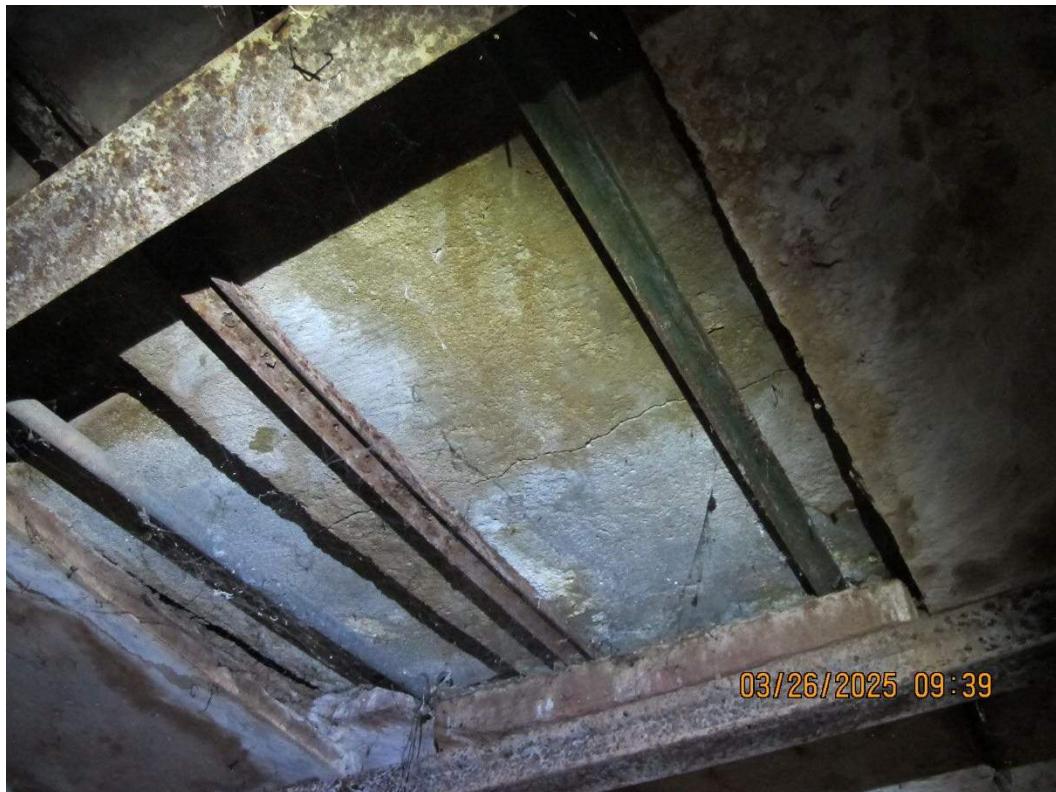
Photo C.15: South Culvert Station (S)2+62

| <u>Map Keynote</u> | <u>Description</u> |
|---|--|
| B | Deteriorated Steel Framing at Lid (Photo C.15 to Photo C.21) – At isolated locations, the steel framing supporting the flagstone lid members (lid construction Type C2) is deteriorated and/or deflected. A few locations have significant section loss due to corrosion. The locations indicated as High Concern (HC) or Medium Concern (MC) have deflected or damaged flagstones above the deteriorated steel framing. This indicates the steel members are not adequately supporting the flagstone lids above which could eventually lead to structural failure of the lid. |

| Deterioration Type: B – Deteriorated Steel Framing at Lid, C – Deteriorated Concrete Lid (accessible from above) | | | |
|---|---|---|---|
| 1 | <ul style="list-style-type: none"> ▪ Excavate damaged culvert lid. ▪ Remove lid and replace with a reinforced precast concrete panel between 6" and 8" thick. ▪ Backfill and replace landscaping/paving. | \$21,000 to \$31,000 per location | No change. |
| 2 | <ul style="list-style-type: none"> ▪ Excavate damaged culvert lid. ▪ Remove lid and replace with a reinforced cast-in-place concrete slab between 6" and 8" thick. ▪ Backfill and replace landscaping/paving. | \$19,000 to \$29,000 per location | No change. |

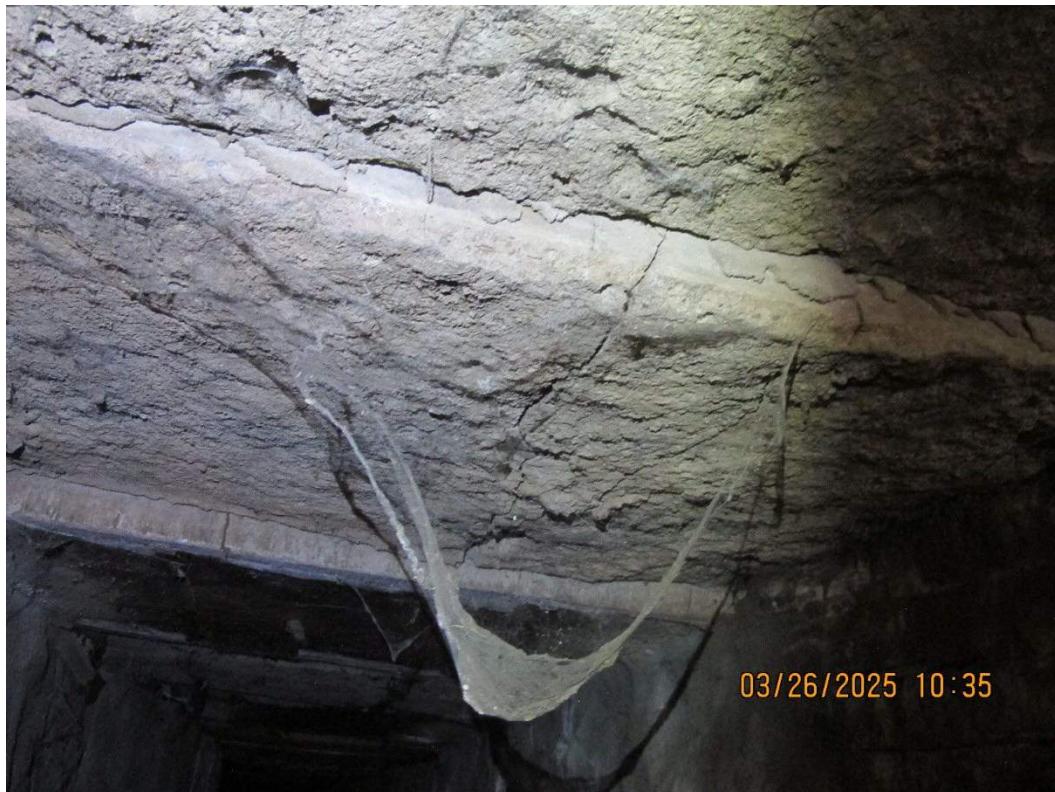
Photo C.22: South Culvert Station (S)3+82

| <u>Map Keynote</u> | <u>Description</u> |
|---|--|
| C | Deteriorated Concrete Lid (Photo C.22 to Photo C.27) – Some of the concrete lids are deteriorated or cracked and deflected. We observed spalled concrete and corroded reinforcing with section loss. Water is most likely infiltrating the culvert lids at these locations and corroding the steel reinforcing in the concrete slabs. This deterioration will continue to progress, which can eventually lead to structural failure of the lid. |

| Deterioration Type: C – Deteriorated Concrete Lid (not accessible from above) | | | |
|--|---|---|---|
| 1 | <ul style="list-style-type: none"> ▪ Perform partial depth overhead concrete repairs with supplemental reinforcing. | \$20,000 to \$23,000 per location | No change. |
| 2 | <ul style="list-style-type: none"> ▪ Dowel rebar into existing concrete lid. ▪ Install new 6"-to-8"-thick reinforced concrete lid to underside of existing lid via shotcrete. ▪ Note: this will reduce the overall height of the culvert in the repaired area. | \$11,000 to \$13,000 per location | Sta. (S)4+53 reduced from 436 cfs to 338 cfs Sta. (S)7+75 to (S)7+86 reduced from 388 cfs to 297 cfs |

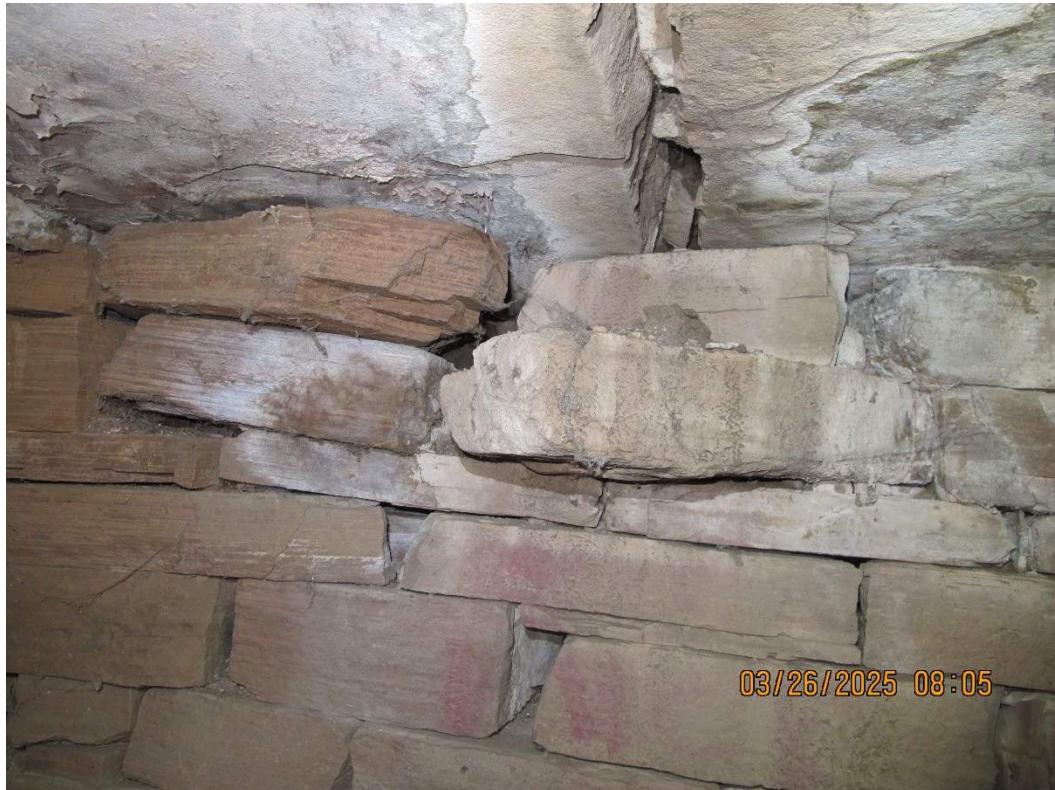
Photo C.28: South Culvert Station (S)0+16

| <u>Map Keynote</u> | <u>Description</u> |
|---|--|
| D | Poor Bearing Condition at Top of Wall (Photo C.28 to Photo C.36) – At several locations there are loose or missing masonry stones at the top of the walls resulting in a poor lid bearing condition. When the flagstone or concrete lids do not have full bearing on the wall below, it increases the stress in both the lids and the walls, making them more prone to cracking or fracturing. |

| Deterioration Type: D – Poor Bearing Condition at Top of Wall | | | |
|--|--|---|---|
| 1 | <ul style="list-style-type: none"> ▪ Reset or replace loose or missing masonry stones. ▪ Provide mortar at joints around repaired masonry stone. | \$600 to \$1,000 per location | No change. |
| 2 | <ul style="list-style-type: none"> ▪ Remove loose masonry, if present, and fill void with low shrinkage concrete repair mortar in void. | \$1,500 to \$2,000 per location | No change. |
| 3 | <ul style="list-style-type: none"> ▪ Monitor for change or progressed deterioration as part of regular inspections and maintenance. | None | No change. |

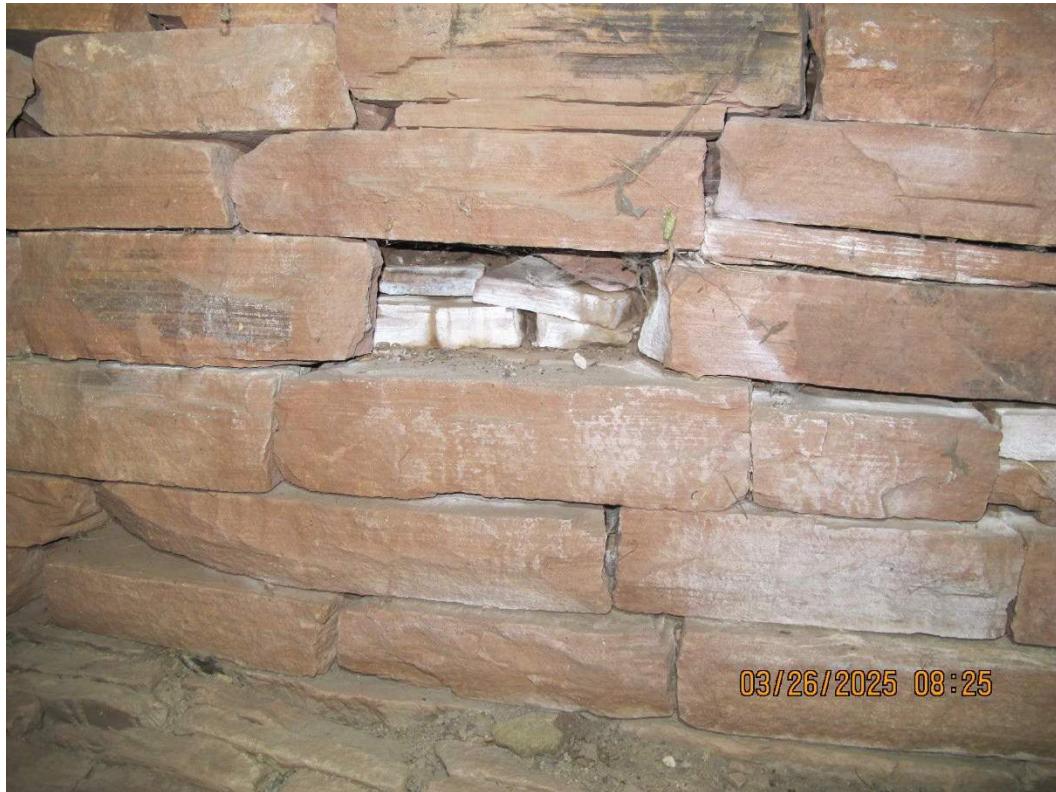
Photo C.37: South Culvert Station (S)0+85

| <u>Map Keynote</u> | <u>Description</u> |
|---|--|
| E | Missing or Displaced Masonry in Wall (Photo C.37 to Photo C.49) – At several locations there are one to two masonry stones missing from the wall, or there is displacement of a few stones within the wall. It is unclear whether these issues were from the original construction or if they were caused by soil loads acting on the walls. This is a low structural concern but should be monitored to determine if the conditions are worsening. |

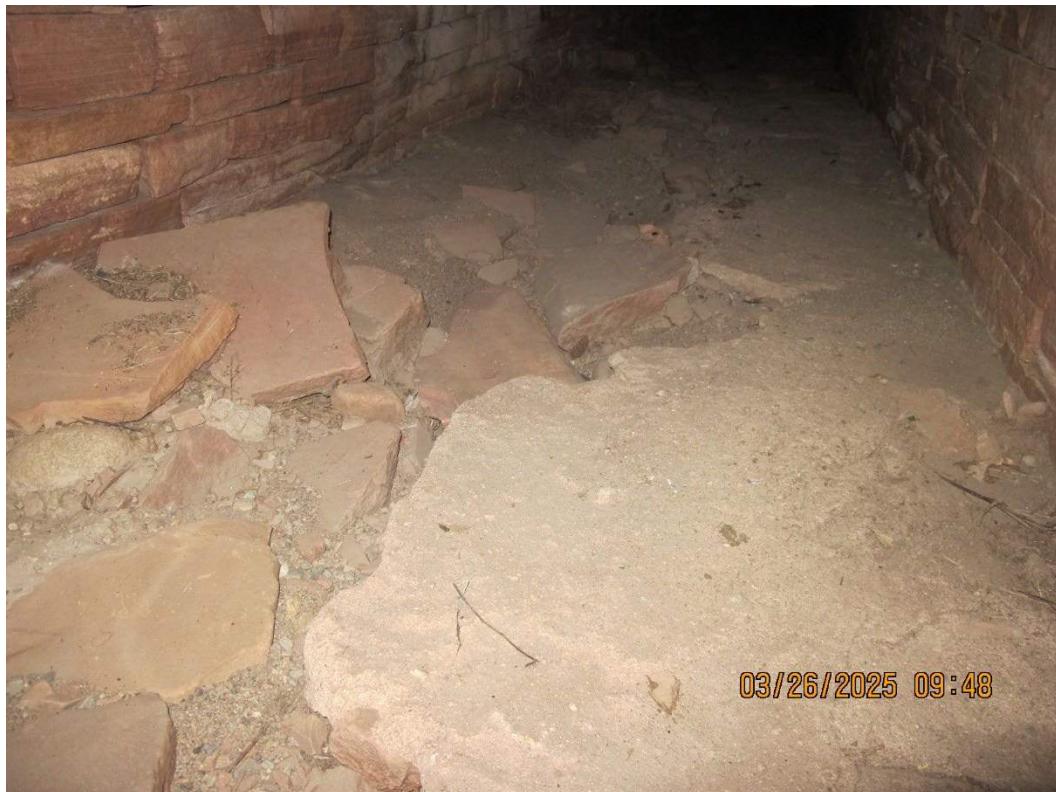
Photo C.50: South Culvert Station (S)2+77

| <u>Map Keynote</u> | <u>Description</u> |
|---|--|
| F | Scour, Washout, or Large Drop at Floor (Photo C.50 to Photo C.56) – Scour (erosion of the soil below the concrete floor caused by flowing water) and washout (erosion and removal of soil and sediment due to water flow) is occurring at a few locations throughout the culvert. Additionally, there are several locations with a drastic drop in the floor elevation, likely due to a change in floor construction resulting in the downstream area degrading more quickly than the adjacent upstream area. These locations cause inconsistent water flow regions and will continue to worsen over time, possibly undermining the foundations of the bearing walls. This could eventually compromise the structural integrity of the walls. |

| Deterioration Type: F – Scour at Culvert Floor | | | |
|---|--|---|---|
| 3 | <ul style="list-style-type: none"> ▪ Monitor for change or progressed deterioration as part of regular inspections and maintenance. | None | No change. |

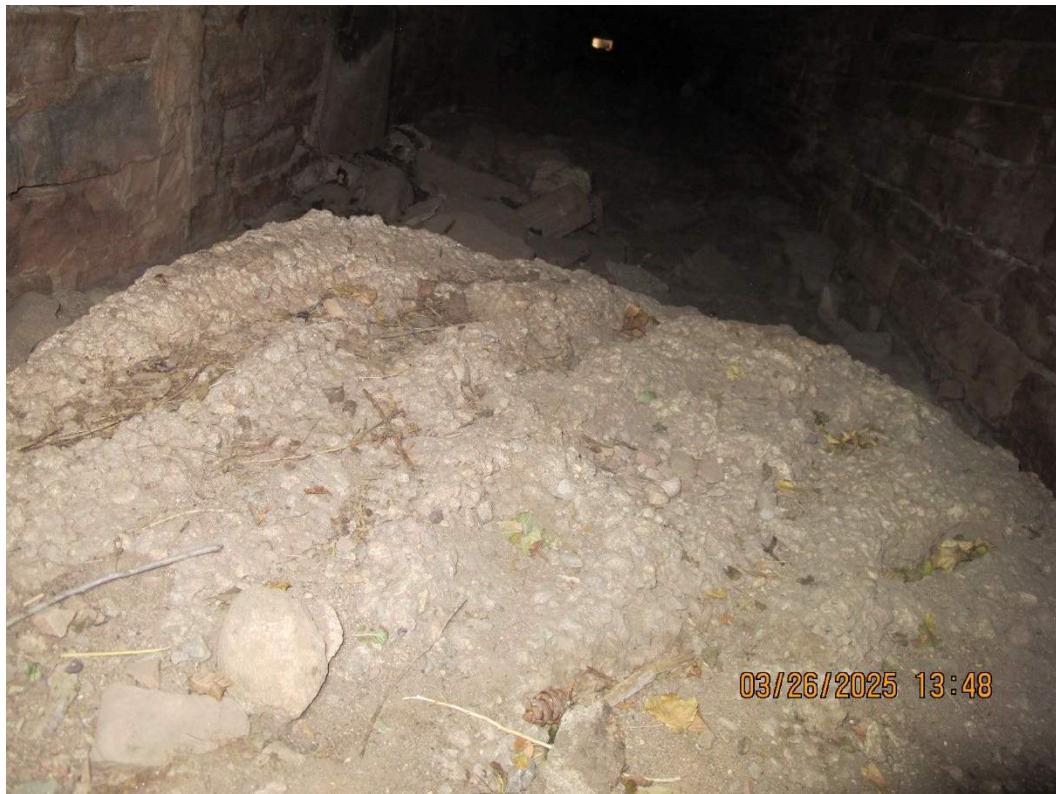
Photo C.57: South Culvert Station (S)8+27

| <u>Map Keynote</u> | <u>Description</u> |
|---|--|
| G | Large Pile of Rubble or Concrete at Floor (Photo C.57 to Photo C.59) – There are several piles of rubble, concrete, or debris present throughout the floor of the culvert. The rubble piles are likely formed by scour and washout dislodging materials from the culvert walls and floor, depositing them in certain low-flow areas. These piles will continue to trap more rubble and debris, worsening the problem. This issue is a Low Concern in regard to structural integrity; however, it could rapidly become a High Concern issue with a large storm event. |

We recommend that a regular maintenance program be established. Maintenance would largely consist of removing debris and silt build-up within the culverts. This would improve drainage performance as well as allow for easier observations during inspection. According to the CDOT 2024 Cost Data, the estimated cost to clean the entire length of both culverts would be approximately \$61,000 to \$65,000. We also recommend that the culverts be inspected every 3 to 4 years to monitor their condition, areas of concern, and determine when and where future repairs are needed.
