STREAM BYPASS FLOW STUDY

25_STRM BYPASS_STUDY_01

*St. Vrain Creek
Ralph Price Reservoir (Button Rock)
to
Supply Irrigating Ditch Diversion*

August 13th, 2025

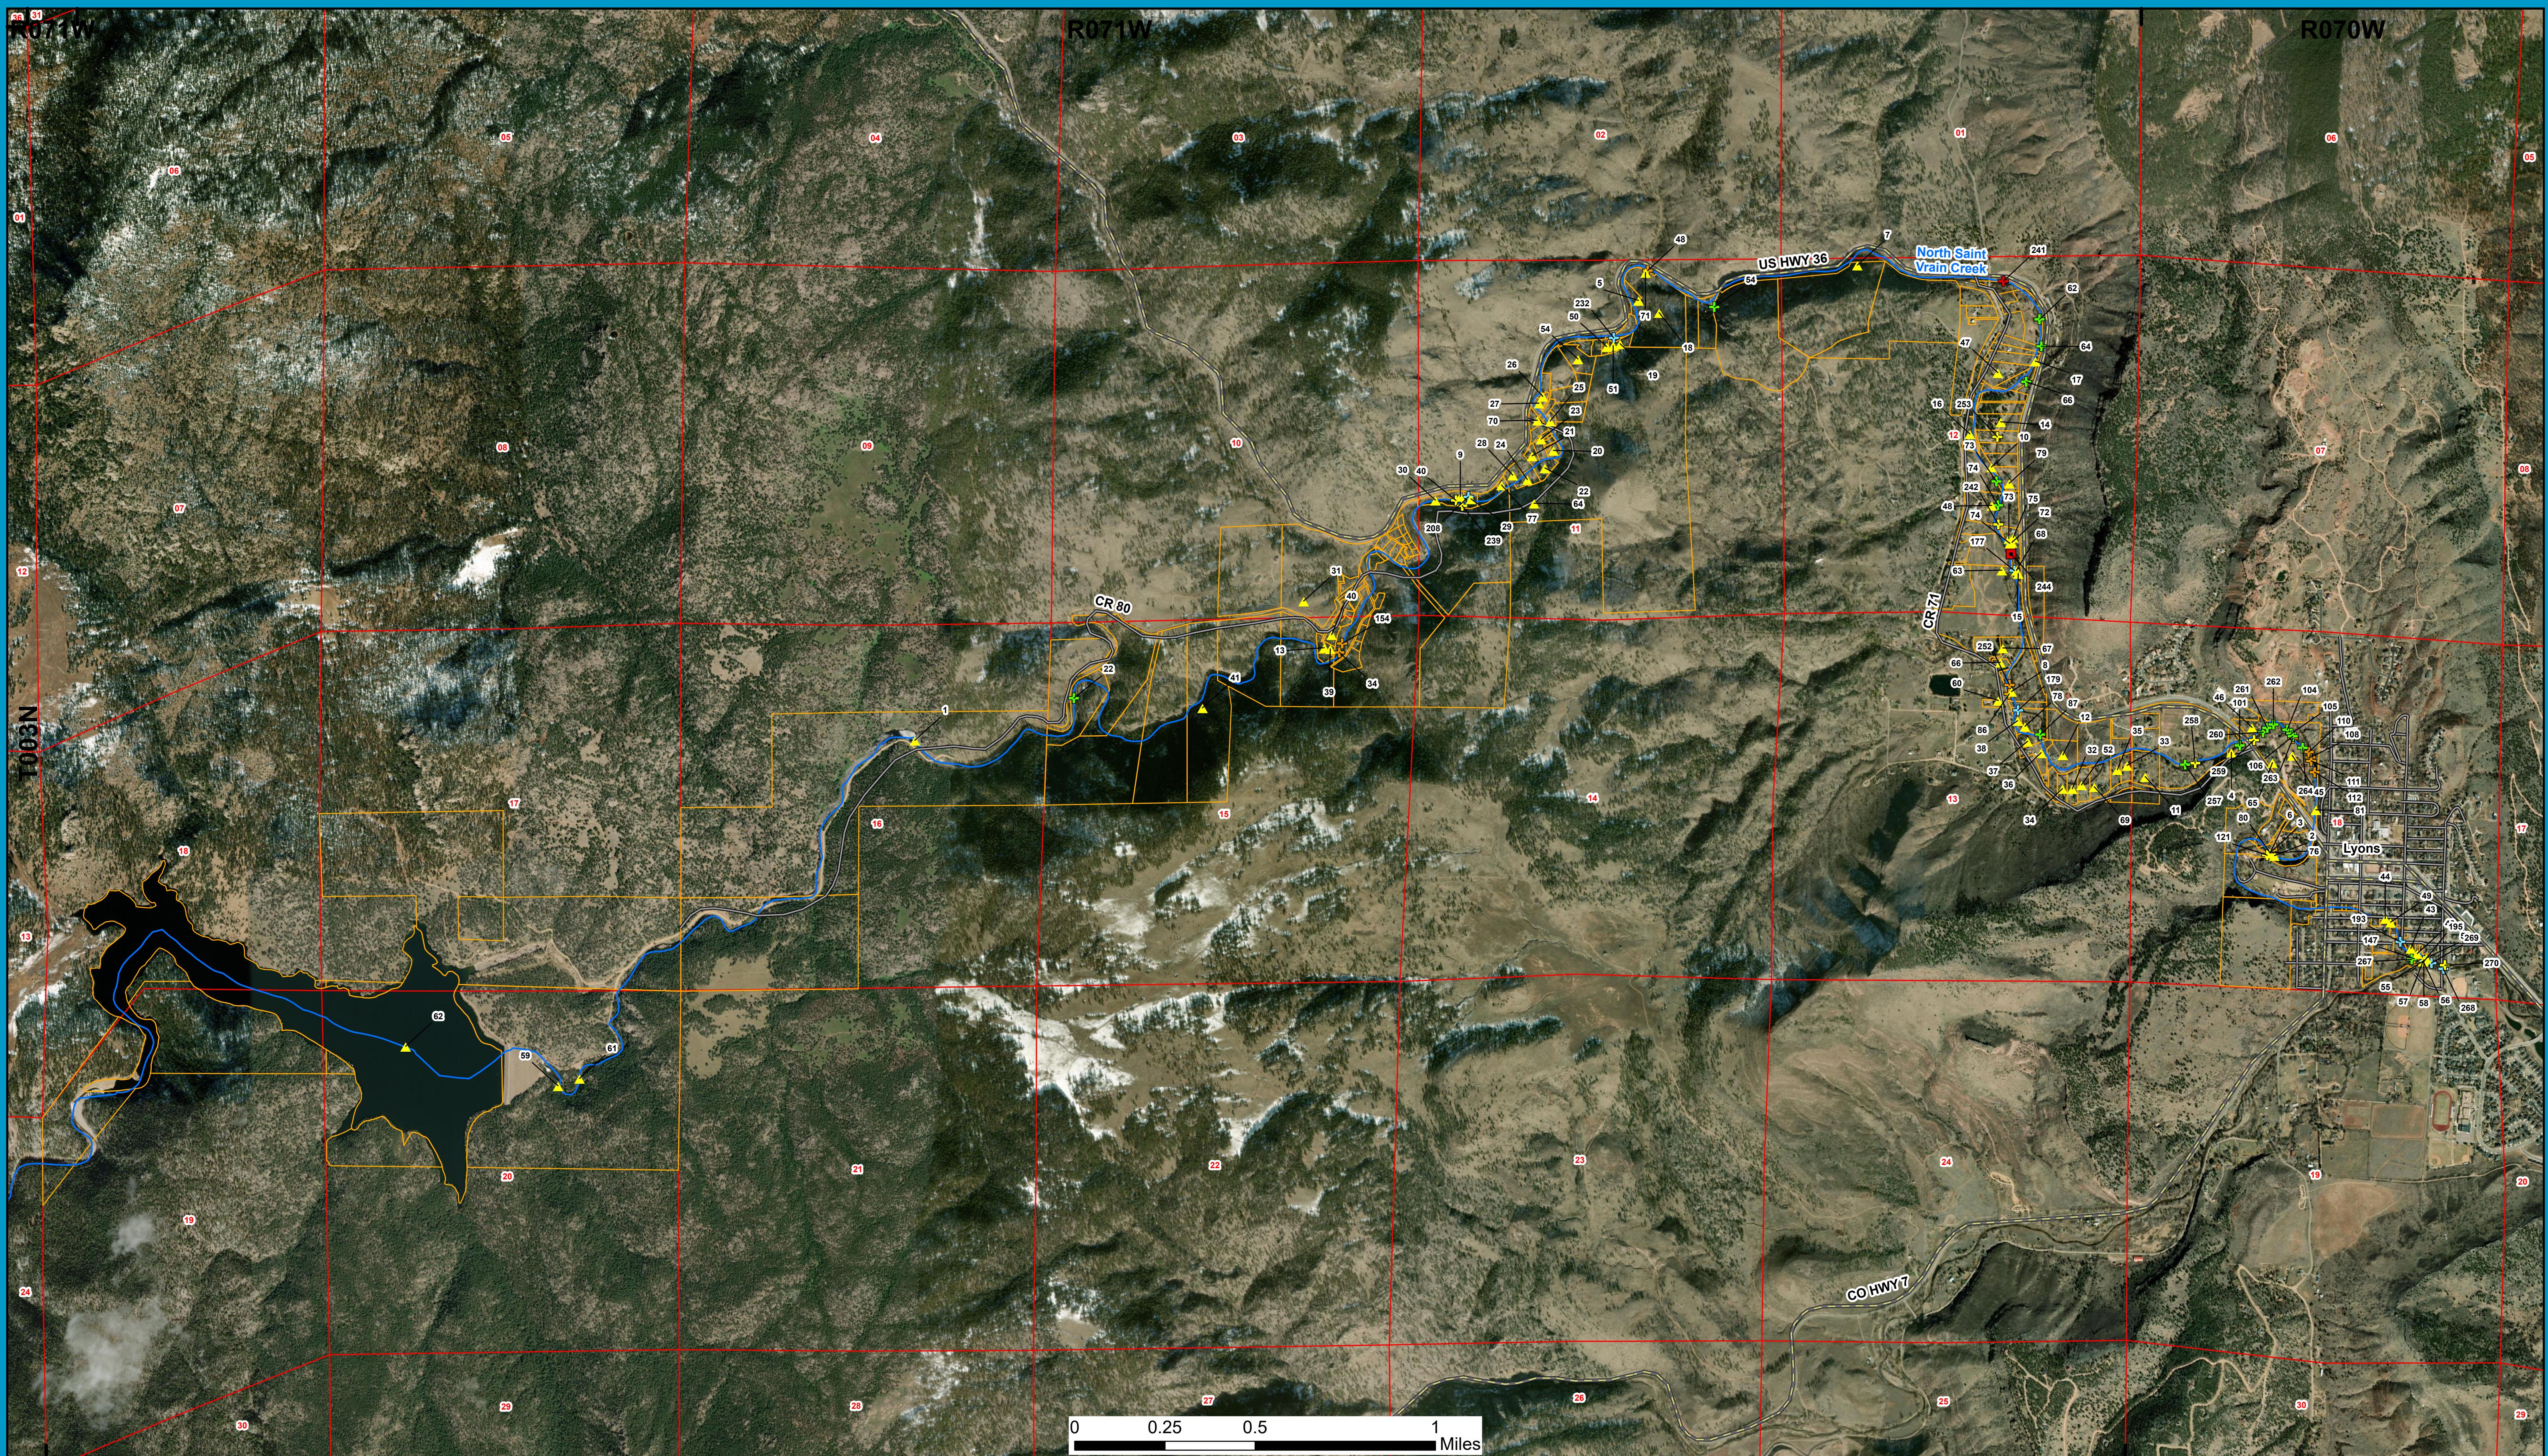
Figure 1.1 - Bypass Diversion Locations & Field Observations

Please refer to **Appendix C (Photo Log)** for specific diversion details and notes. **Figure 1.1** in Appendix A provides locations of bypass diversion locations and provides numerical indicators to match the respective photos found in Appendix C (Photo Log).

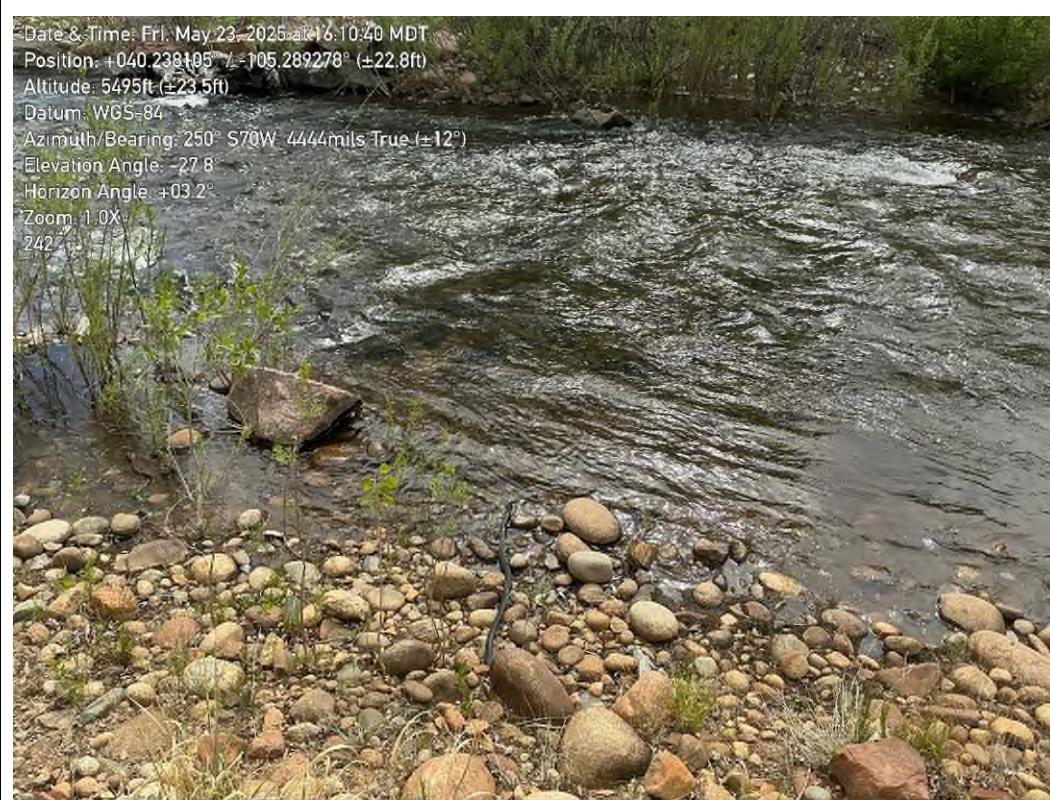
Photograph: 47

Black 1" tube in river that goes to Donald & Dawn Elsberry - no associated water right observed.

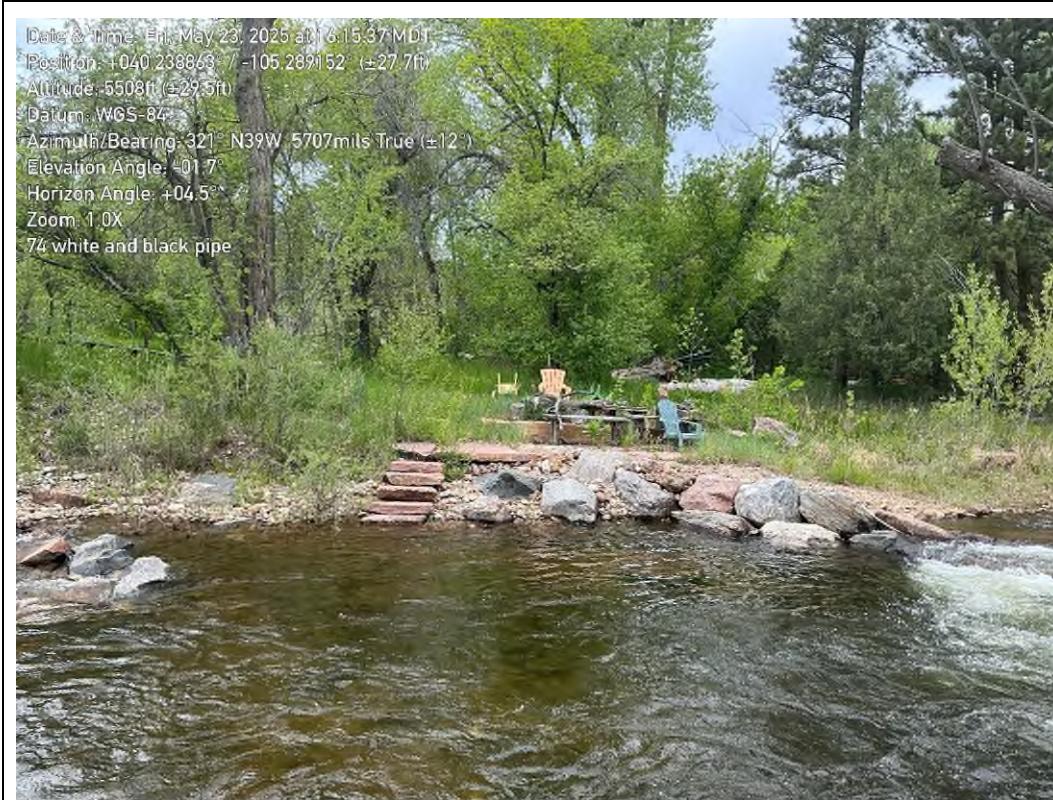
Photograph: 49

Black and white pipe for pumping in background. Belongs to Burdock Hollow LLC – no meters observed.

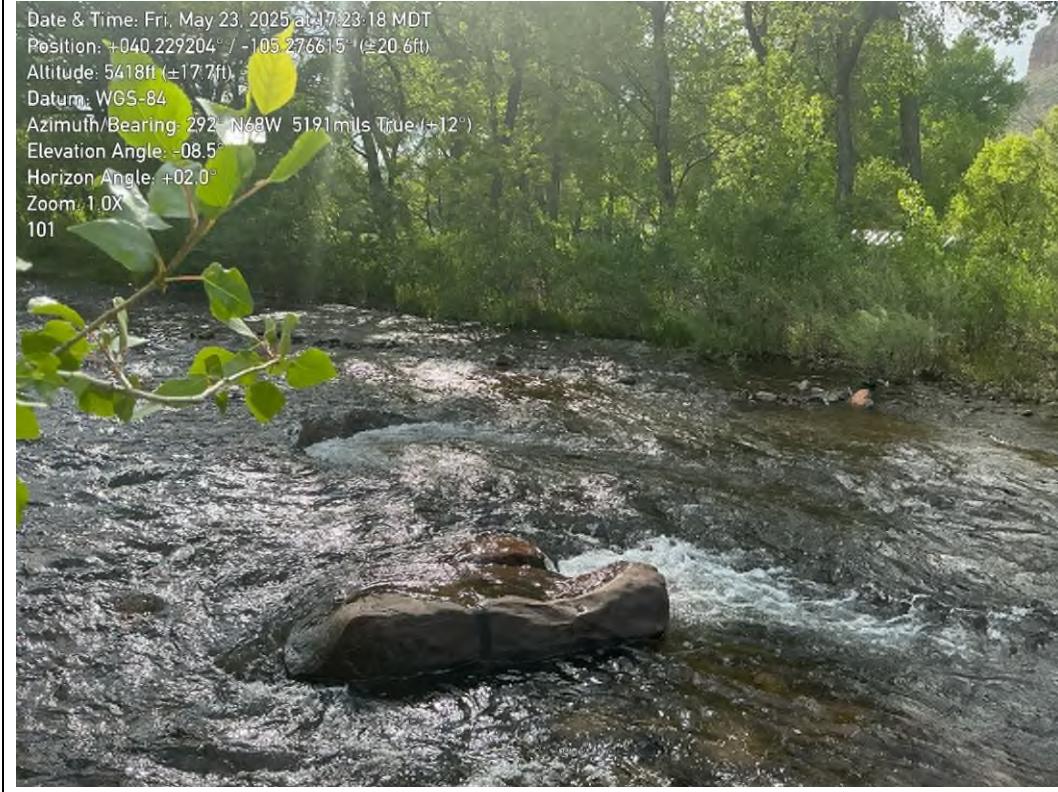
<p>Photograph: 58 Date: 5/23/2025 Location: Lyons, CO Description: <i>Wier built in water. Irrigation pulls upstream from Planet Bluegrass Farm LLC. Extensive irrigation occurring. No water rights found.</i></p>

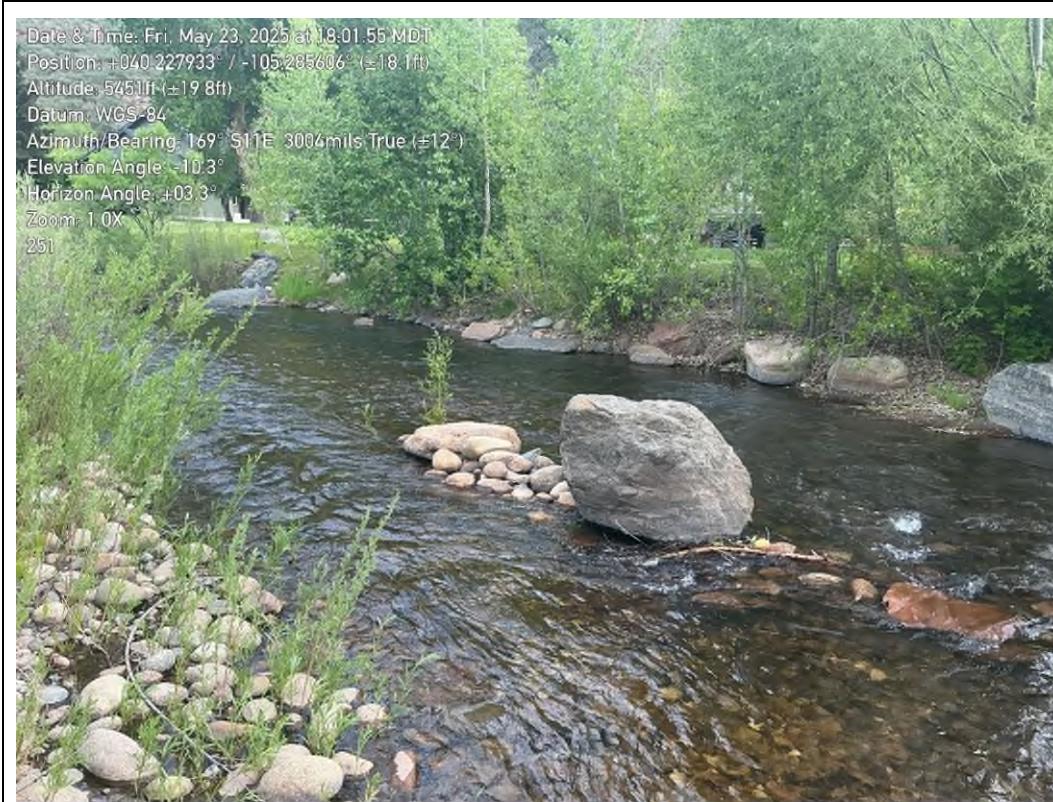
Photograph: 64

No concern - possibly man-made erosion control or flow control structure.

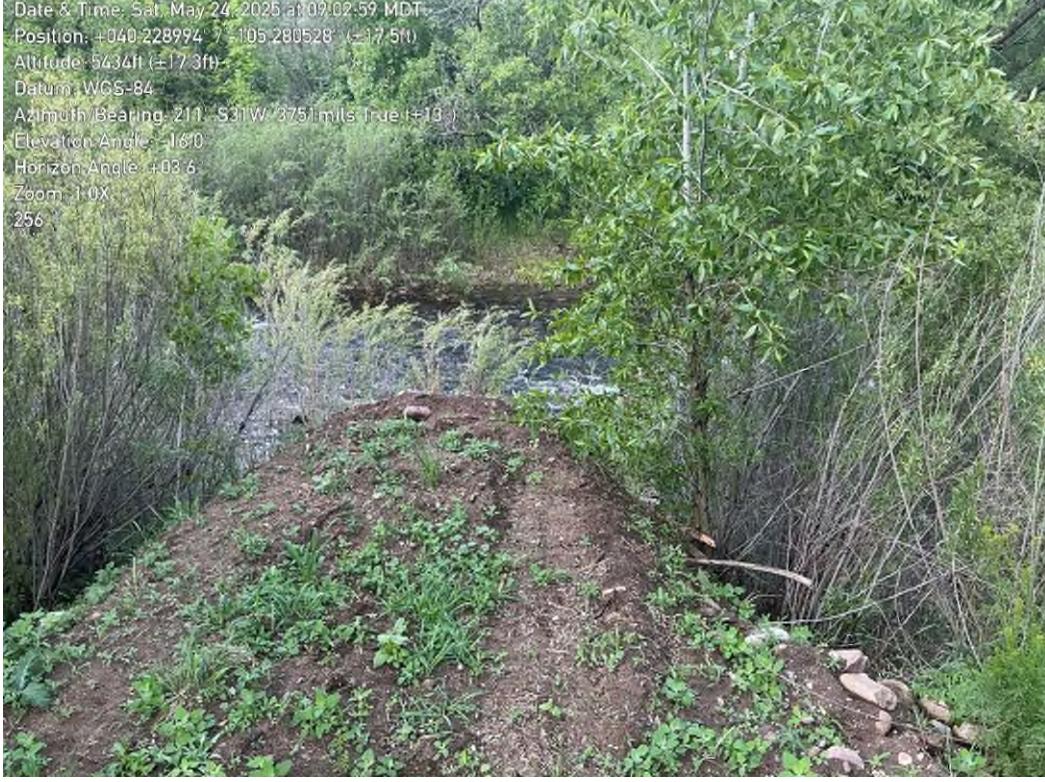
<p>Photograph: 83 Date: 5/24/2025 Location: Lyons, CO Description: <i>Bank area to possibly draw water. They are drawing from other areas- Black pipe and container directly behind this point. Planet Bluegrass Farms LLC. No water rights observed.</i></p>

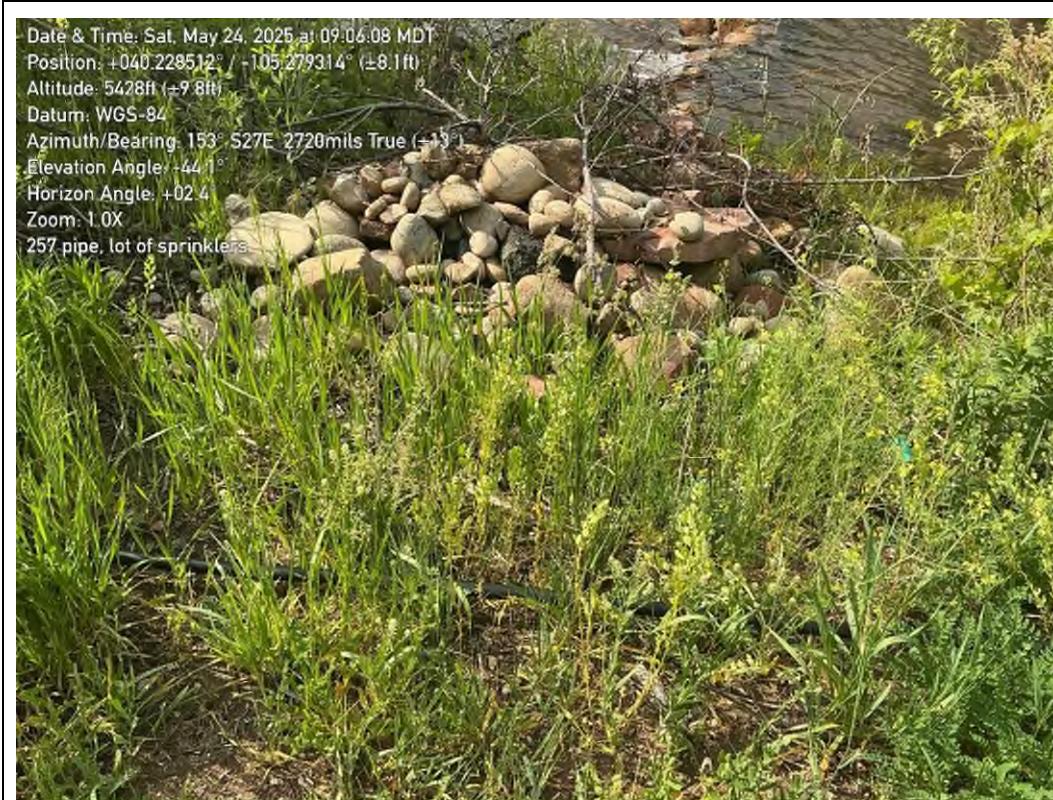
Photograph: 86

*Pipe by man-made
weir - Bluegrass
Farms LLC*

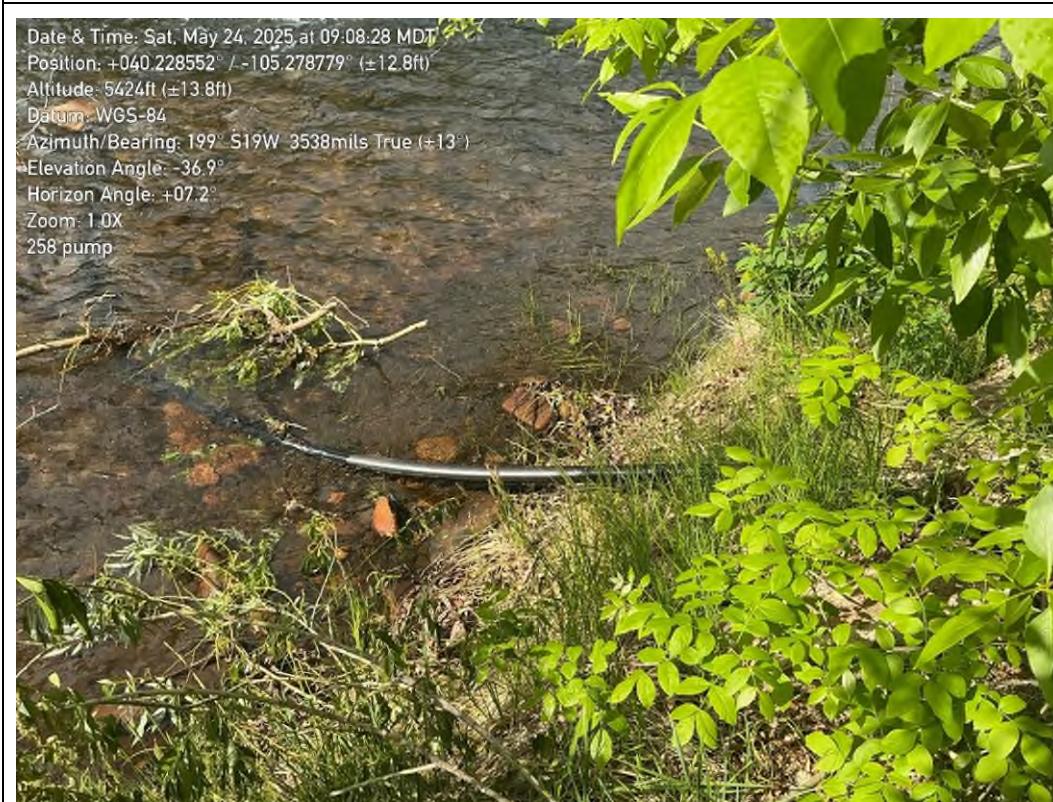
Photograph: 87

*Pumps from river-
2.5" pipe. Waters
almost all the
property. No water
rights observed.
Bluegrass Farms LLC*

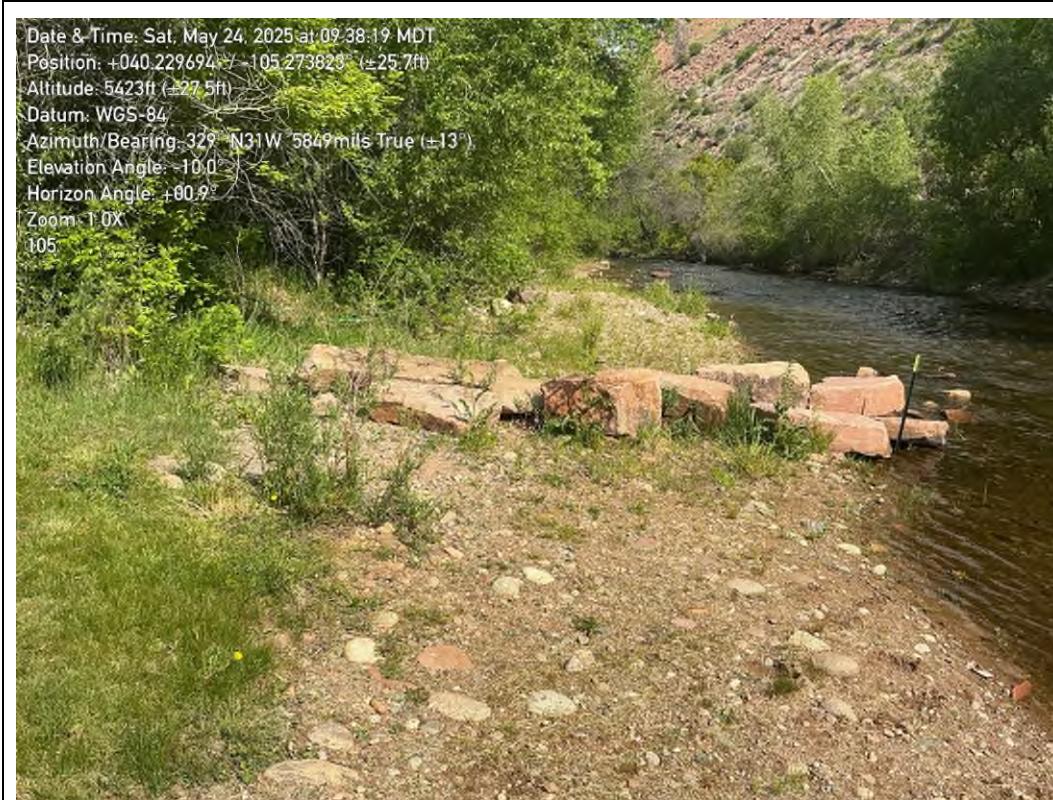
Photograph: 101

Larger Weir.

Festivaria LLC

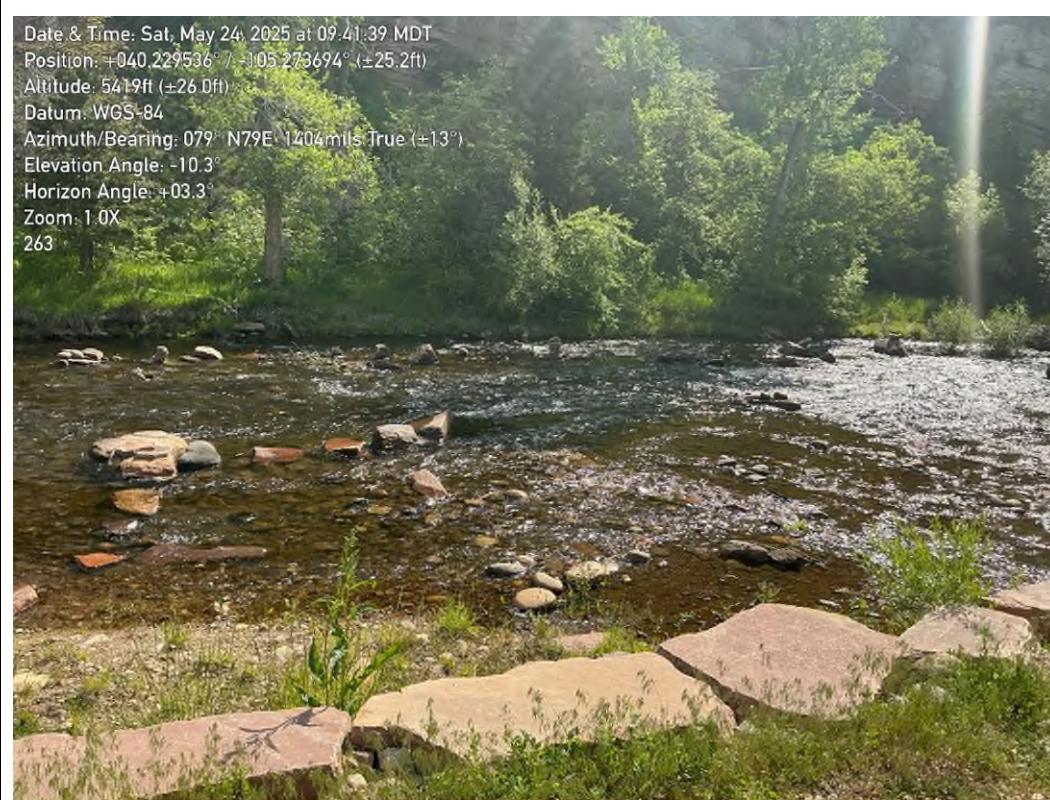
Photograph: 103

Weirs to slow water.

Festivaria LLC

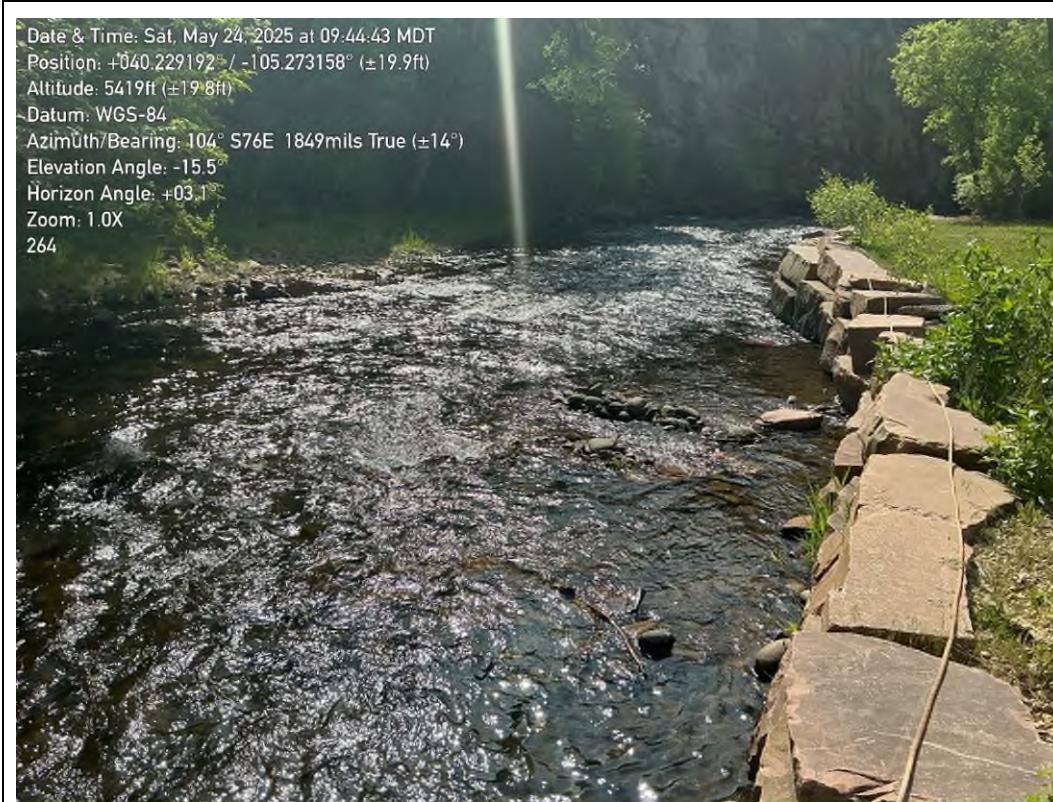
Photograph: 105

Additional Weir.
 Festivaria LLC

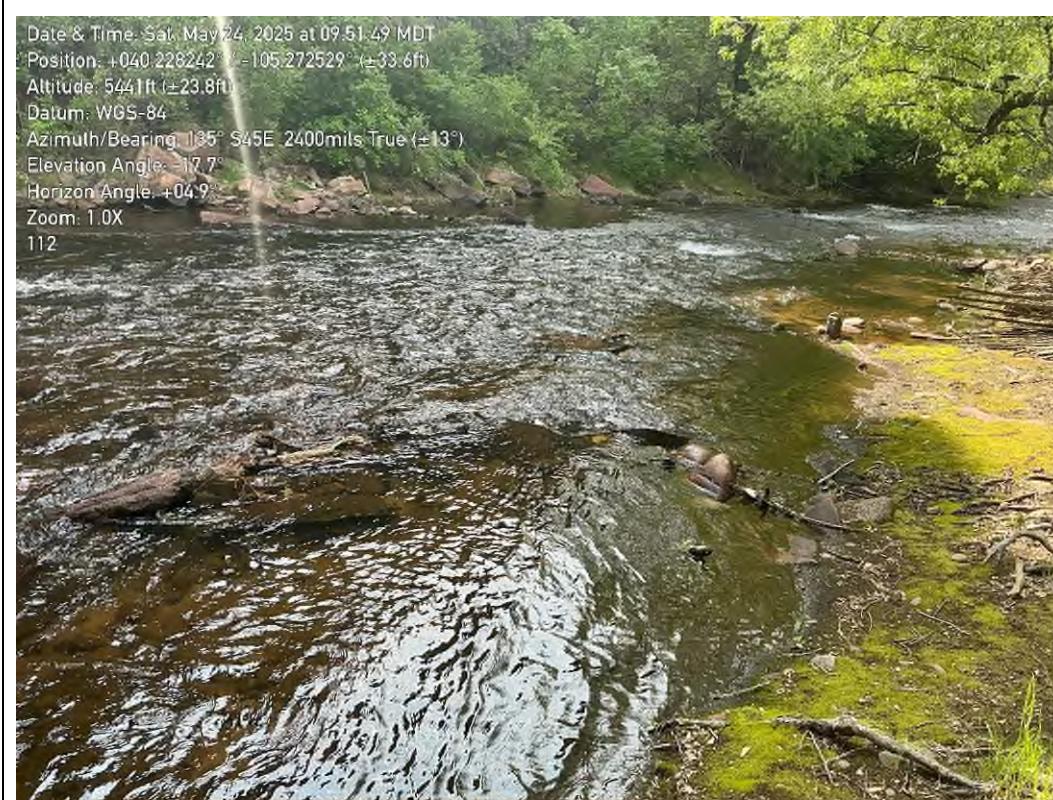
Photograph: 111

J-Hook shaped weir.
 Festivaria LLC

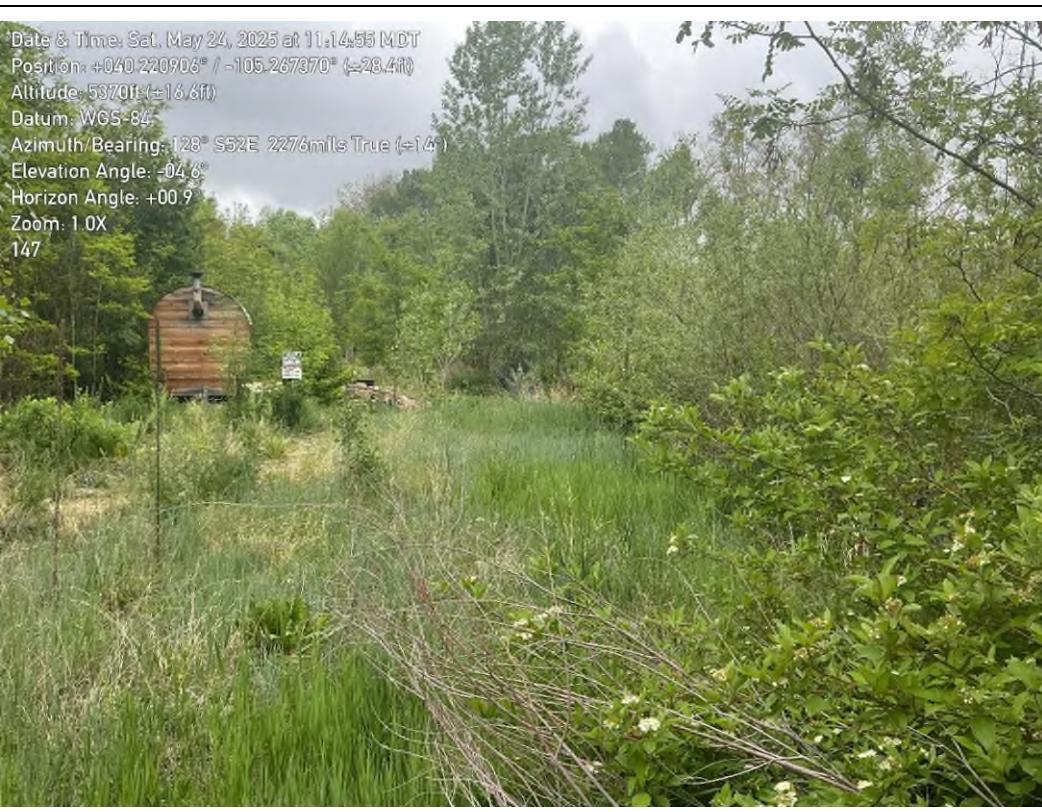
<p>Photograph: 139 Date: 5/24/2025 Location: Lyons, CO Description: Pump on neighbor that is next to Town of Lyons where the above 2.5" pipe was. Water right associated: https://dwr.state.co.us/Tools/Structures/0501228</p>

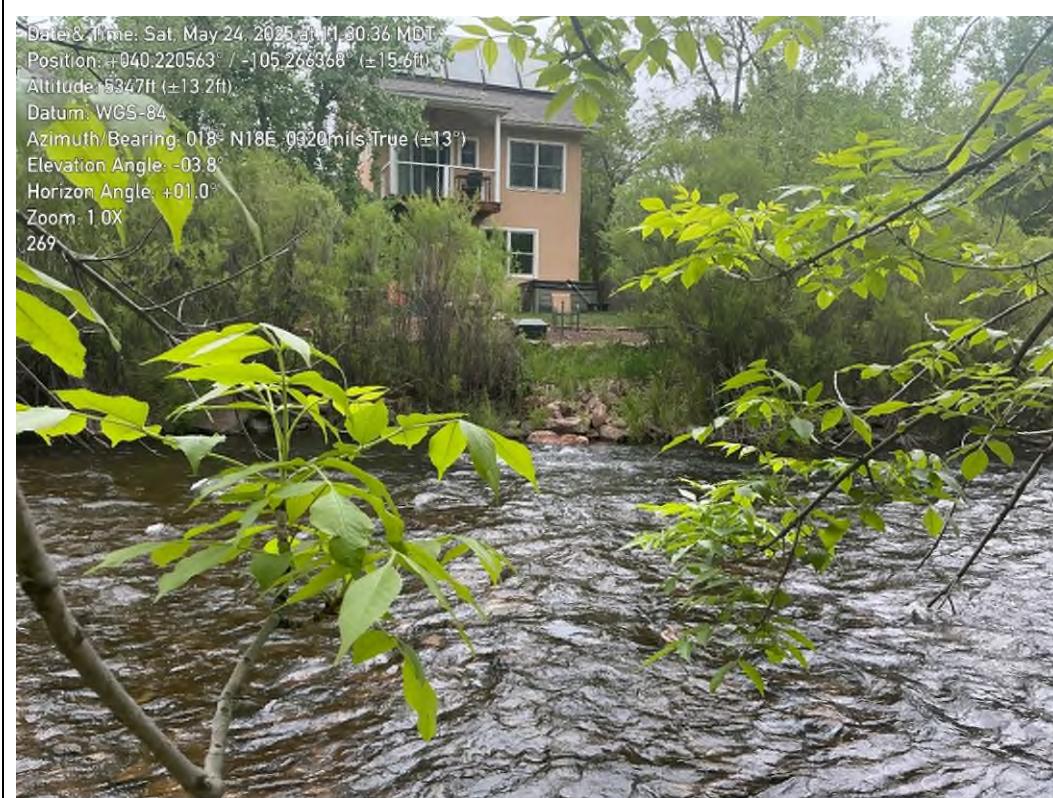
Photograph: 144

Possible Pump in yard w/ river access. No water right association observed. No homeowner information available.

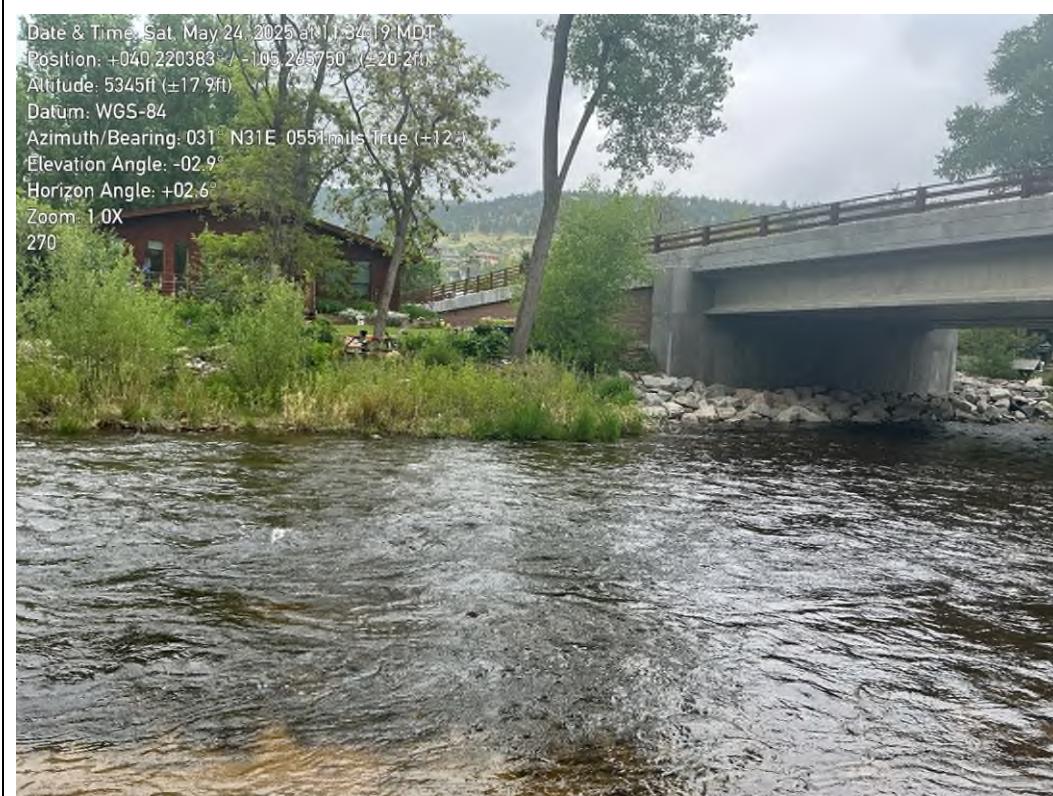
Photograph: 145

1" Black pipe in water - no water right observed.
