Memo

RE: McConnell Drive Pavement Rehabilitation Recommendation

The purpose of this memo is to provide a recommendation for the distressed asphalt pavement on McConnell Drive from 2nd Avenue to Bohn Court. This is the stretch of roadway in front of the Lyons Middle Senior High School.

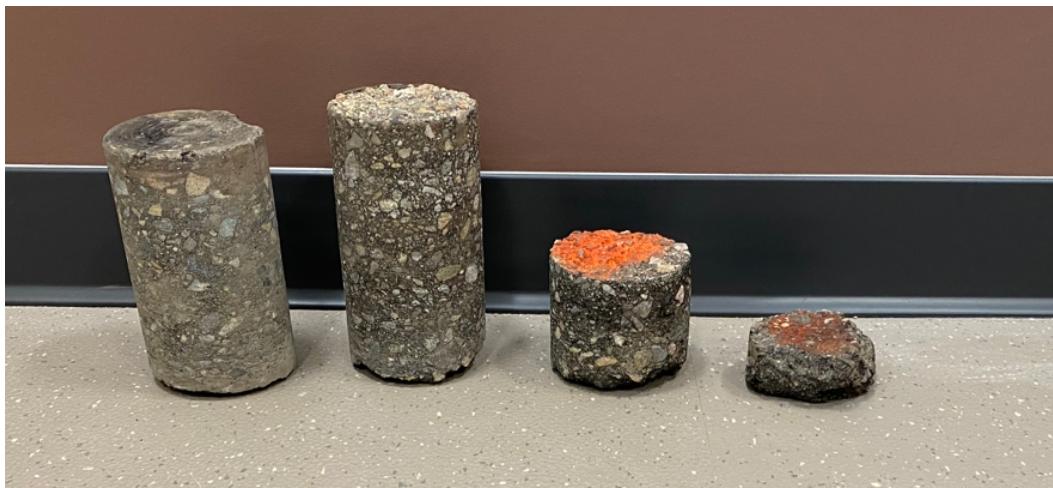
Picture of Core Samples. Left to right - Block Cracking section near 2nd Ave, block cracking section 200' north of Bohn Ct, fatigue cracking section near southernmost school crosswalk, fatigue cracking section near northernmost school crosswalk (bottom 2" of this core disintegrated)

For the blocked cracked areas, the cores show that these areas have an approximate pavement thickness of seven inches and the lower sections of pavement are in good condition. This further indicates that a mill and overlay would be an adequate treatment for this condition. The milling would remove the worn upper layer and there is a stable foundation layer for the new pavement overlay.

The cores show that the fatigue cracked areas have an approximate pavement thickness of four inches and the pavement material is fatigued and fractured throughout the entire core. It is unknown why those pavement areas are thinner, but it is likely the reason why the pavement in these areas is so highly distressed. The asphalt and aggregate base in these areas will have to be removed, excavated to low enough to all for a full pavement section, and rebuilt with new aggregate base and asphalt.

It is recommended that this section of McConnell drive be included in the 2023 pavement maintenance and rehabilitation program if there is a sufficient budget for the program. The section is approximately 1,200 feet long and 40 feet wide for a total of 5,300 square yards. It is assumed that approximately 10% of the section will require full-depth reclamation or 530 square yards.
