Flagstone Culvert Investigation

Final Report
July 16, 2025

Town Of Lyons
432 5th Ave
P.O Box 49
Lyons, Colorado 80540

Town Project Number: 24-CULVERT-01
Martin/Martin, Inc. Project Number: 25.0203.S.01

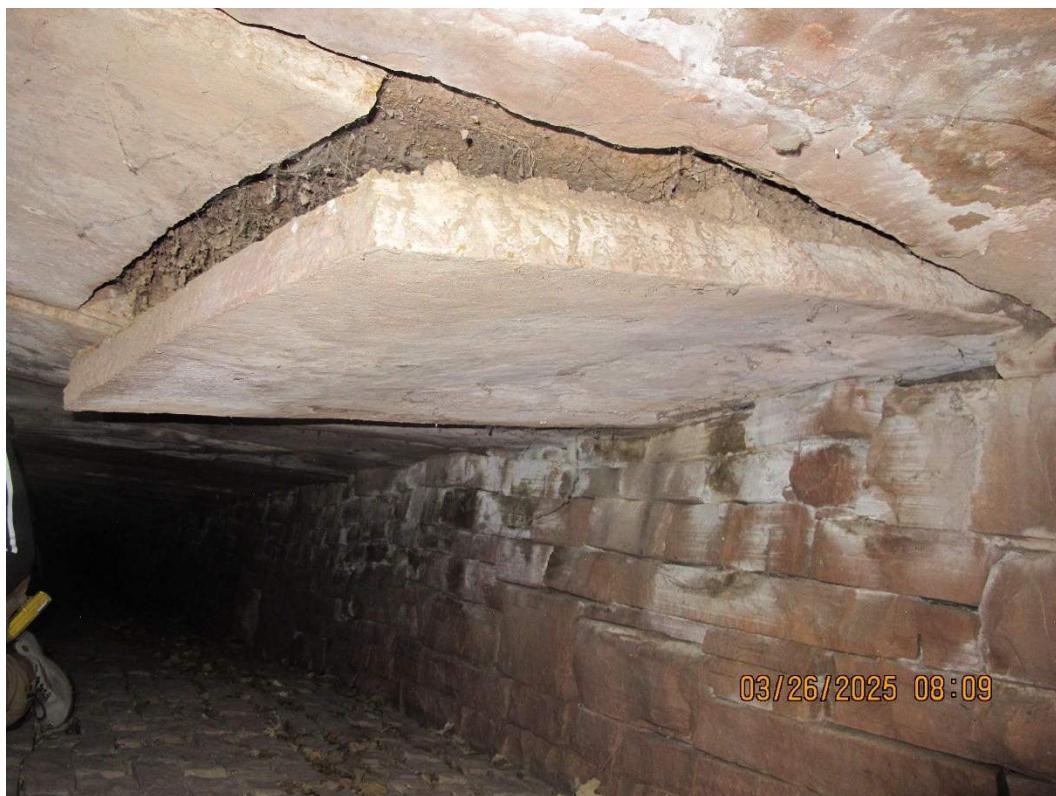
Photo C.2: South Culvert Station (S)0+24

DAMAGE TYPE A (Flagstone Lid Fracture)

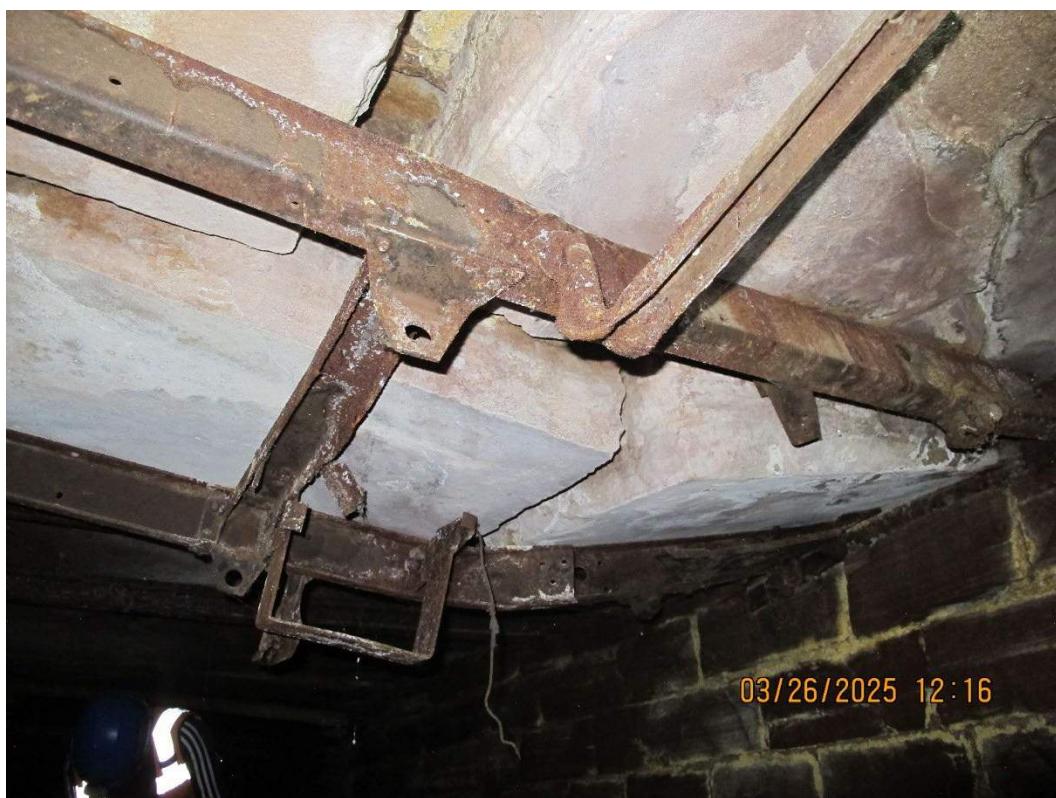
Photo C.16: South Culvert Station (S)7+04

DAMAGE TYPE B (Deteriorated Steel Framing at Lid)

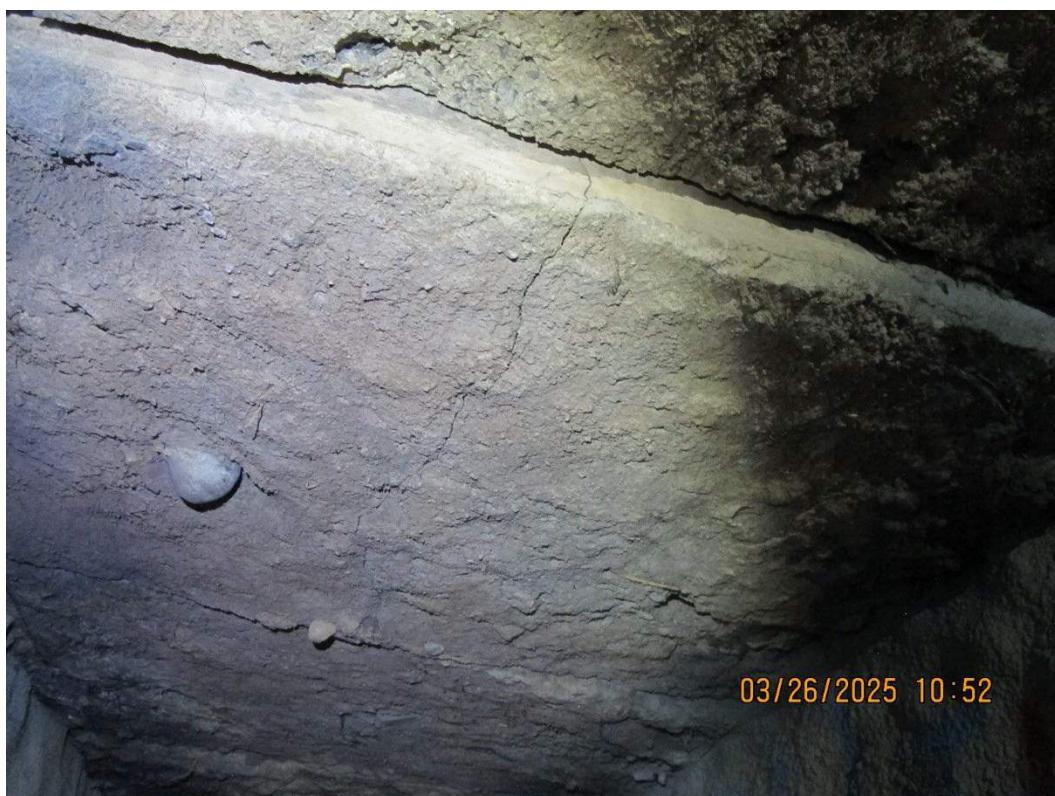
Photo C.23: South Culvert Station (S)4+53

DAMAGE TYPE C (Deteriorated Concrete Lid)

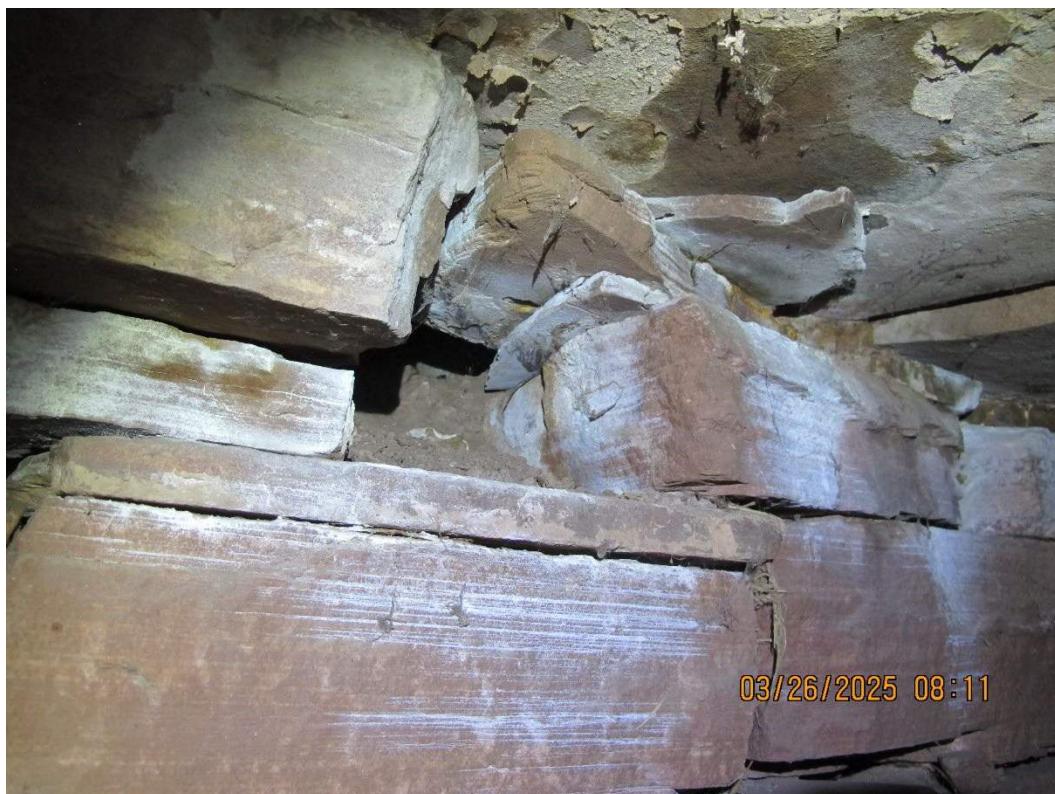
Photo C.29: South Culvert Station (S)0+24

DAMAGE TYPE D (Poor Bearing Condition at Top of Wall)

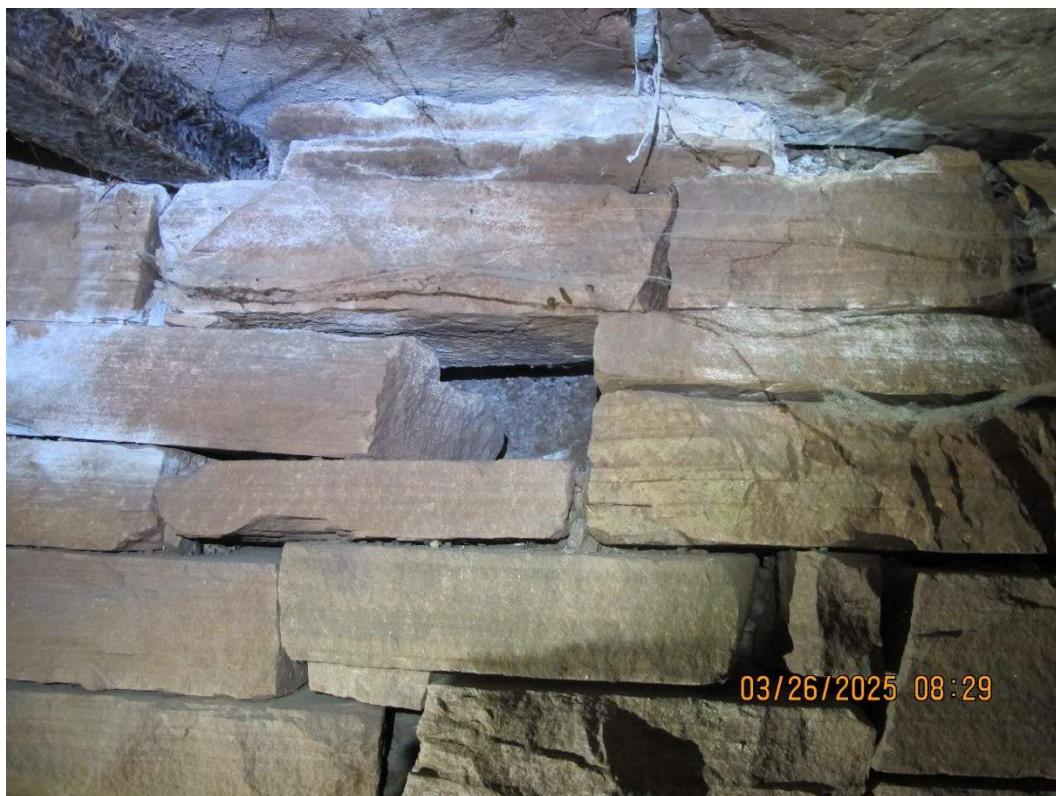
Photo C.38: South Culvert Station (S)0+91

DAMAGE TYPE E (Missing or Displaced Masonry in Wall)

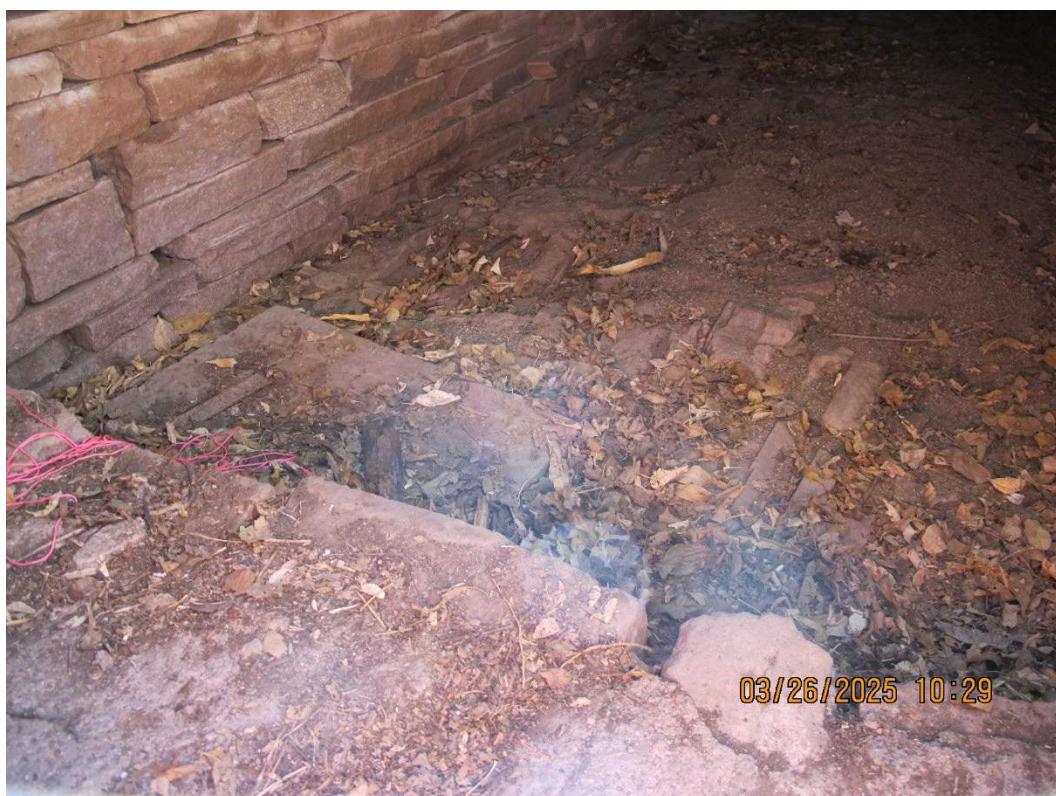
Photo C.50: South Culvert Station (S)2+77

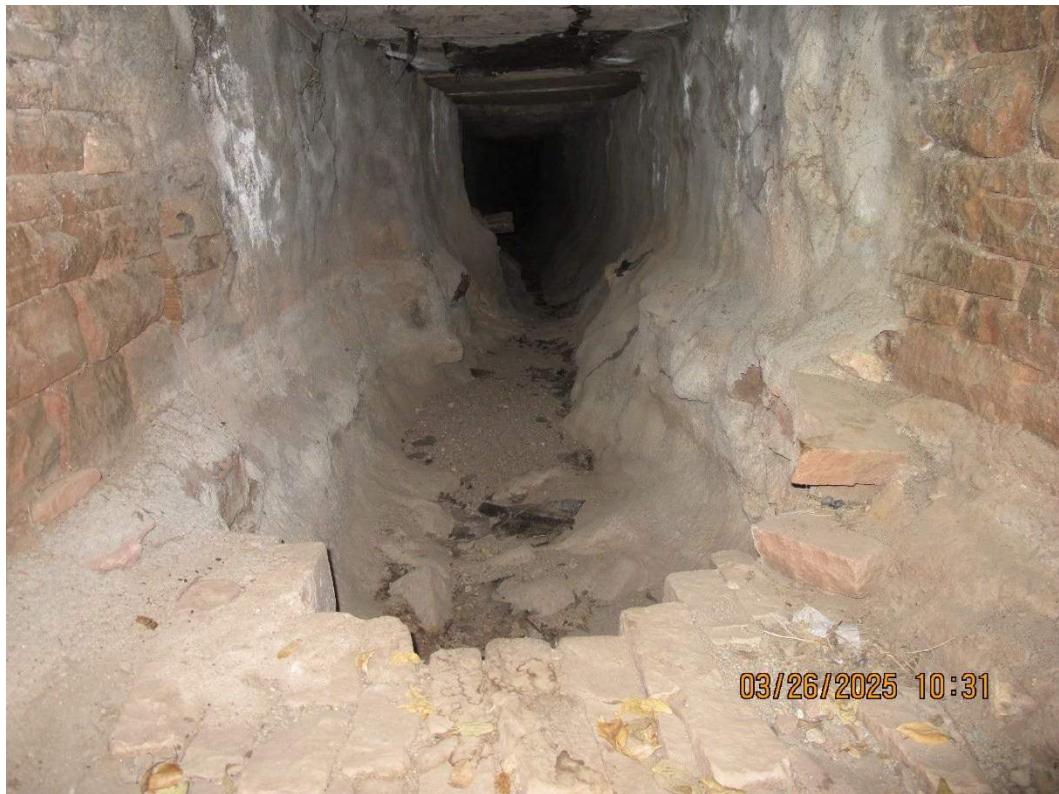
Photo C.51: South Culvert Station (S)3+63

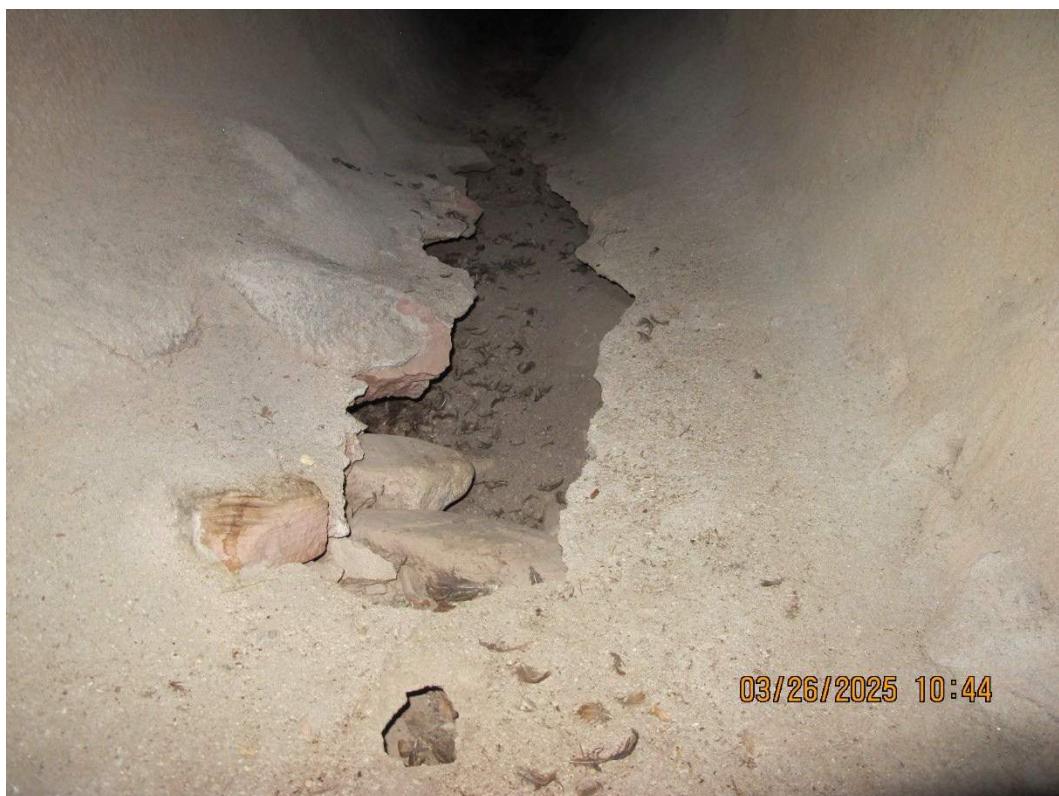
Photo C.52: South Culvert Station (S)3+80

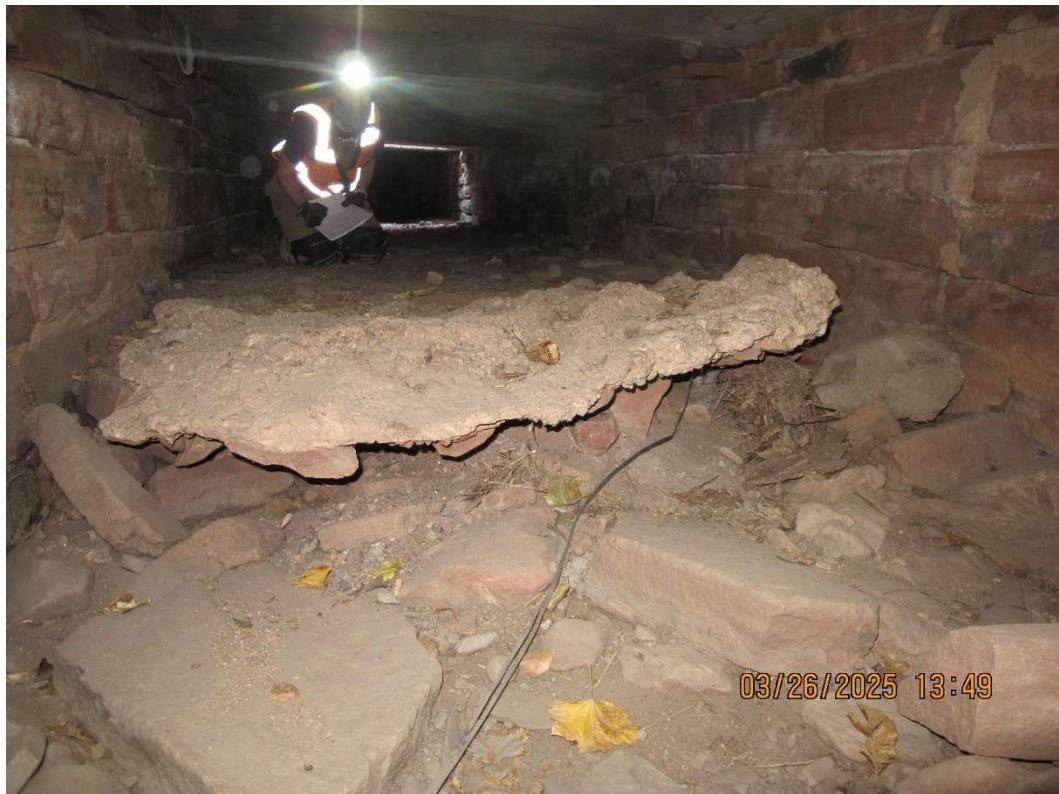
Photo C.53: South Culvert Station (S)4+14

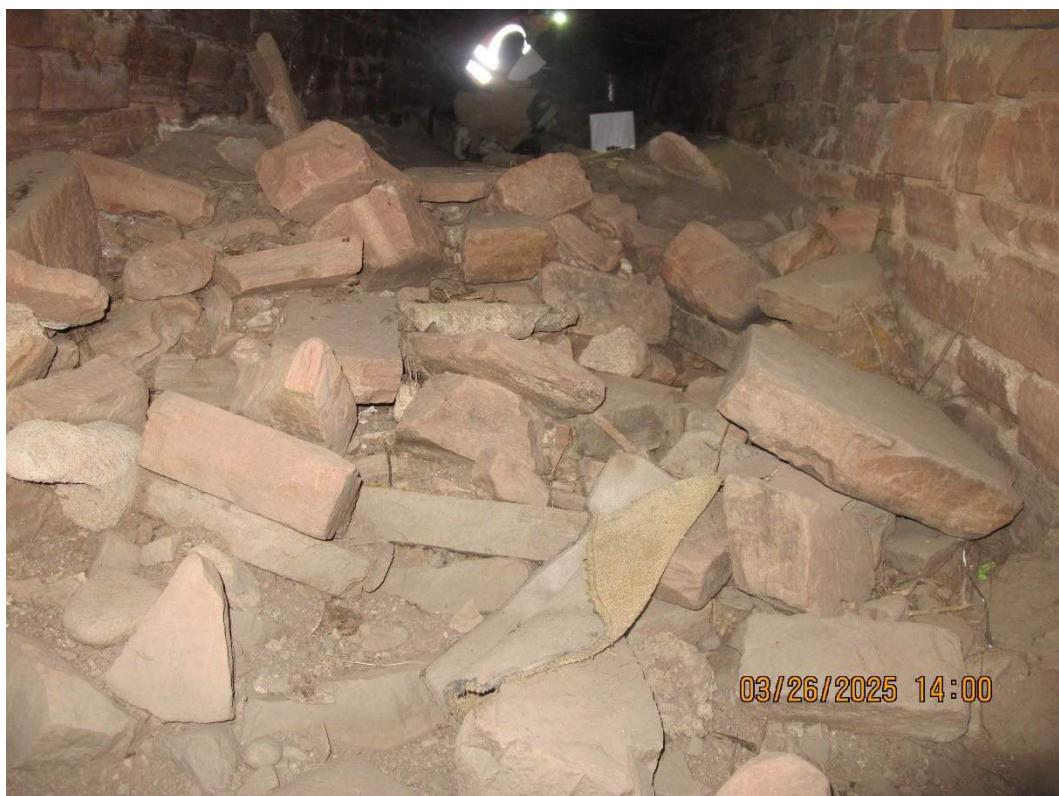
Photo C.54: South Culvert Station (S)8+30

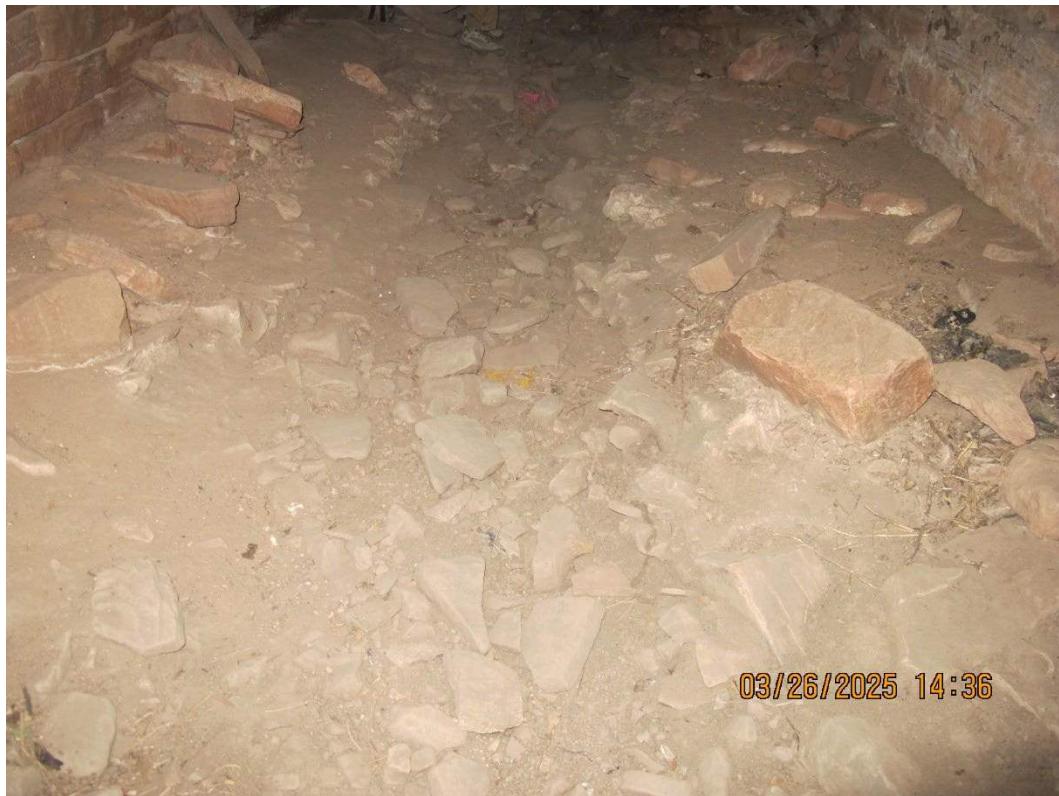
Photo C.55: South Culvert Station (S)8+62

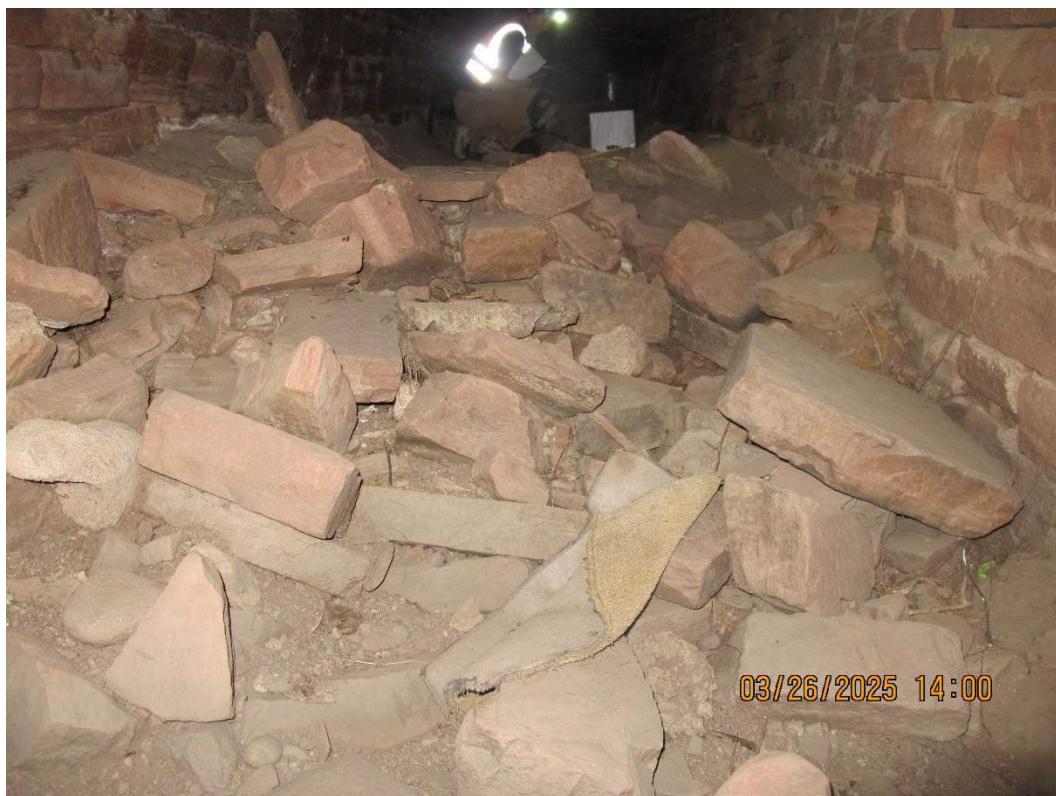
Photo C.57: South Culvert Station (S)8+27

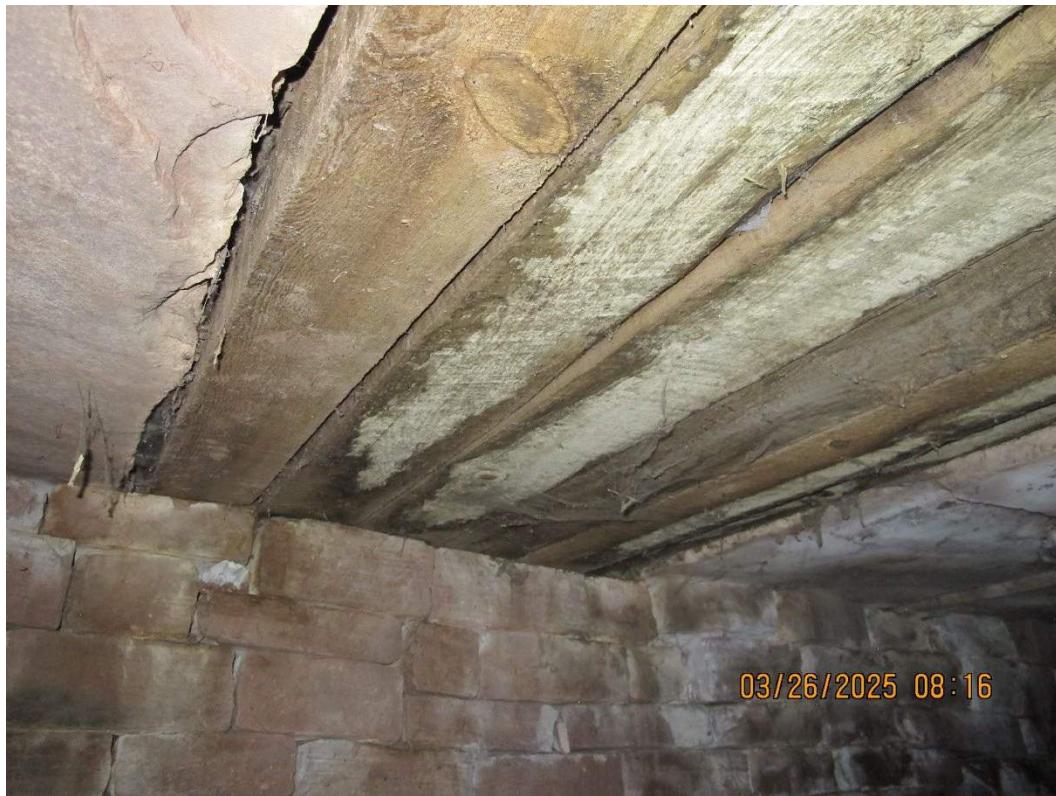
Photo E.1: Previous Repair type PR1, South Culvert Station (S)0+35

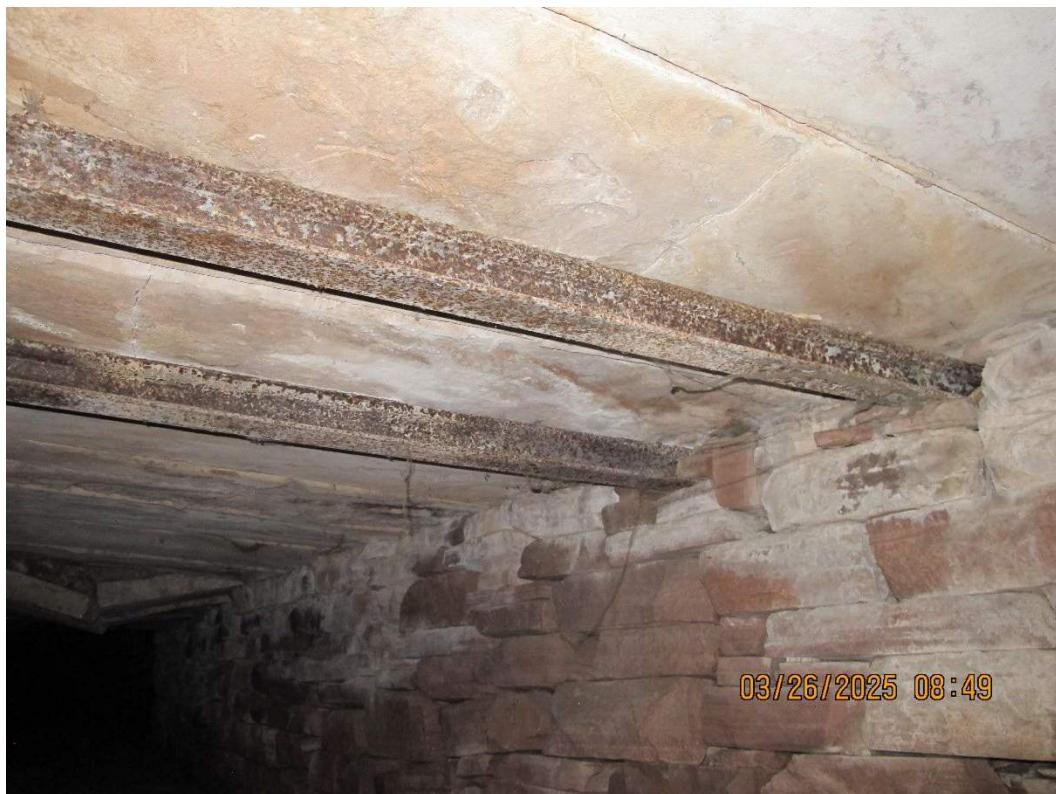
Photo E.2: Previous Repair Type PR2, South Culvert Station (S)1+35

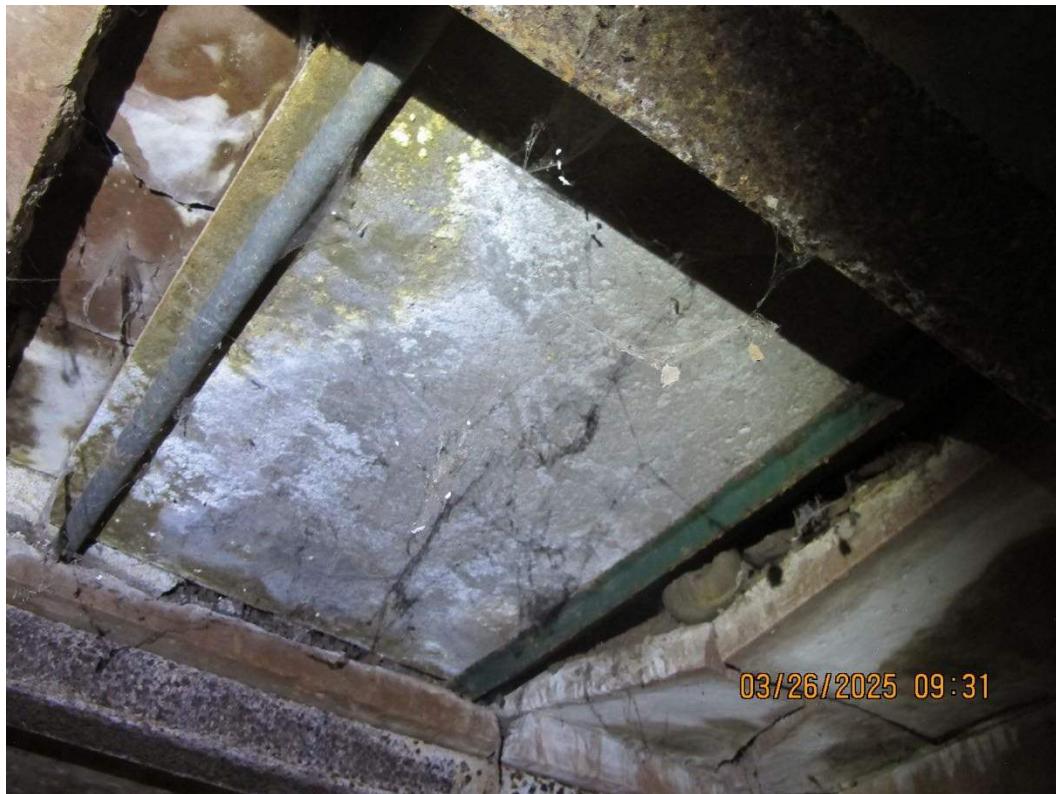
Photo E.3: Previous Repair Type PR3, South Culvert Station (S)2+43

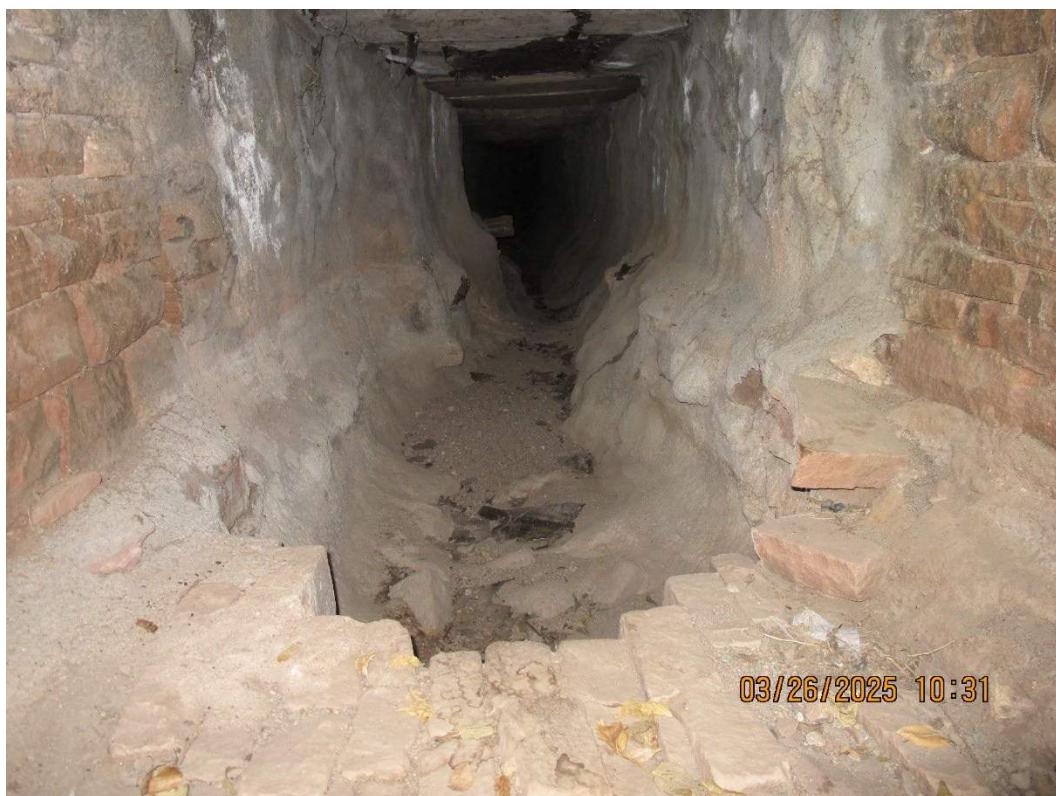
| <u>Map Keynote</u> | <u>Repair Description</u> | <u>Station(s)</u> | <u>Photo</u> |
|---|--|--|---|
| PR4 | Shotcrete applied to the stacked masonry walls (Note: locations indicated in this section are also included in the 'Existing Conditions' section as Construction Type W3) | 3+80 to 4+70 5+48 to 6+30 | Photo E.4 |

Photo E.4: Previous Repair Type PR4, South Culvert Station (S)3+80

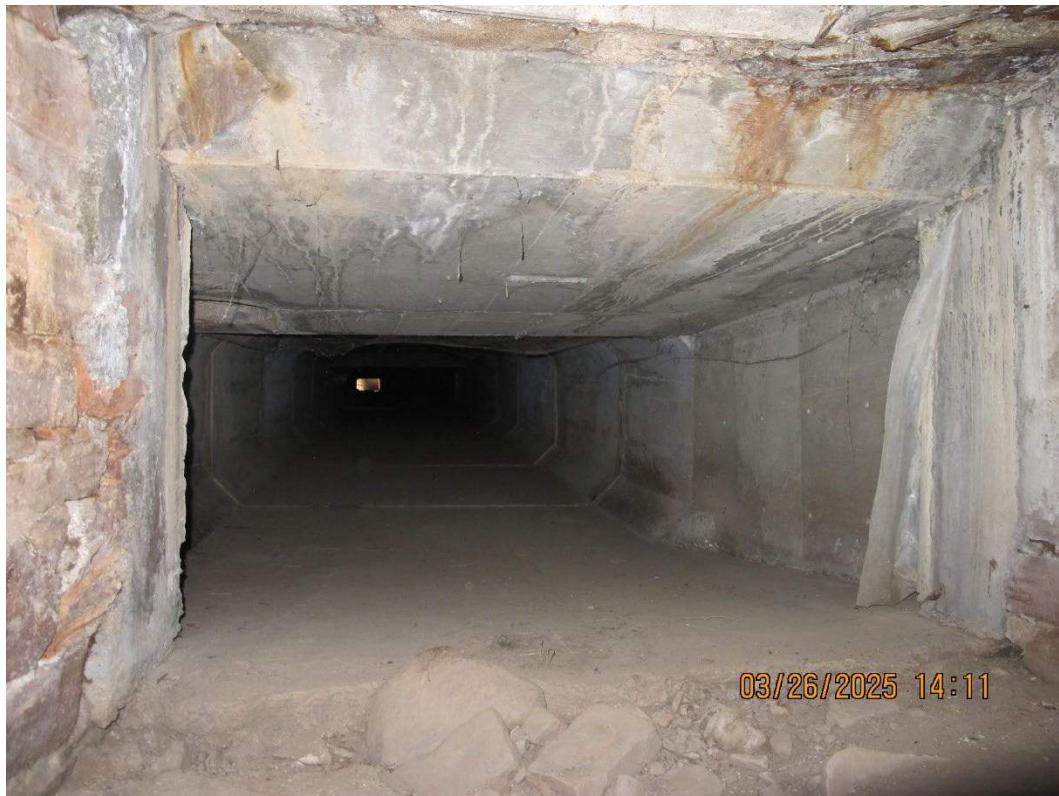
Photo E.5: Previous Repair Type PR5, South Culvert Station (S)8+94

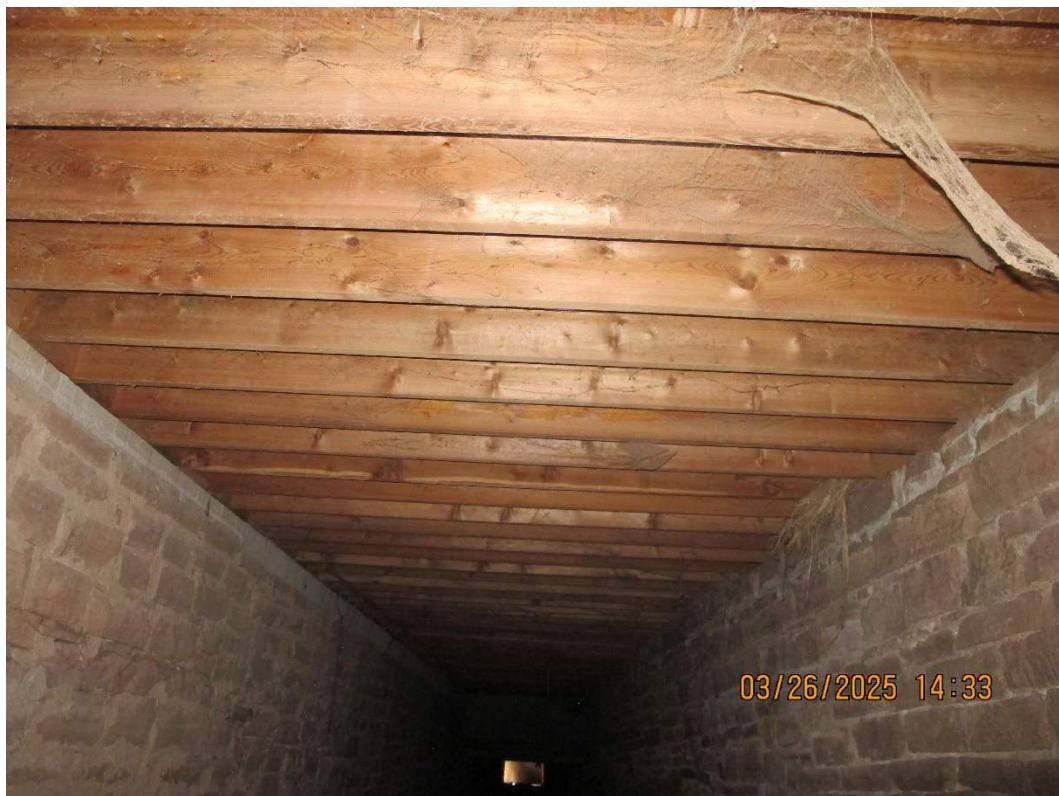
Photo E.6: Previous Repair Type PR6, South Culvert Station (S)9+71
