STREAM BYPASS FLOW STUDY

25_STRM BYPASS_STUDY_01

*St. Vrain Creek
Ralph Price Reservoir (Button Rock)
to
Supply Irrigating Ditch Diversion*

August 13th, 2025

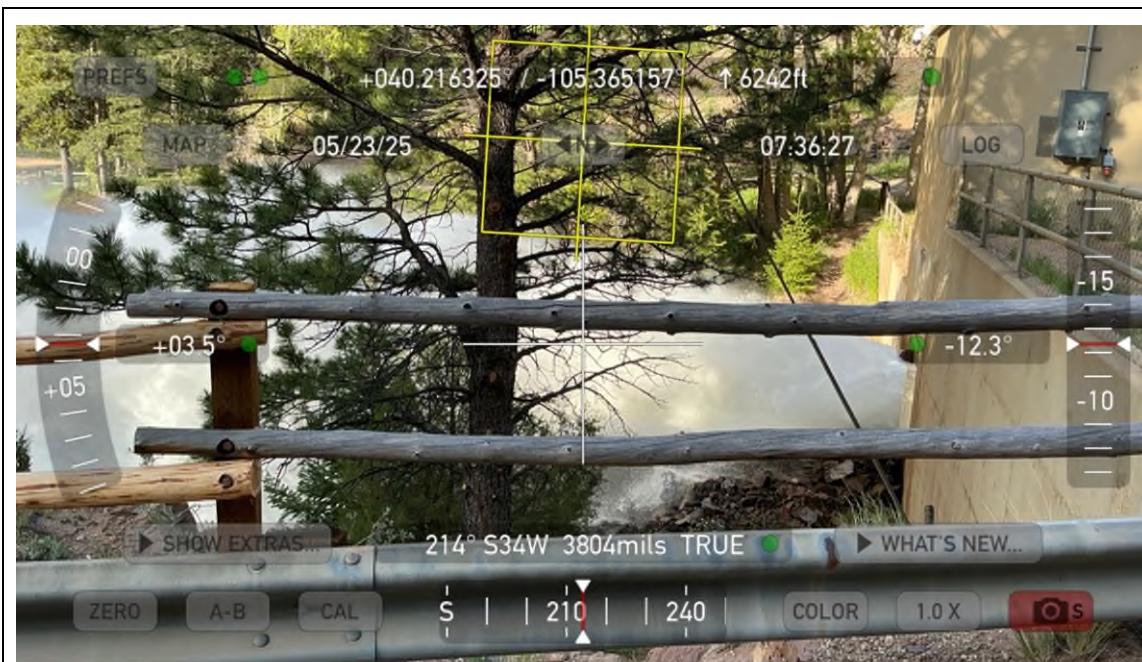
Photograph: 1

Dam Outlet - Flow Control

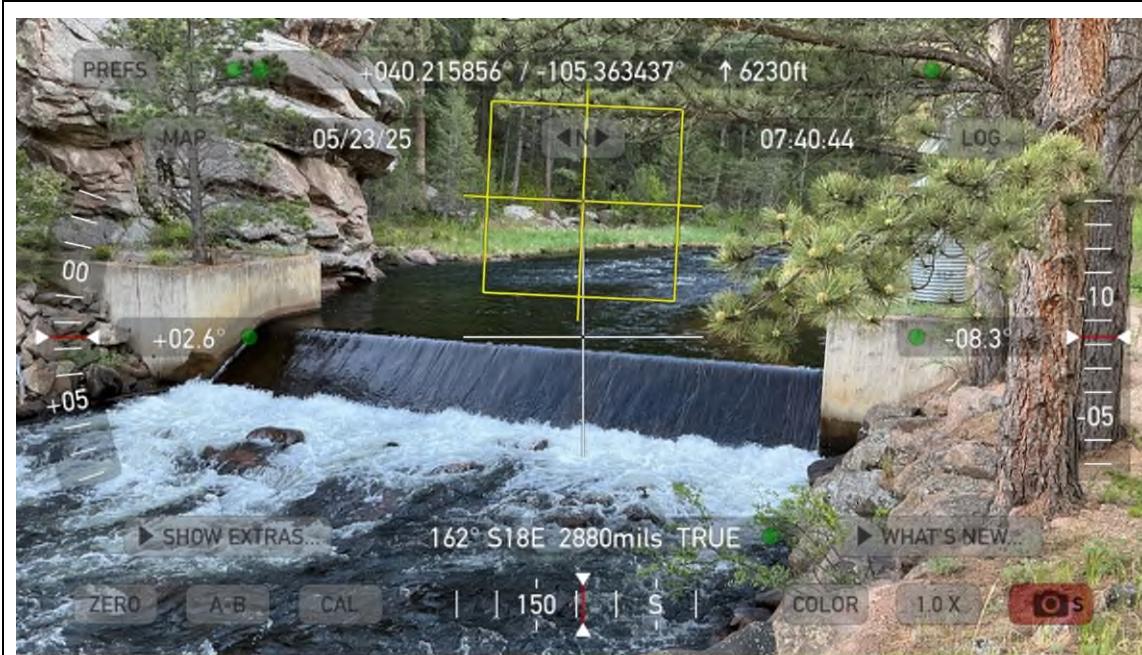
Photograph: 3

Flow Control

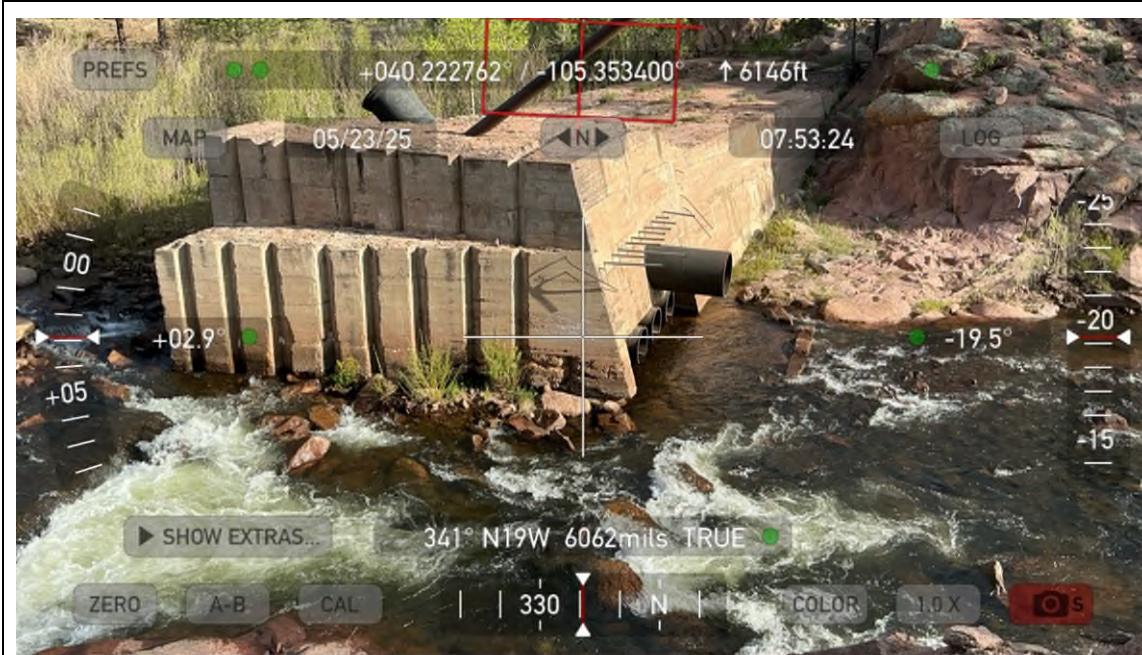
Photograph: 5

Old Flow Control

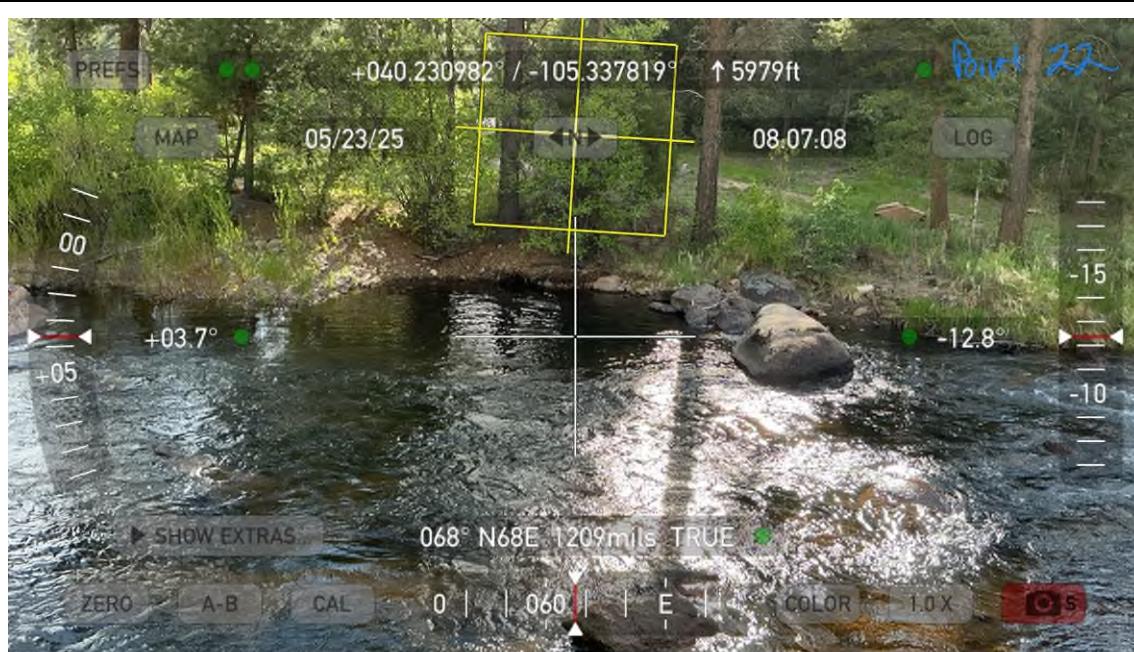
Photograph: 7

Description:
Small Pool- Possible
Pumping – **No
Permitted Observed.**

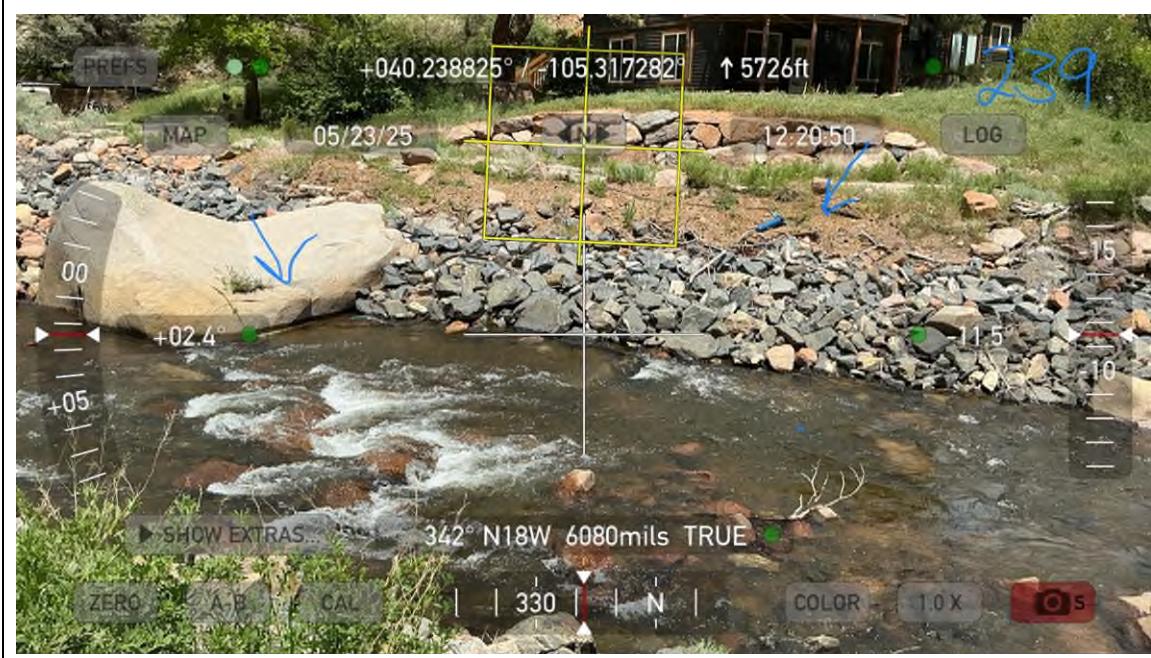
<p>Photograph: 25</p> <p>Date: 5/23/2025</p> <p>Location: Lyons, CO</p> <p>Description: Aaron Lawson - pump in river records indicate Lawson Pump https://dwr.state.co.us/Tools/Structures/0501046</p>

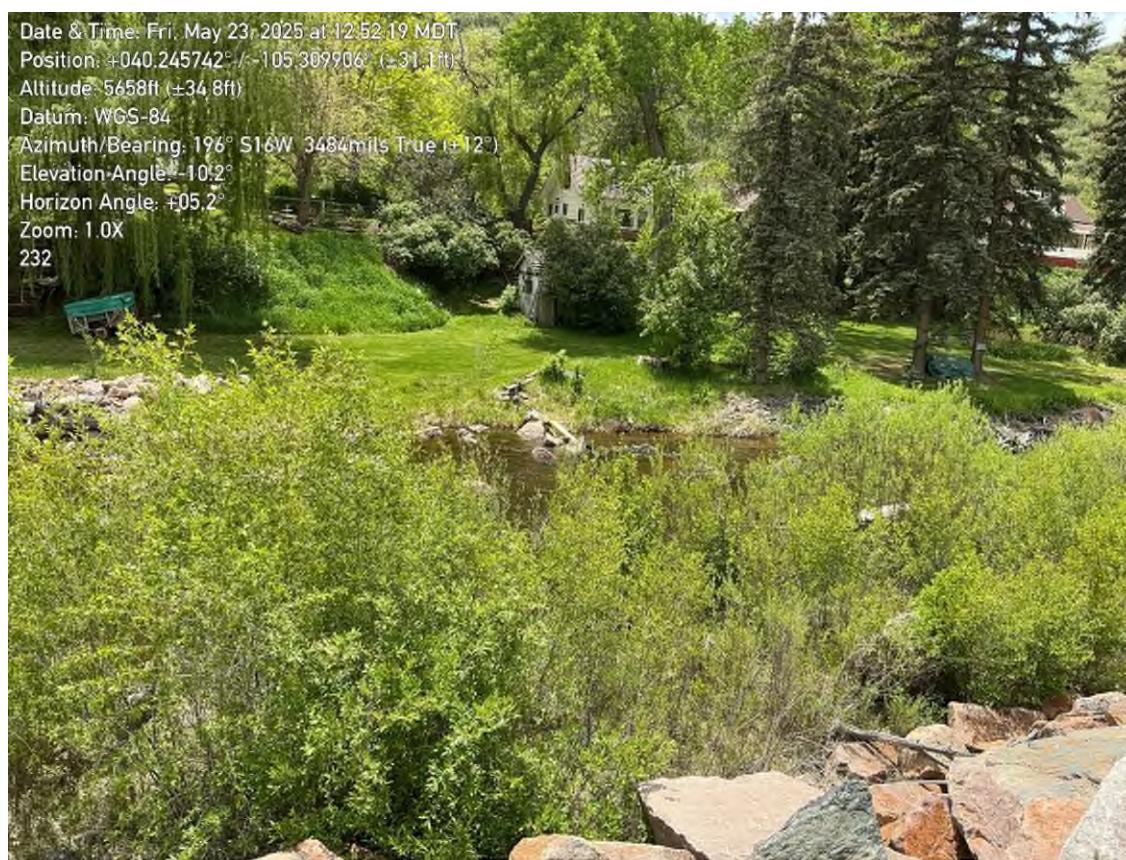
Photograph: 28

Pump in water - Sim
Pump 3.

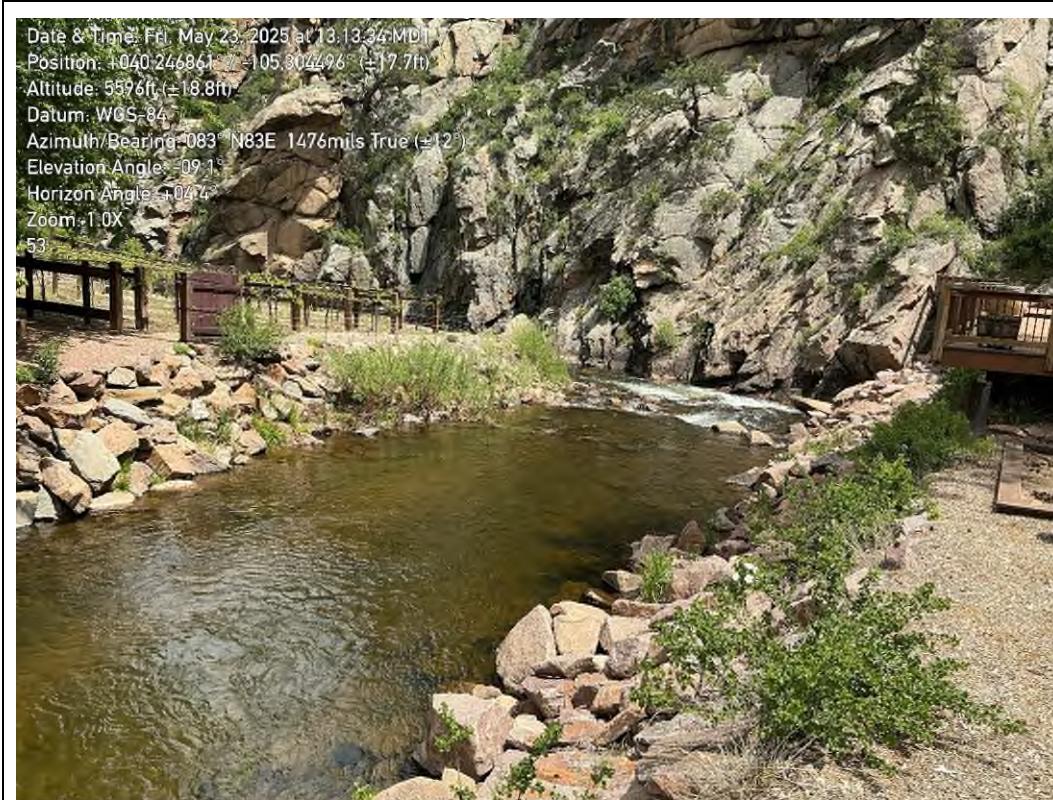
Photograph: 30

Natural - No Concerns

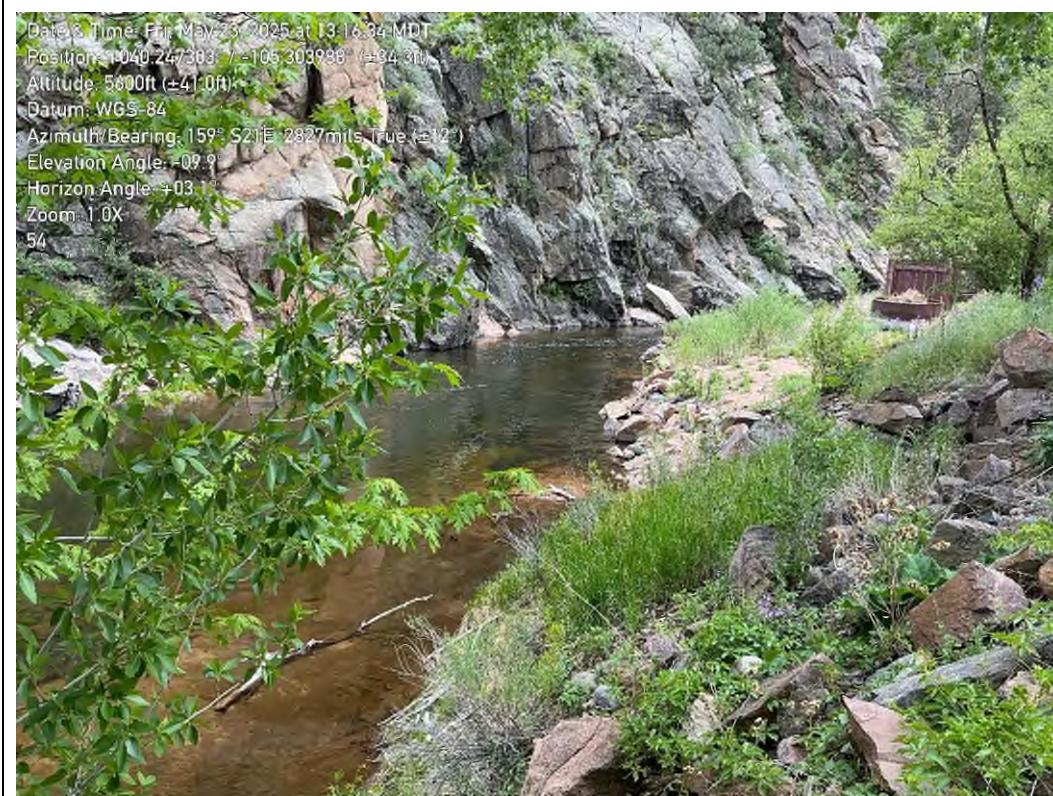
Photograph: 31

However, there is a shallow well here of 18 ft. and a small winery business- Rusty Vines Vineyard. Heather & Rex Heiby.

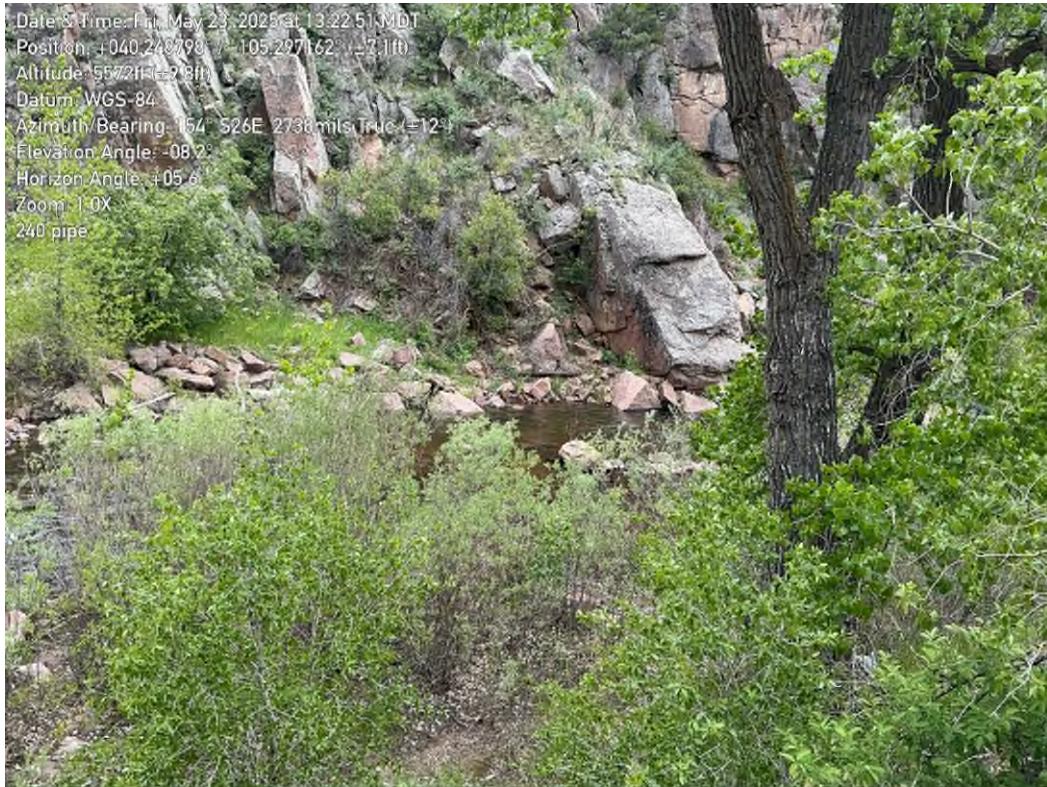
Photograph: 34

Older pipe - possibly part of above diversion.

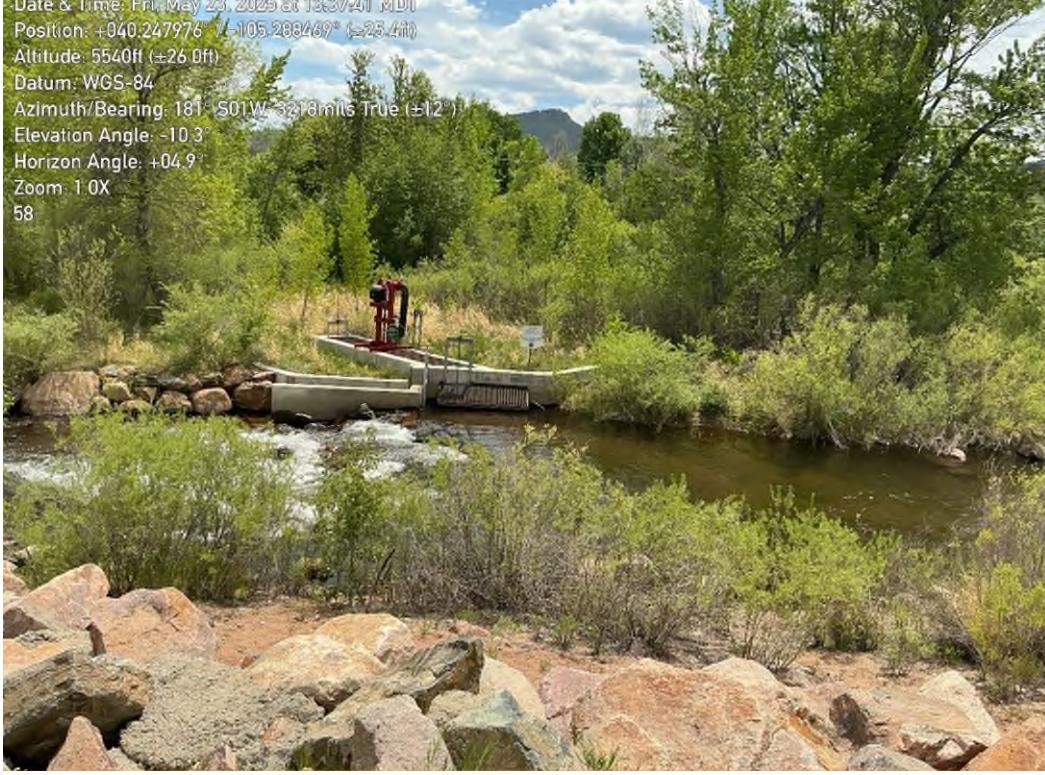
<p>Photograph: 36 Date: 5/23/2025 Location: Lyons, CO Description: St. Vrain & Left-hand water conservancy ditch.</p>
<p>Date & Time: Fri, May 23, 2025 at 13:40:47 MDT Position: +040.247910 / -105.288735° (±24.0ft) Altitude: 5526ft (±25.0ft) Datum: WGS-84 Azimuth/Bearing: 172° S08E 3058mils True (±12°) Elevation Angle: -08.0° Horizon Angle: +03.6° Zoom: 1.0X 241</p>

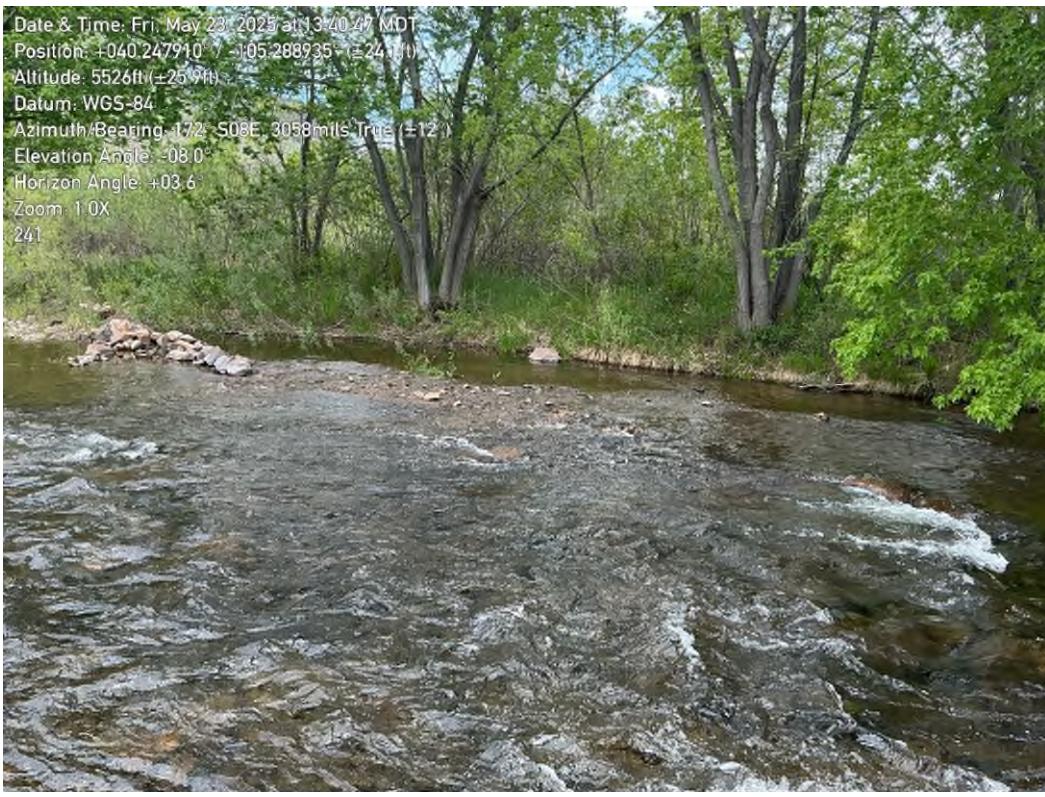
<p>Photograph: 37 Date: 5/23/2025 Location: Lyons, CO Description: <i>Ditch that is approximately 12" wide where it narrows on shore and approximately 20' long diversion in stream. There is possible association this water right: Appears expired.</i> https://dwr.state.co.us/Tools/Structures/0505283 or https://dwr.state.co.us/Tools/Structures/0505276</p>

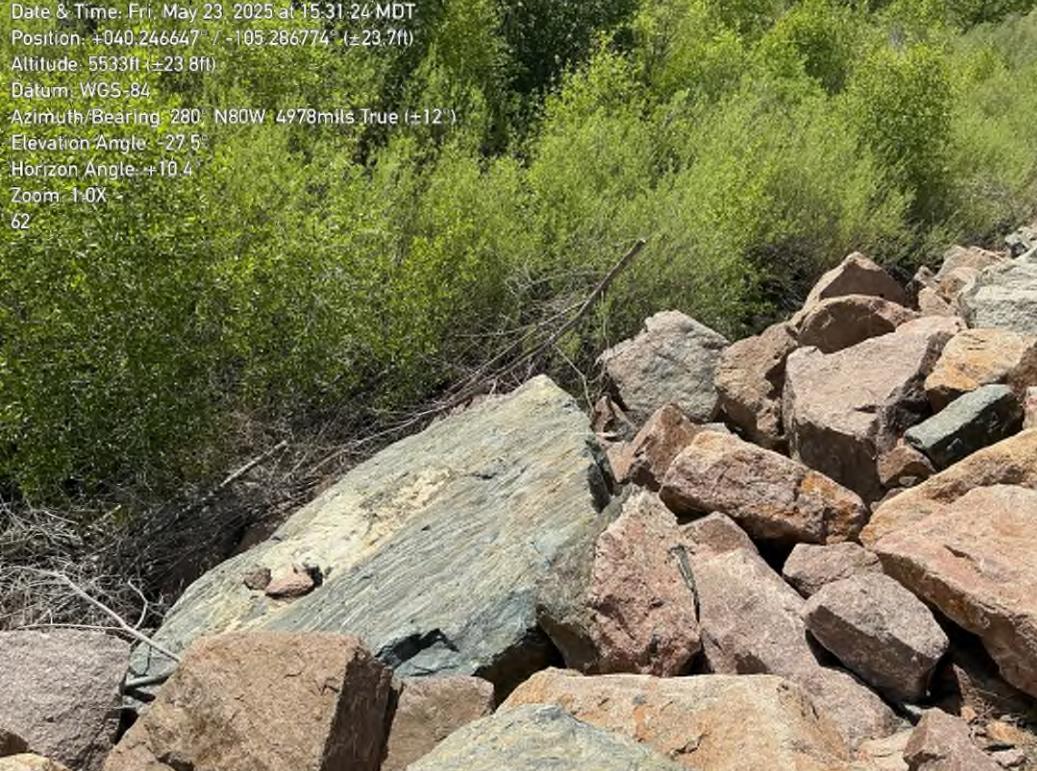
<p>Photograph: 38 Date: 5/23/2025 Location: Lyons, CO Description: <i>Black pipe running back from pump on next picture. Undetermined end point/alignment, possibly under road.</i></p>

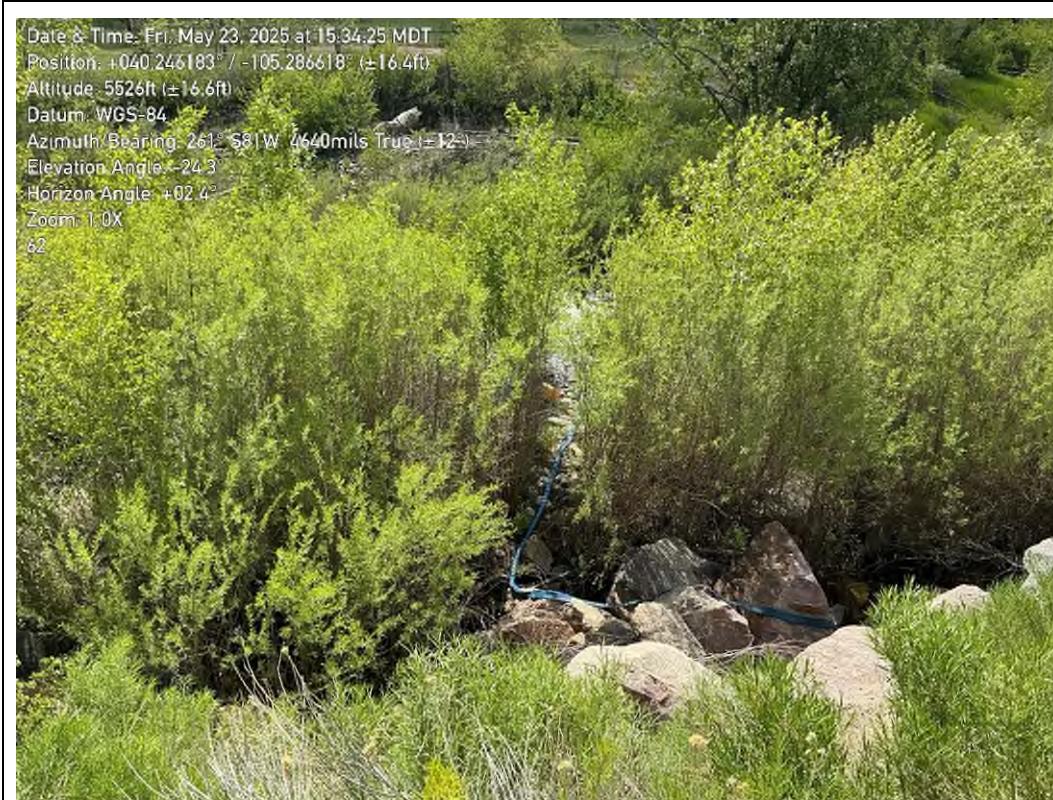
Photograph: 39

Pump in water not associated with any water right. Goes back upstream and possibly under road.

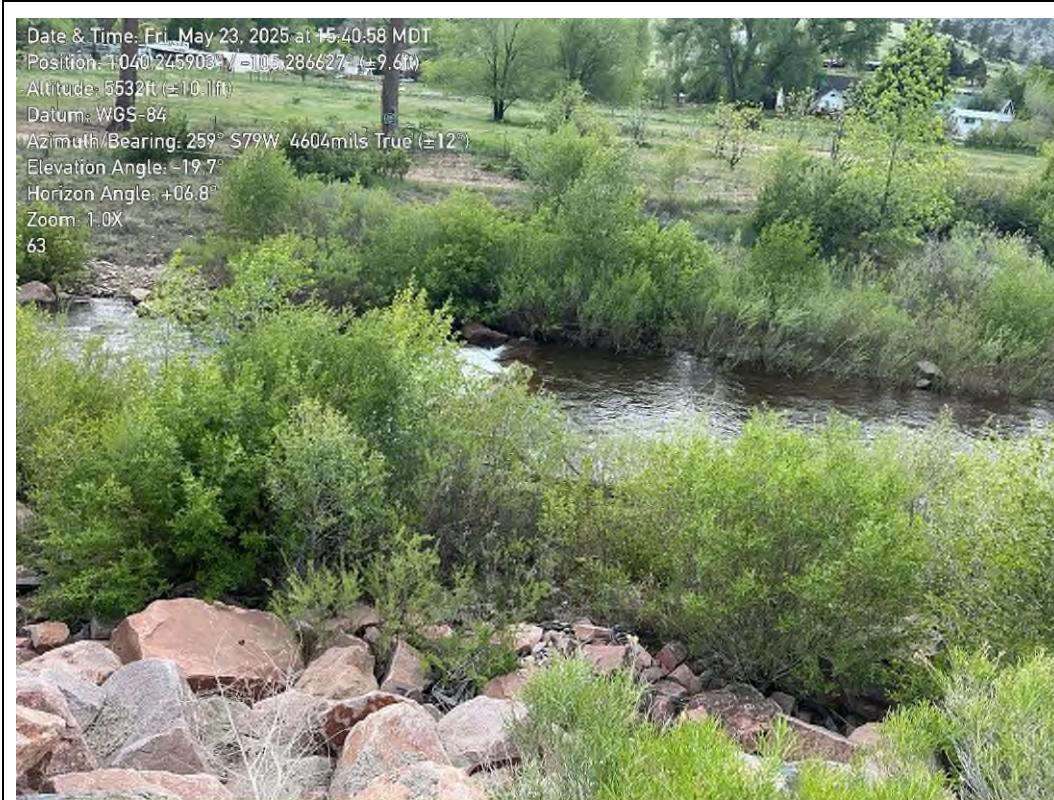
Photograph: 41

Natural - Beach area does exist where pumping could occur.

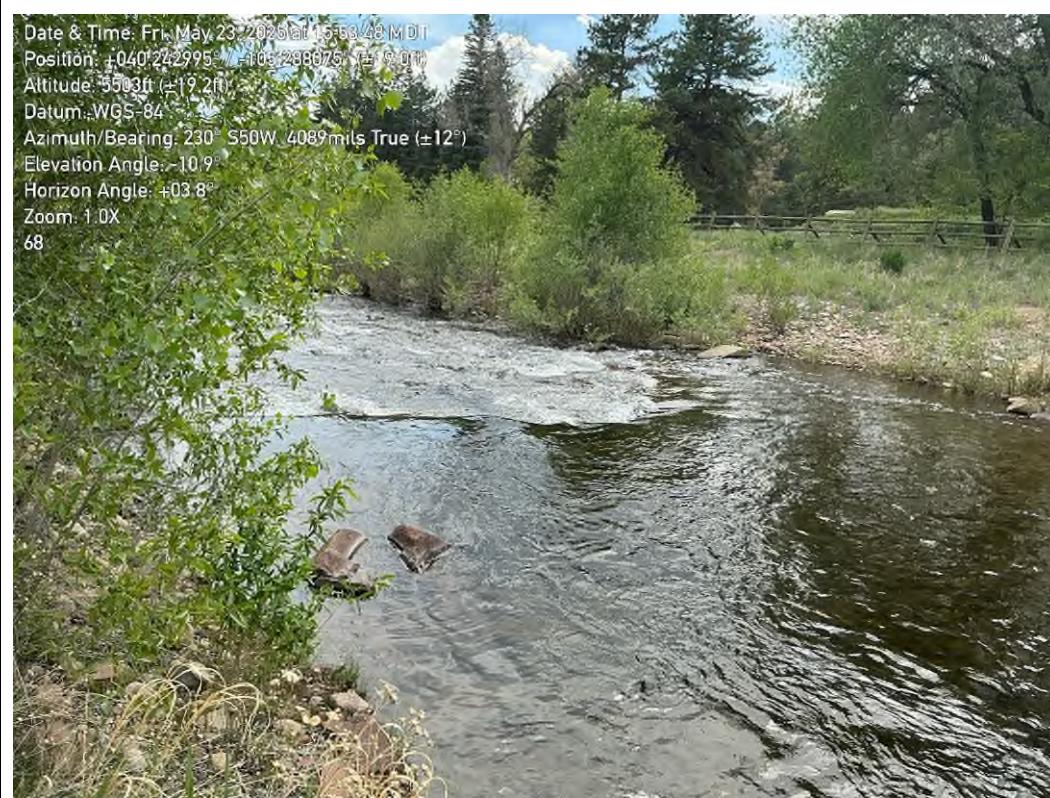
Photograph: 44

Natural - No Concerns

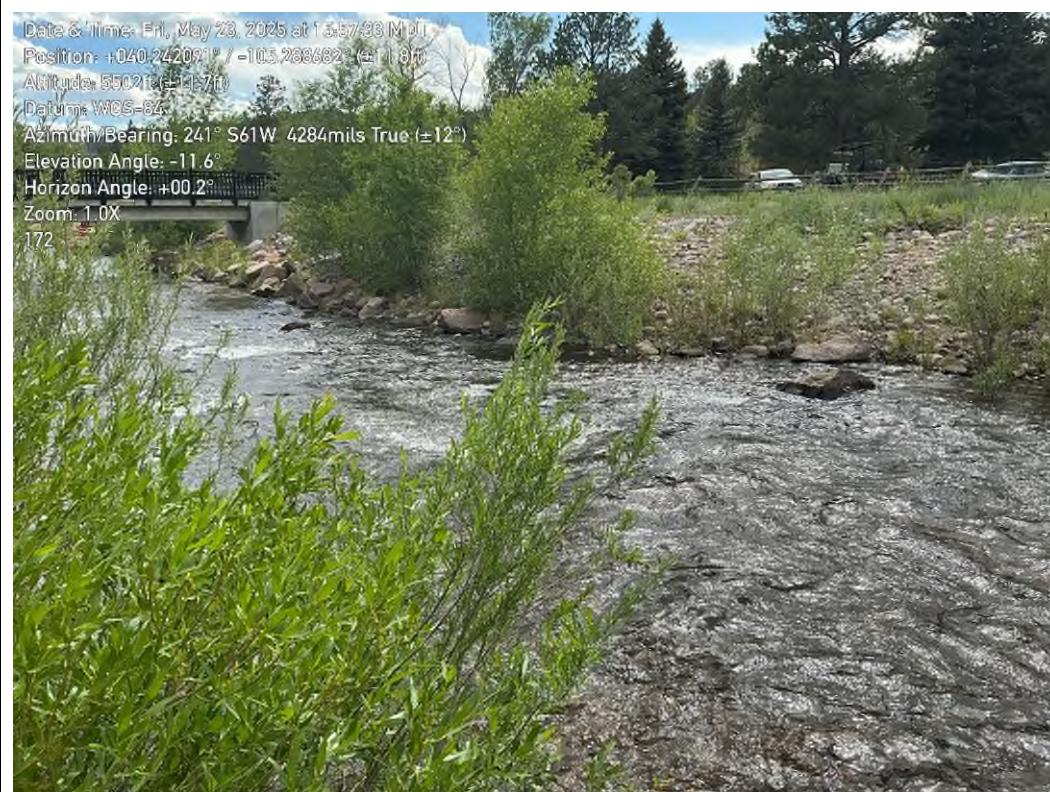
Photograph: 45

Natural - No Concerns

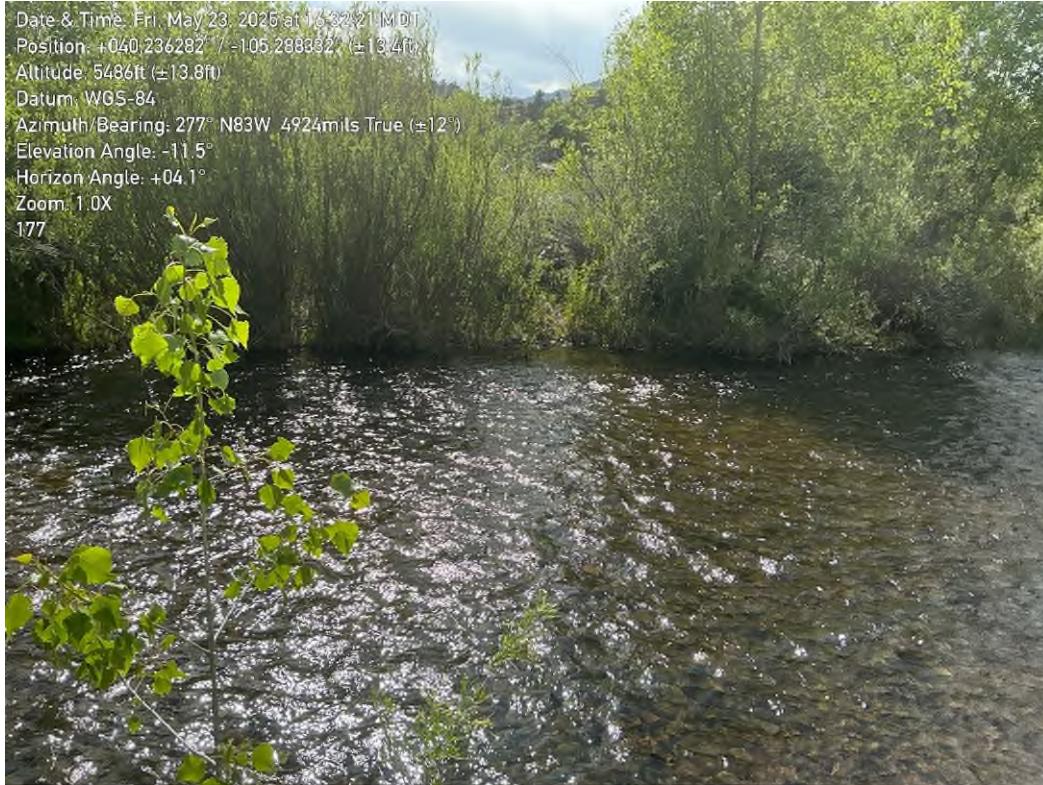
Photograph: 51

Diversion	Diversion to Apple Valley Pond- Left Hand has opposed this before and the pond was limited to 50-acre ft per year- no meter was observed.	Minimum 2' Opening	No	Logger	M+JB Holdings LLC	Apple Valley Pond: Map ID 63	51	177
Diversion	Diversion to pool on Lyons property.		No	Logger	Lyons	Yes	138	267

Diversion to Apple Valley Pond - Left Hand has opposed this before and the pond was limited to 50-acre ft per year - no meter was observed. Owner is M+JB Holdings LLC

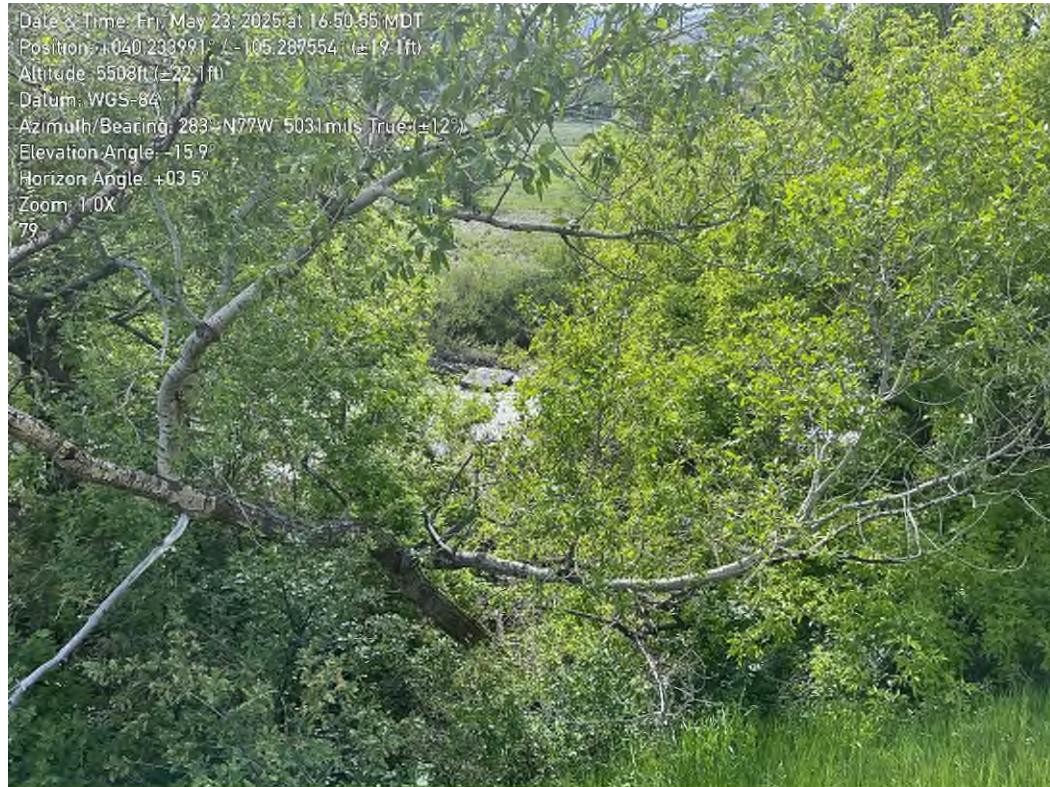
Photograph: 53

Natural - No Concerns

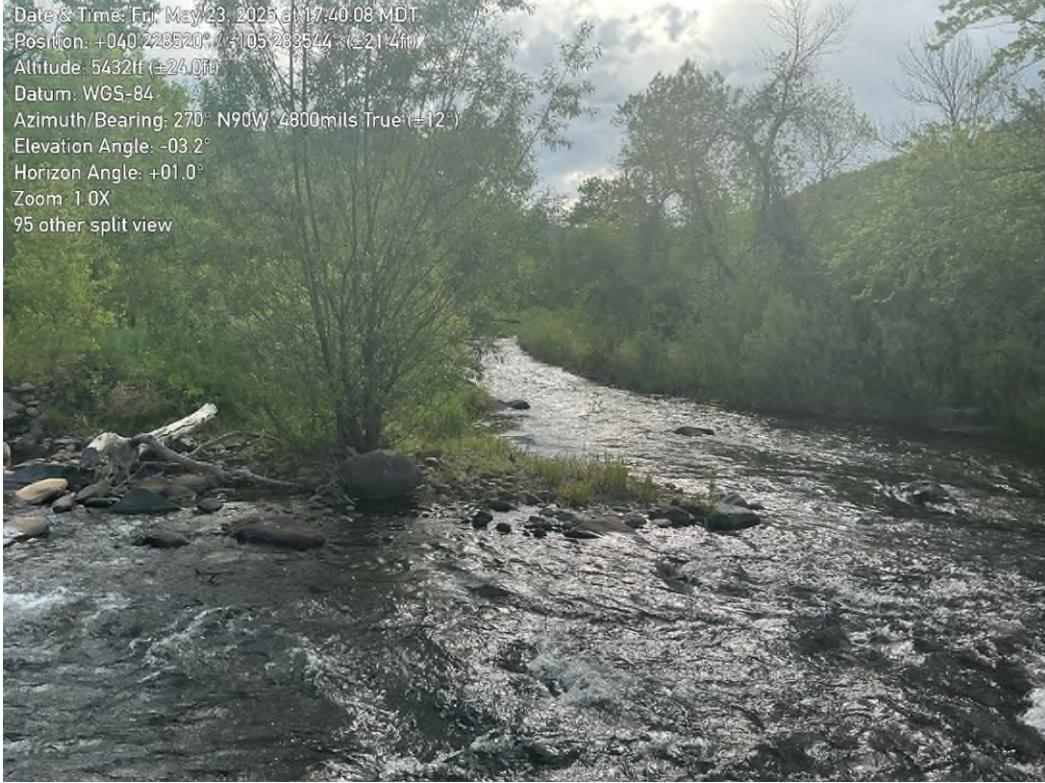
<p>Photograph: 61 Date: 5/23/2025 Location: Lyons, CO Description: Natural - No Concern</p>
<p>Date & Time: Fri, May 23, 2025 at 17:49:45 MDT Position: +040 227702° / -105 284394° (± 12.6 ft) Altitude: 5446ft (± 13.1 ft) Datum: WGS-84 Azimuth/Bearing: 289° N71W 5138mils True (± 12°) Elevation Angle: -16.9° Horizon Angle: +02.5° Zoom: 1.0X 92</p>

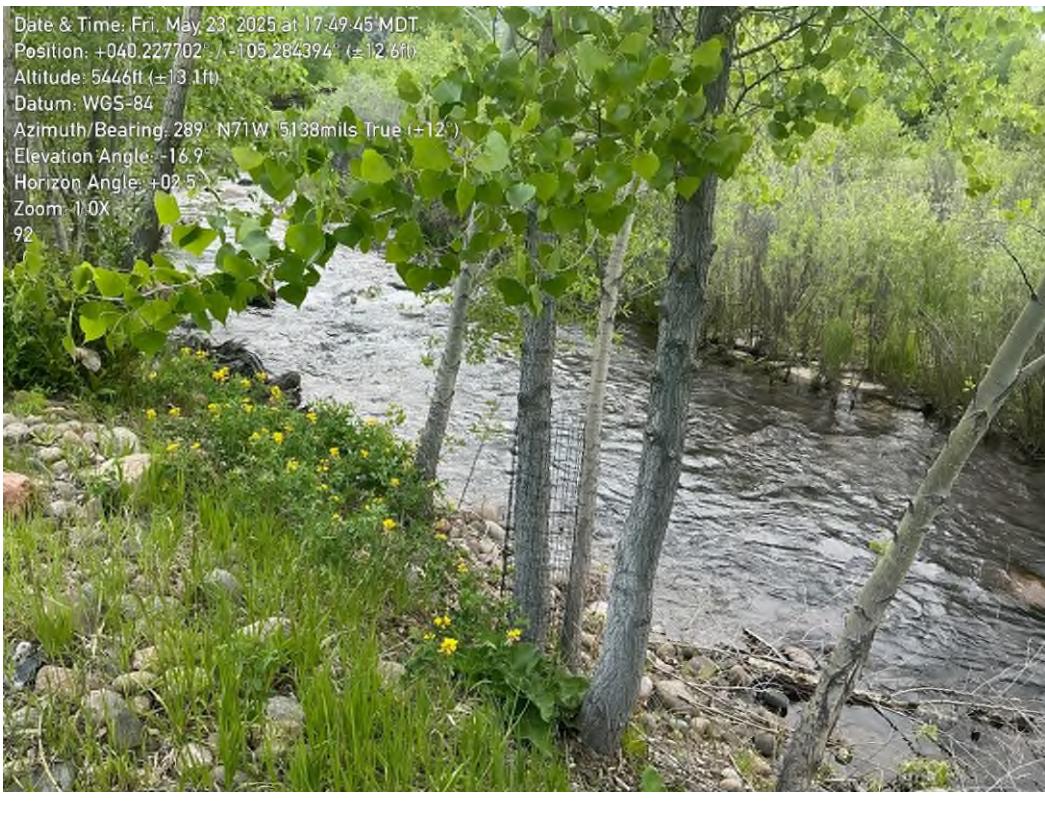
<p>Photograph: 62 Date: 5/23/2025 Location: Lyons, CO Description: <i>Natural - Shallow well nearby - Dean Richard Revocable Trust - Kindly let us on property and say his water is not metered but he believes he uses close to what he is permitted for.</i> Pump 1 & 2 https://dwr.state.co.us/Tools/Structures/0501295 & https://dwr.state.co.us/Tools/Structures/0501218</p>

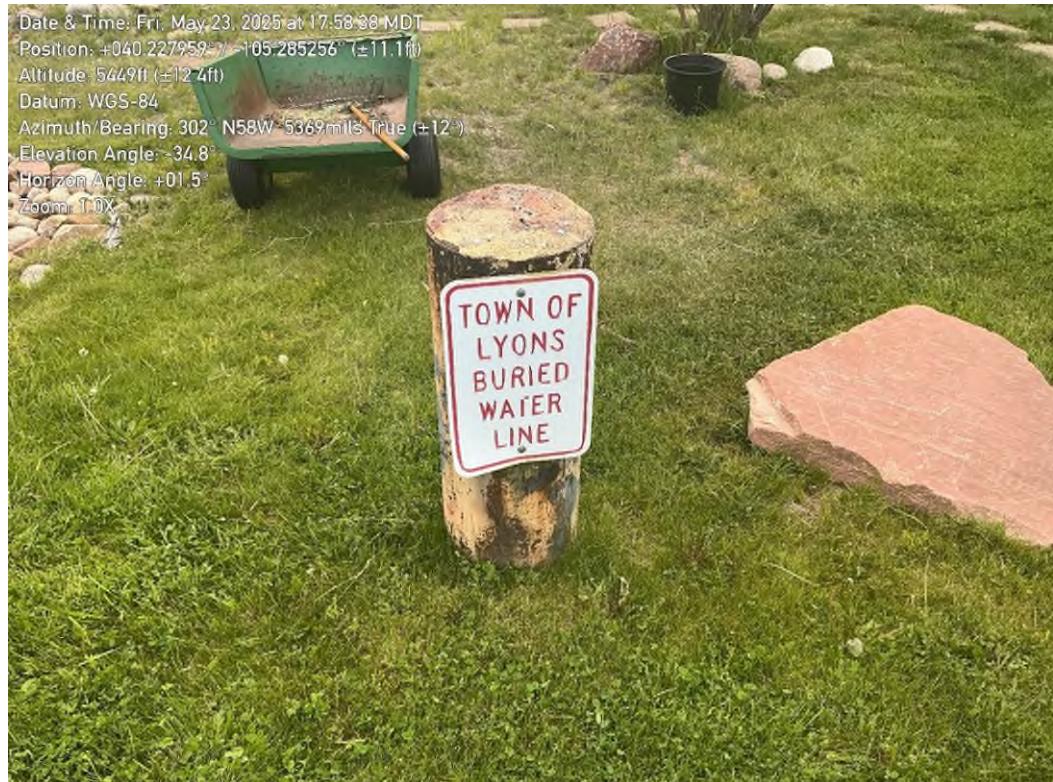
A photograph of a wooden post standing in a grassy area. A red and white sign is attached to the post, reading "TOWN OF LYONS BURIED WATER LINE". In the background, there is a green wheelbarrow, some rocks, and a large red rock.	<p>Photograph: 63 Date: 5/23/2025 Location: Lyons, CO Description: Lyons water line.</p>

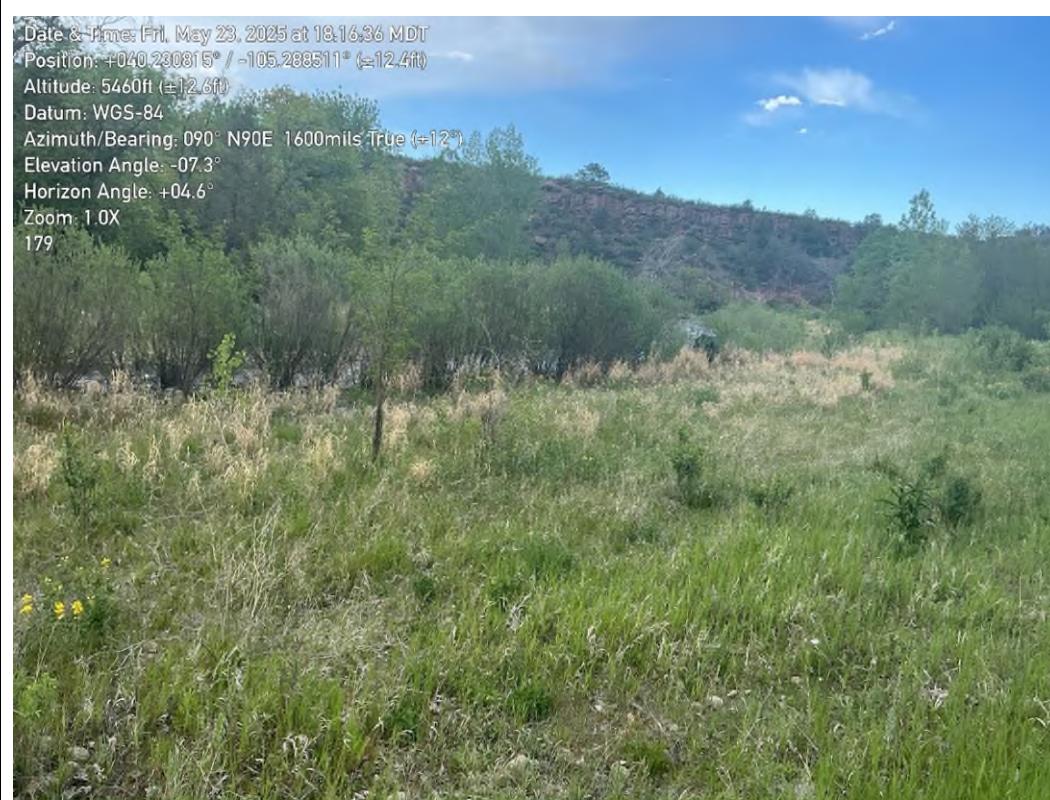
Photograph: 66

Pump by river-correlates to Peterson Pump.

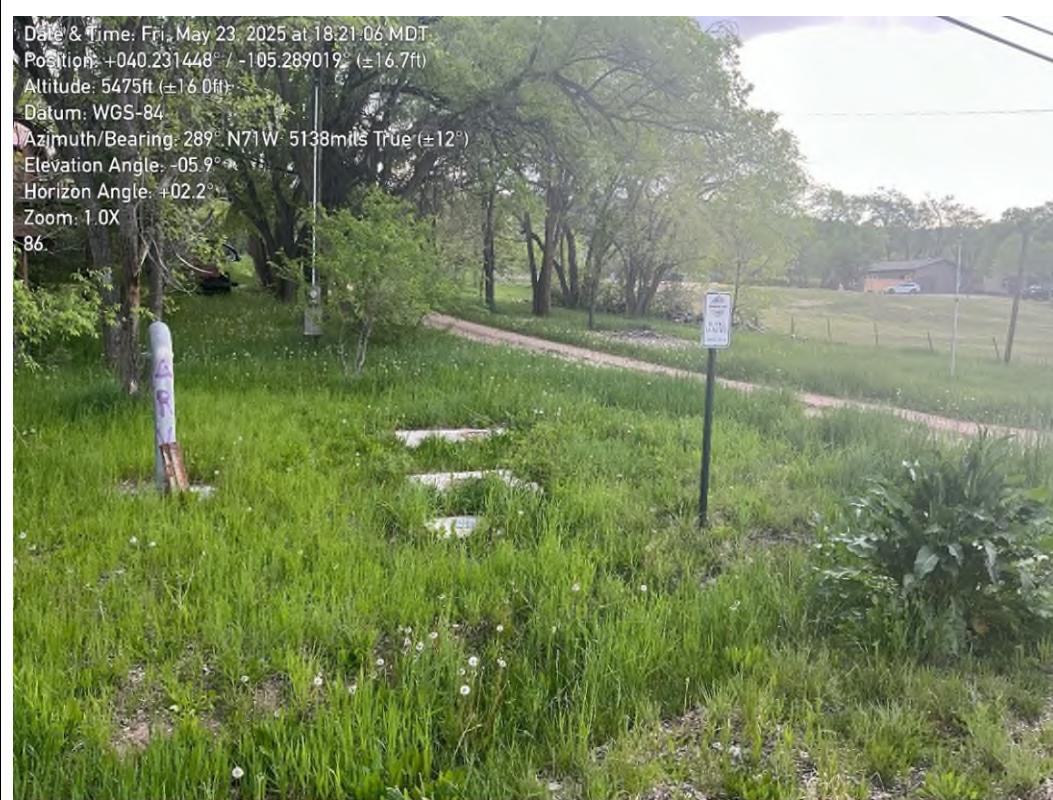
Photograph: 68

City of Boulder Water

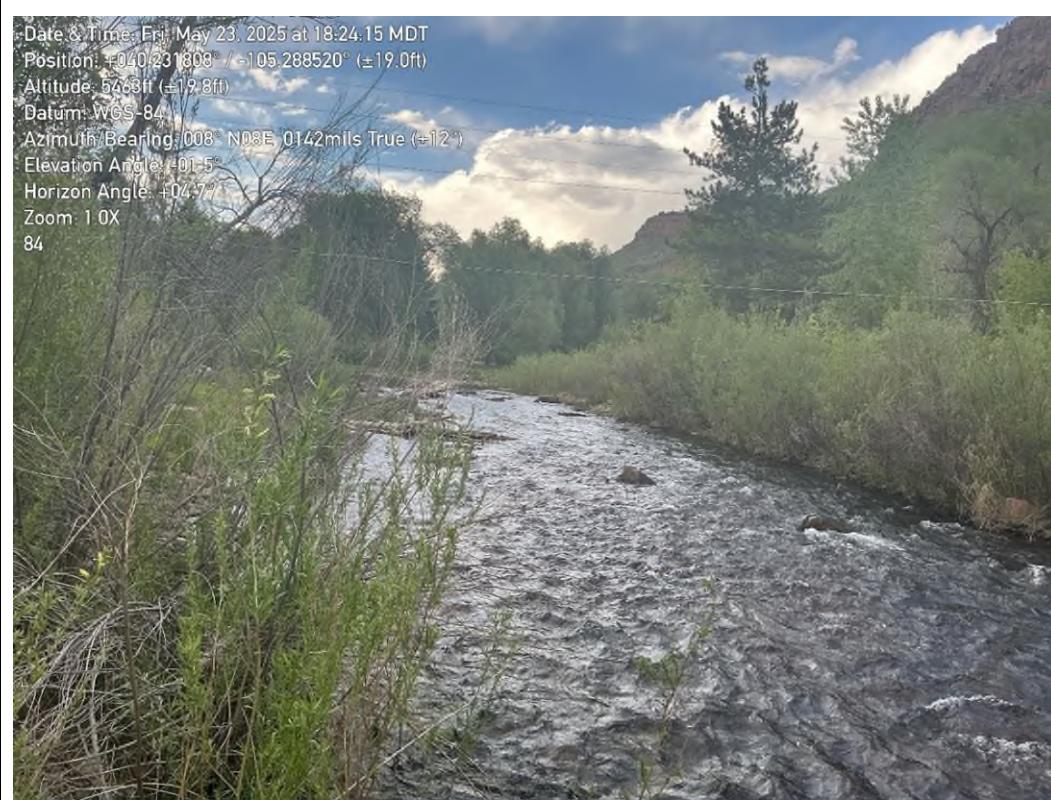
Photograph: 70

Natural - No Concern

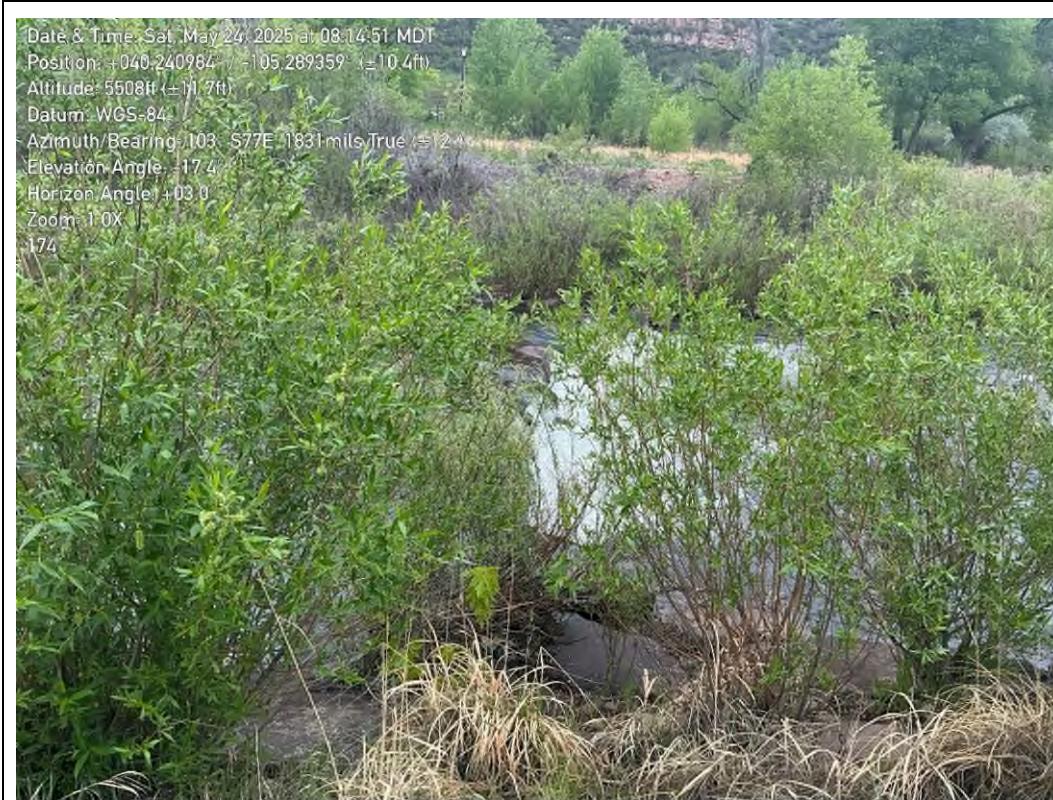
Photograph: 74

Natural - No Concern.

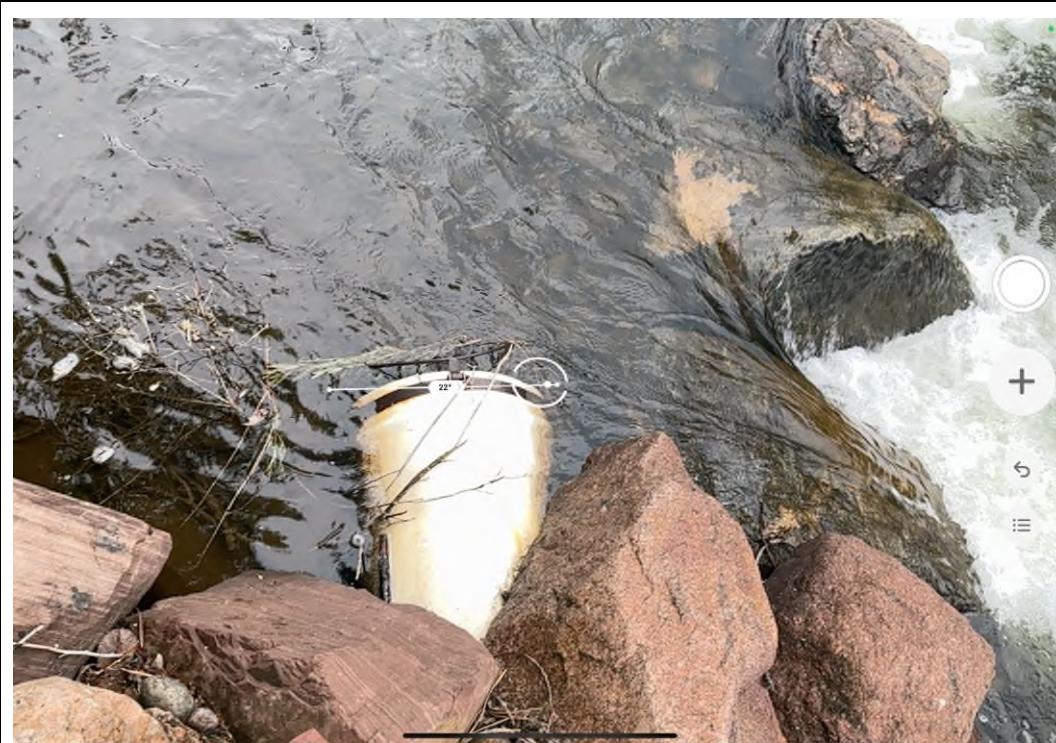
Photograph: 76

Measurement for pipe. On County of Boulder property.

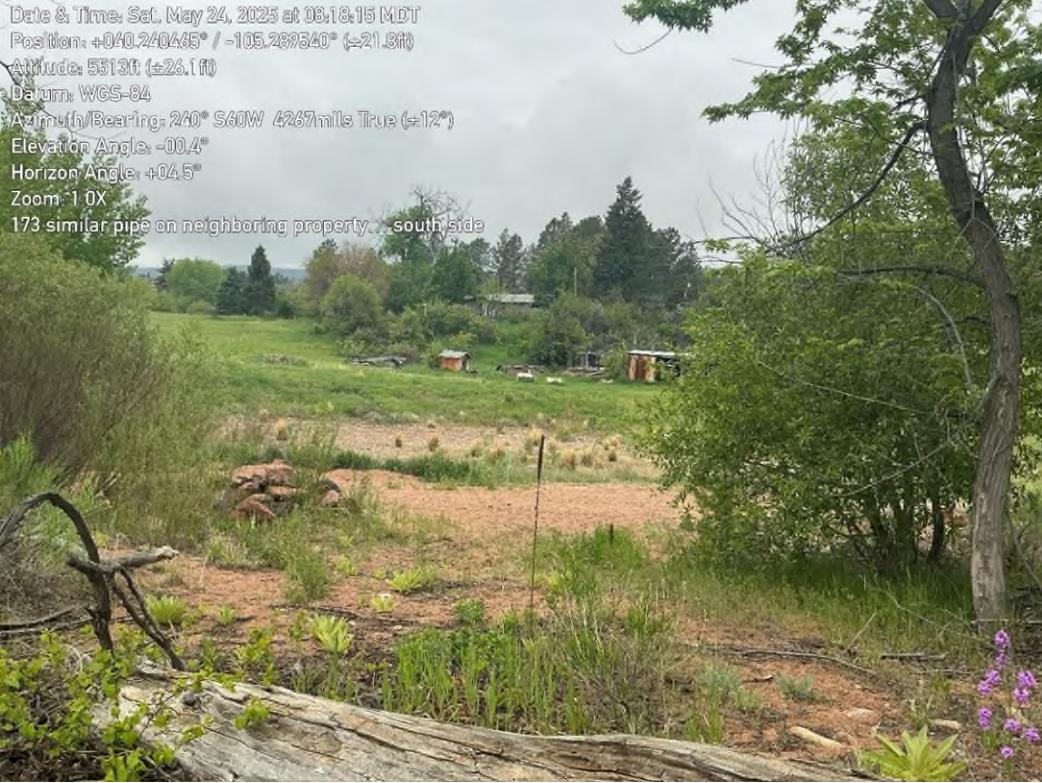
<p>Photograph: 78 Date: 5/24/2025 Location: Lyons, CO Description: The similar sized pipe is on neighbors' property of Burdock Hollow LLC. This is listed as Sosey Ditch Flow Control for North Saint Vrain Creek.</p>
<p>Date & Time: Sat, May 24, 2025 at 08:21:26 MDT Position: +040.239851° / -105.289359° ($\pm 25.5\text{ft}$) Altitude: 5494ft ($\pm 30.0\text{ft}$) Datum: WGS-84 Azimuth/Bearing: 091° S89E 1618mils True ($\pm 20^\circ$) Elevation Angle: -09.7° Horizon Angle: -02.9° Zoom: 1.0X 73</p>
