STREAM BYPASS FLOW STUDY

25_STRM BYPASS_STUDY_01

*St. Vrain Creek
Ralph Price Reservoir (Button Rock)
to
Supply Irrigating Ditch Diversion*

August 13th, 2025

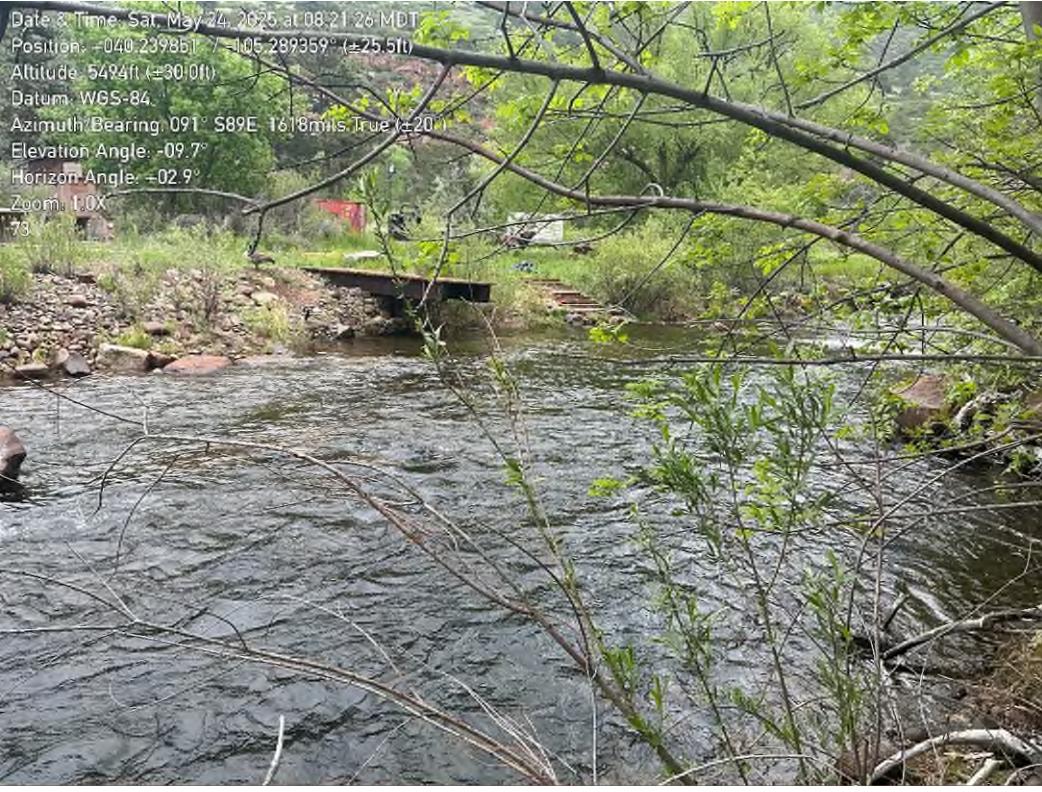
<p>Photograph: 79 Date: 5/24/2025 Location: Lyons, CO Description: <i>Blue pumps takes water to red shipping container and there is mass irrigation. They have one expired permit & a point of diversion that may have expired in 2015. Land belongs to Janis & James McCain.</i> https://dwr.state.co.us/Tools/Structures/0505598</p>

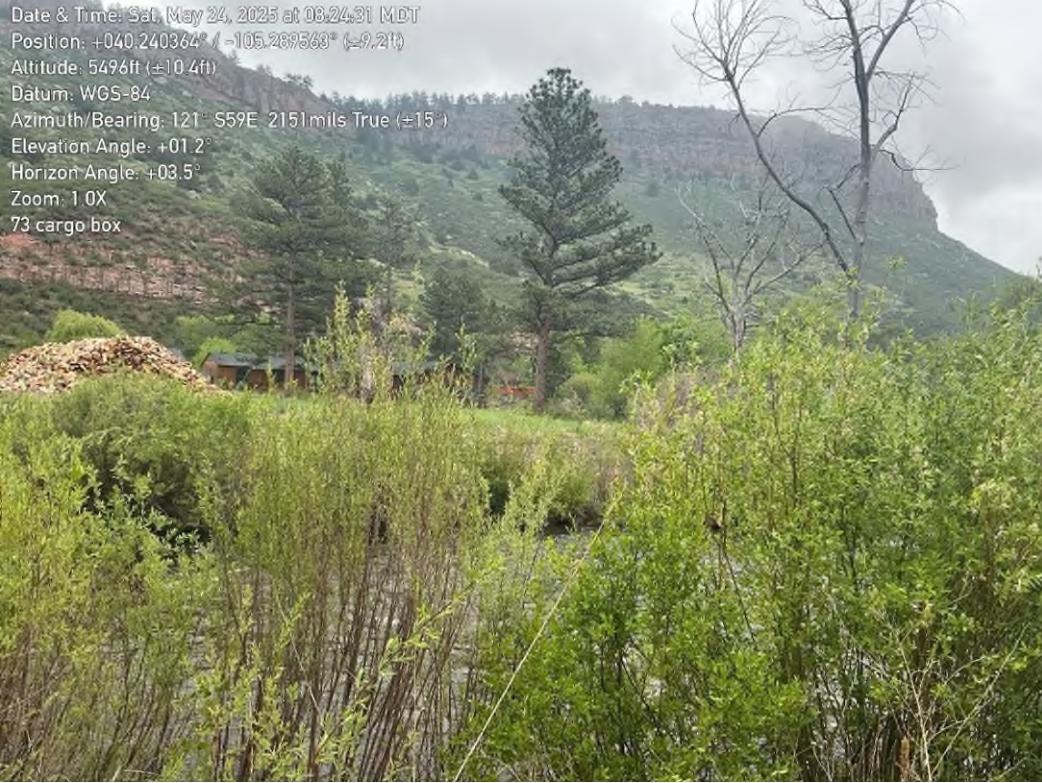
<p>Photograph: 80 Date: 5/24/2025 Location: Lyons, CO Description: <i>Second view of shipping container that pump goes to.</i></p>
<p>Date & Time: Sat, May 24, 2025 at 08:43:59 MDT Position: +040.229552° / -105.286433° (±20.3ft) Altitude: 5508ft (±19.9ft) Datum: WGS-84 Azimuth/Bearing: 272° N88W 4836mils True (±13°) Elevation Angle: -23.3° Horizon Angle: +03.7° Zoom: 1.0X 87</p>

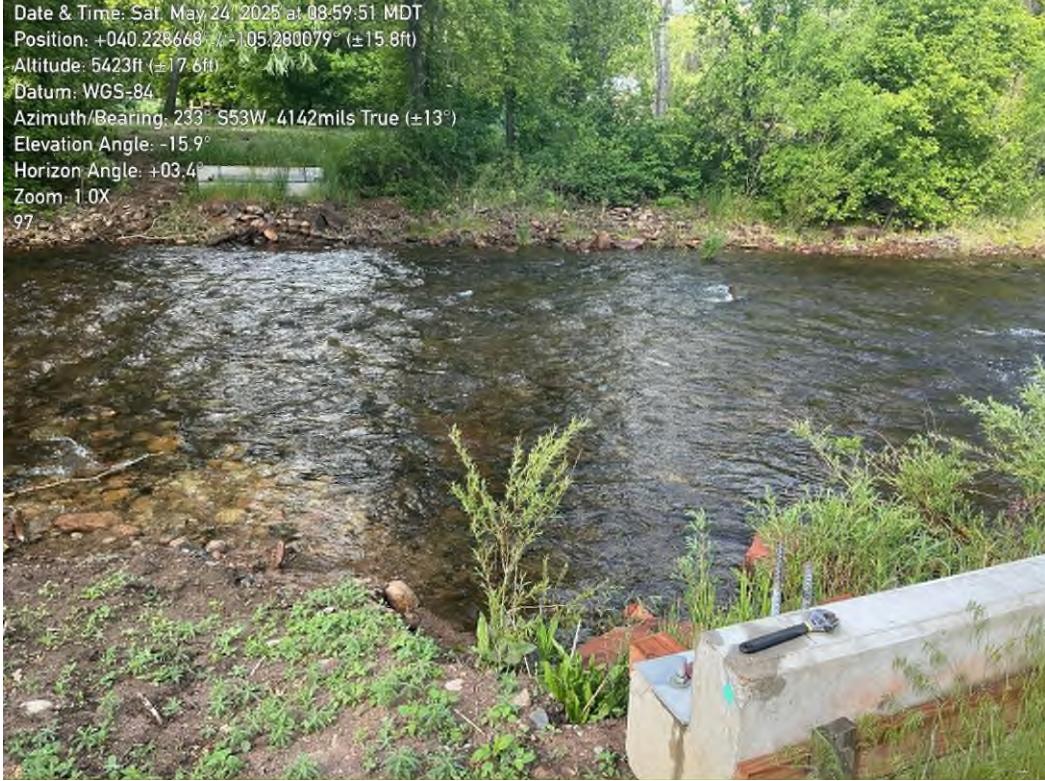
<p>Photograph: 82 Date: 5/24/2025 Location: Lyons, CO Description: Bridge for events - no water concerns at this point.</p>
<p>Date & Time: Sat, May 24, 2025 at 09:02:59 MDT Position: +040.228994, -105.280528° (±17.5ft) Altitude: 5434ft (±17.3ft) Datum: WGS-84 Azimuth/Bearing: 211° S31W 3751mils True (±13°) Elevation Angle: -16.0° Horizon Angle: +03.6° Zoom: 1.0X 256</p>

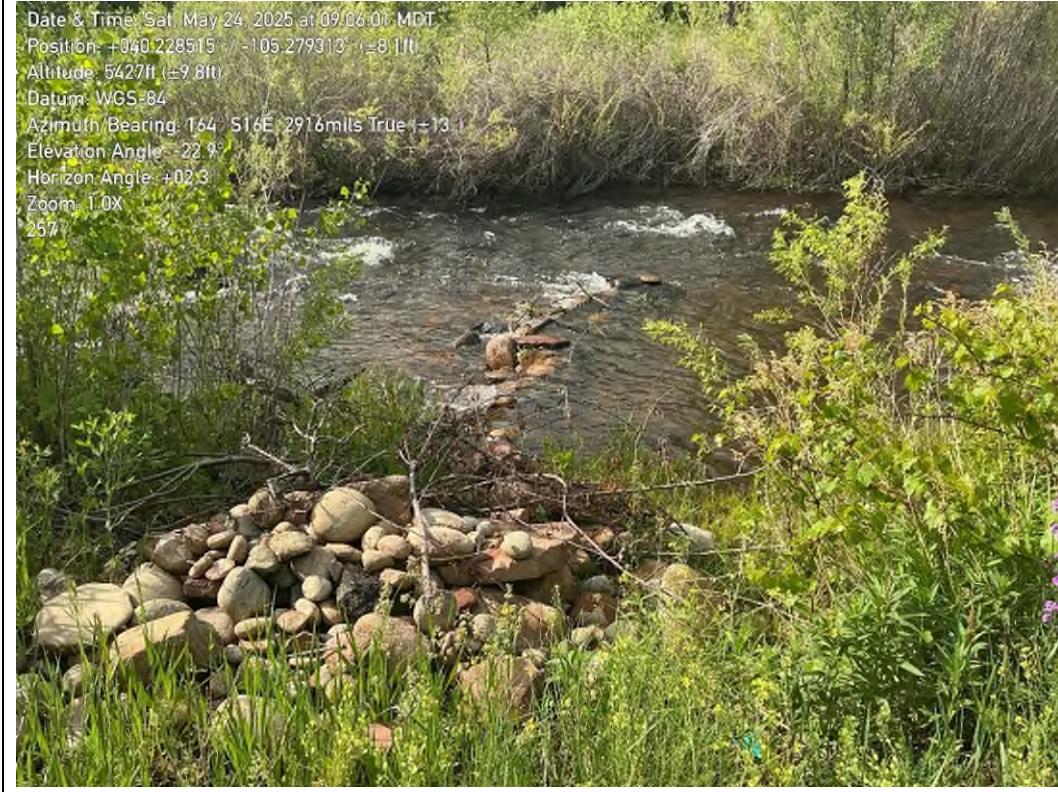
<p>Photograph: 85 Date: 5/24/2025 Location: Lyons, CO Description: <i>Man made weir with pipe. Bluegrass Farms LLC</i></p>

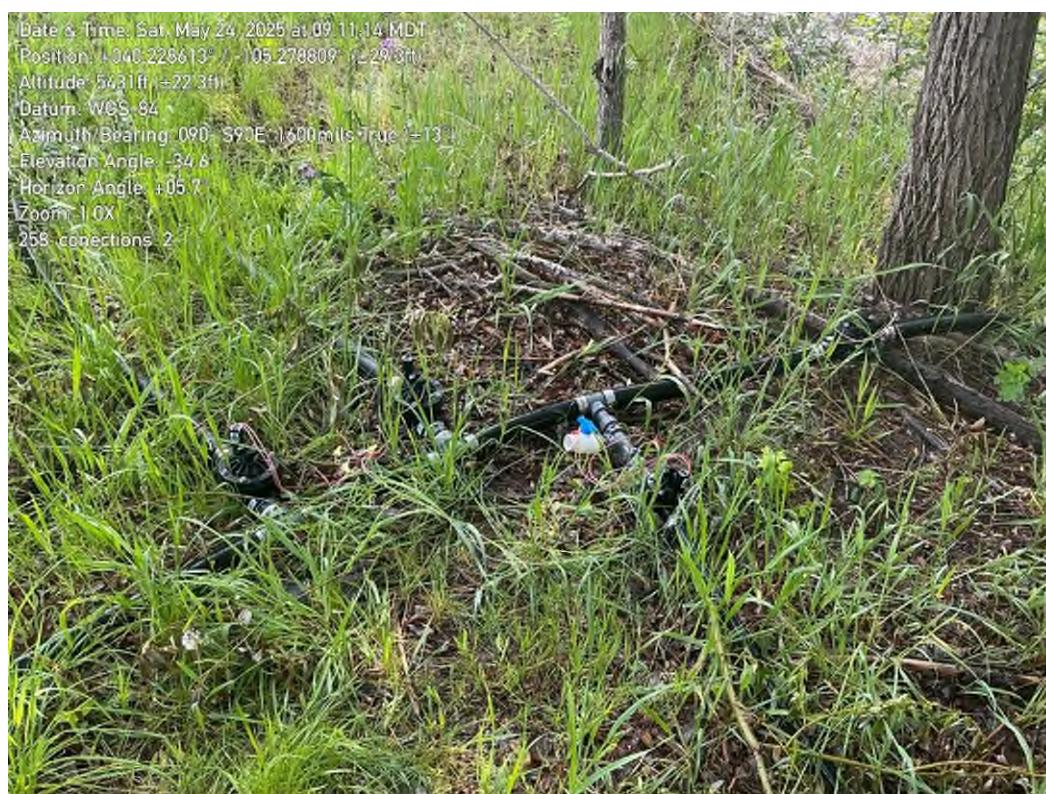
Photograph: 88

Pipes from river to irrigation - Bluegrass Farms LLC

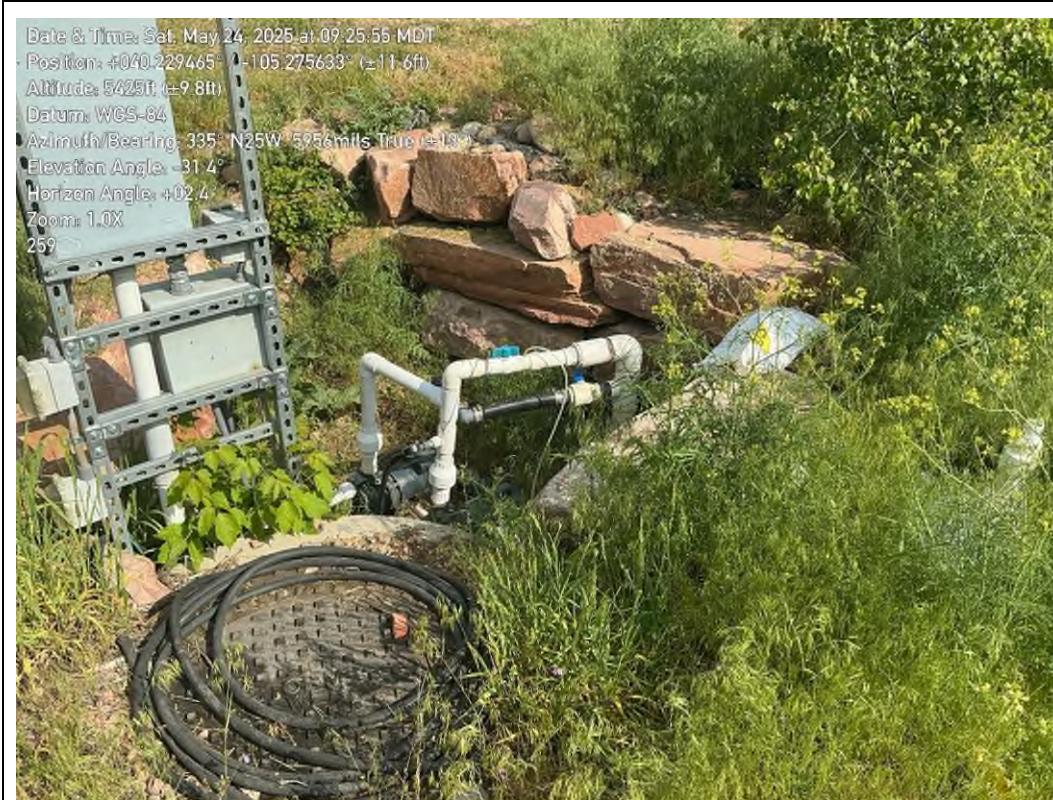
Photograph: 91

Second view of pump.
Festivaria LLC

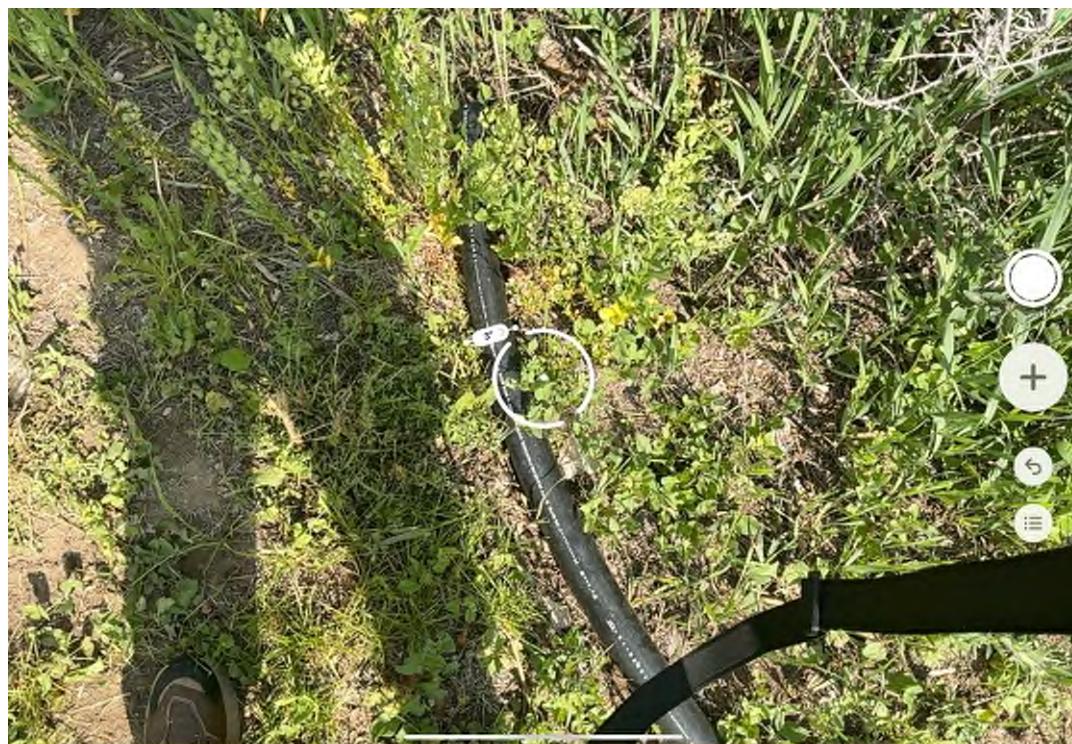
Photograph: 97

Size of pipe from 260 is 3".

Festivaria LLC

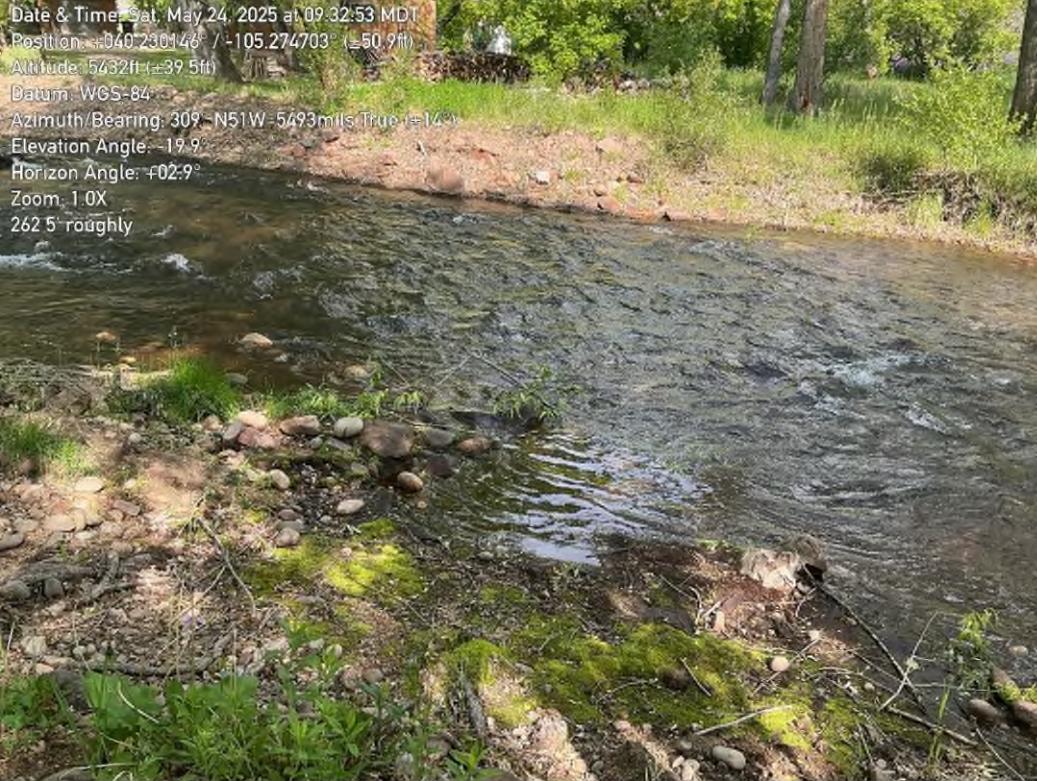
<p>Date & Time: Sat, May 24, 2025 at 09:32:53 MDT Position: +040.230148° / -105.274703° (±50.9ft) Altitude: 5432ft (±39.5ft) Datum: WGS-84 Azimuth/Bearing: 309° N51W 5493mils True (±14°) Elevation Angle: -19.9° Horizon Angle: +02.9° Zoom: 1.0X 262.5' roughly</p>	<p>Photograph: 99 Date: 5/24/2025 Location: Lyons, CO Description: 5' Wiers - likely part of visitors. Not off stream diversion. Festivaria LLC</p>

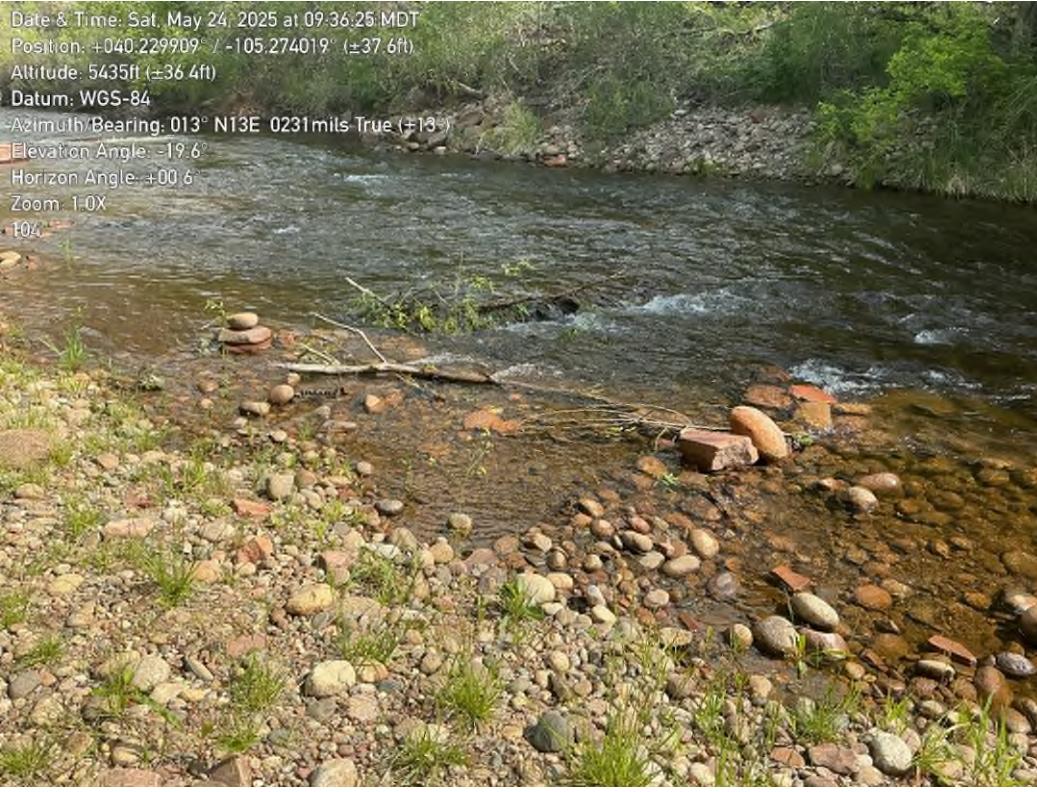
<p>Date & Time: Sat, May 24, 2025 at 09:36:25 MDT Position: +040.229909° / -105.274019° (±37.6ft) Altitude: 5435ft (±36.4ft) Datum: WGS-84 Azimuth/Bearing: 013° N13E 0231mils True (±13°) Elevation Angle: -19.6° Horizon Angle: +00.6° Zoom: 1.0X 102.5' roughly</p>	<p>Photograph: 100 Date: 5/24/2025 Location: Lyons, CO Description: More Weirs. Festivaria LLC</p>

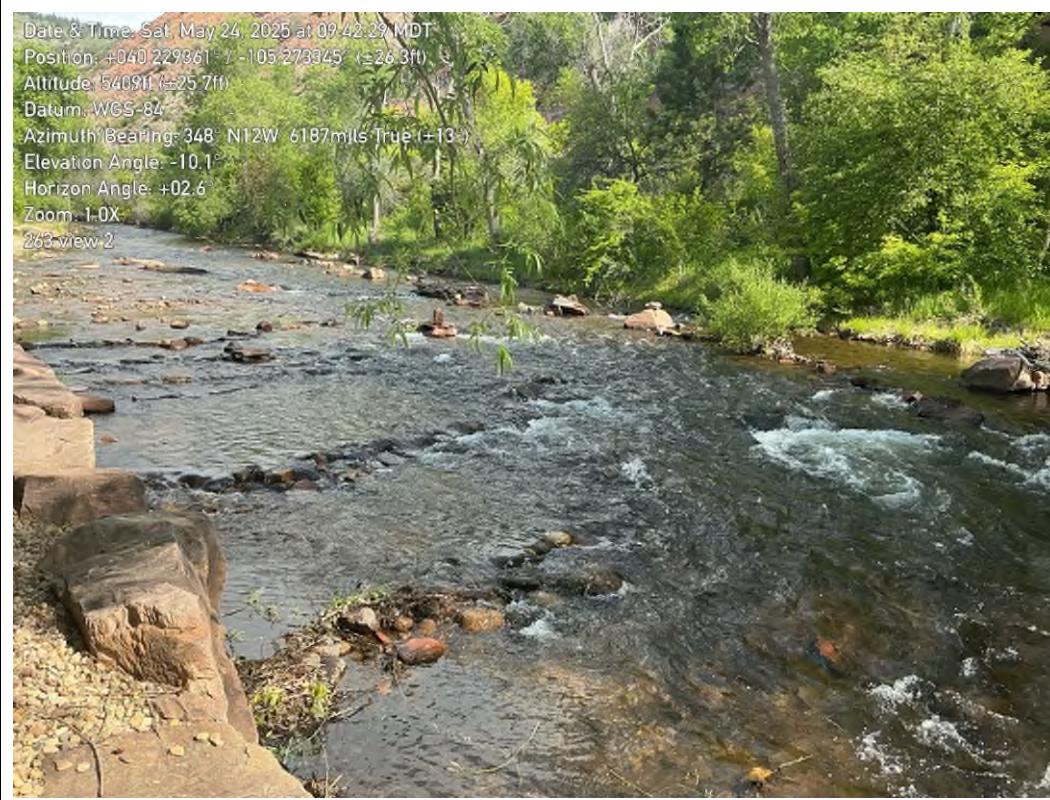
Photograph: 104

Additional Weir.
 Festivaria LLC

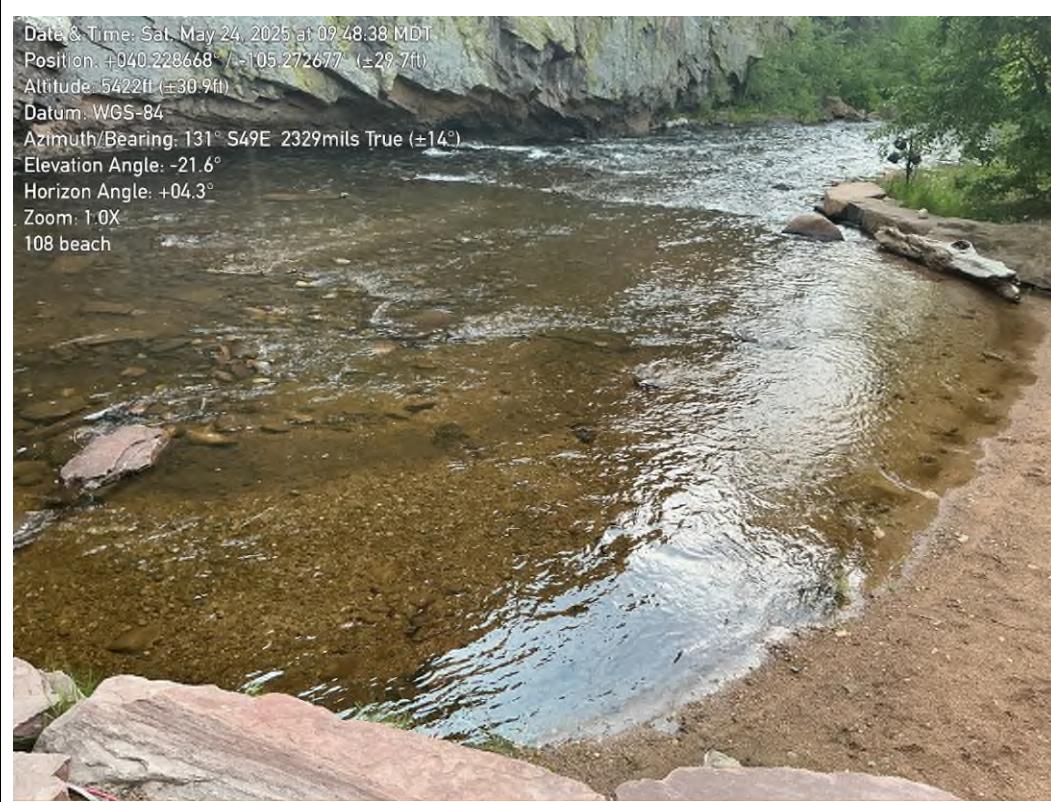
Photograph: 109

Beach area.

Festivaria LLC

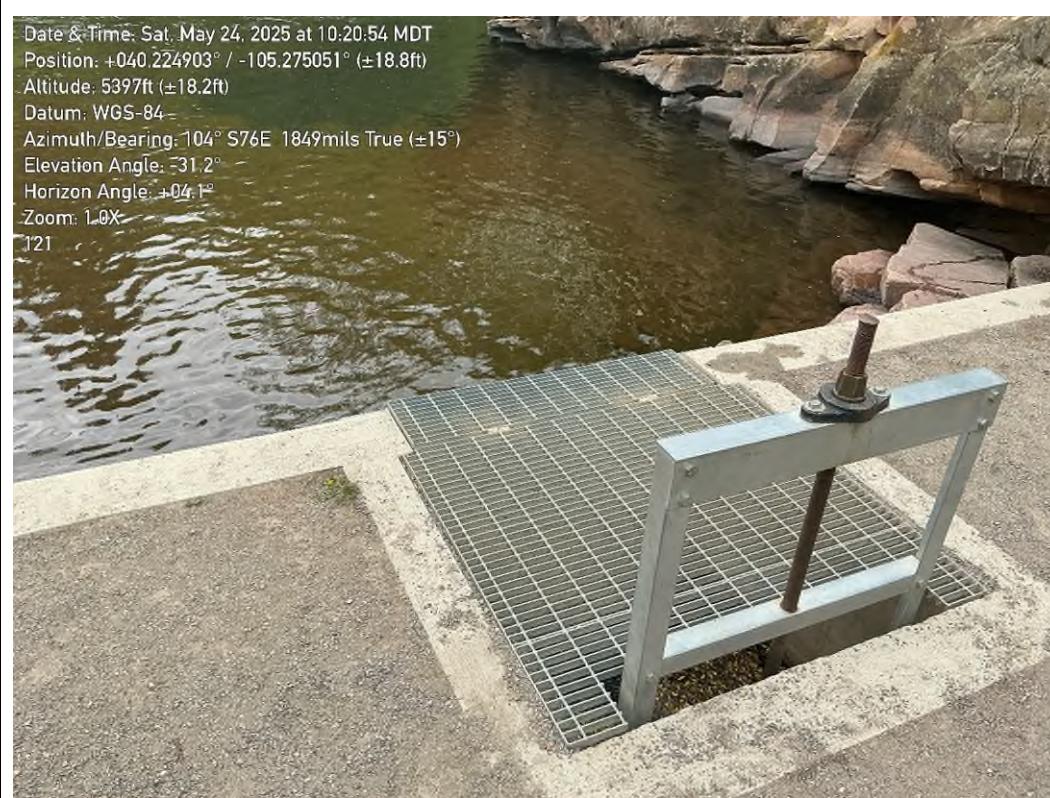
Photograph: 117

Lyons ditch diversion- 5 block stretch others may be pulling from -
No meter. No flow at the end of 5 blocks.

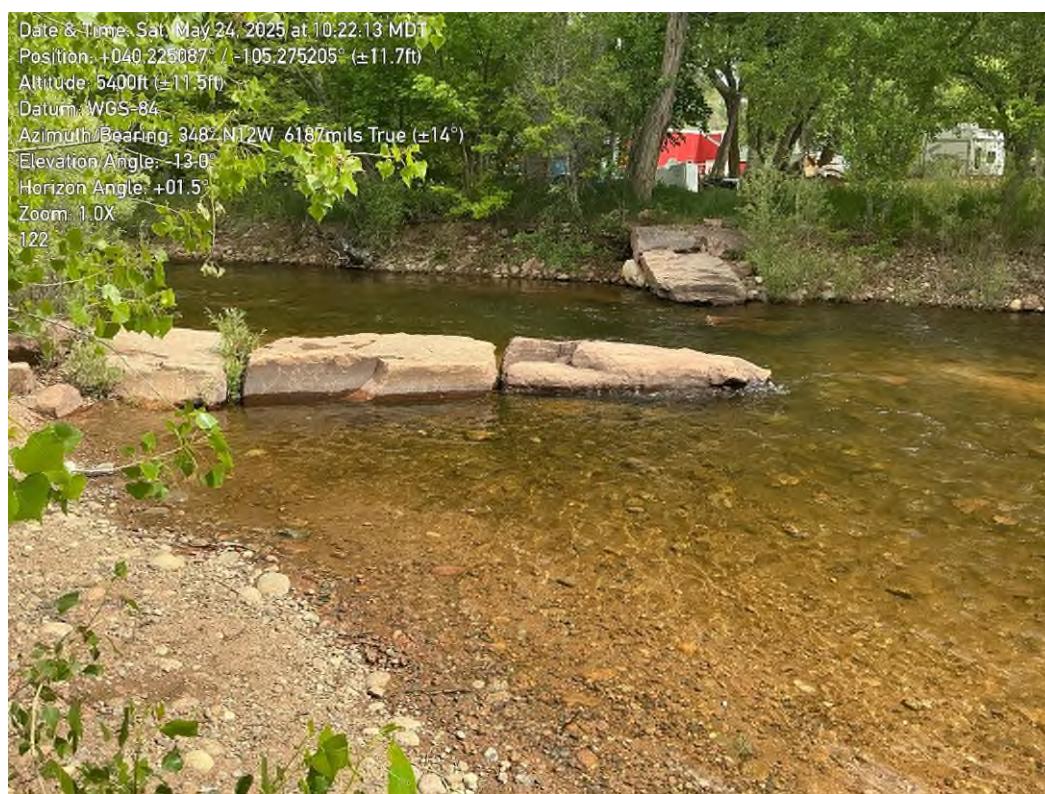
Photograph: 119

Lyons Weir.

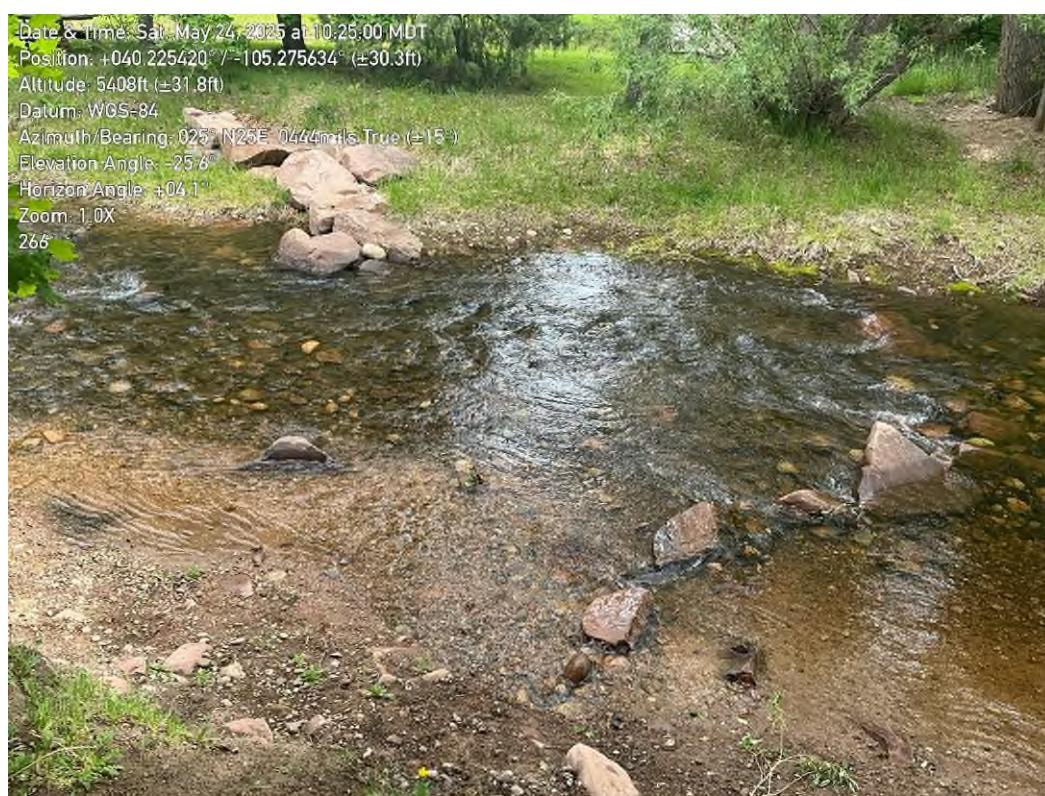
Photograph: 121

Lyons Weir.

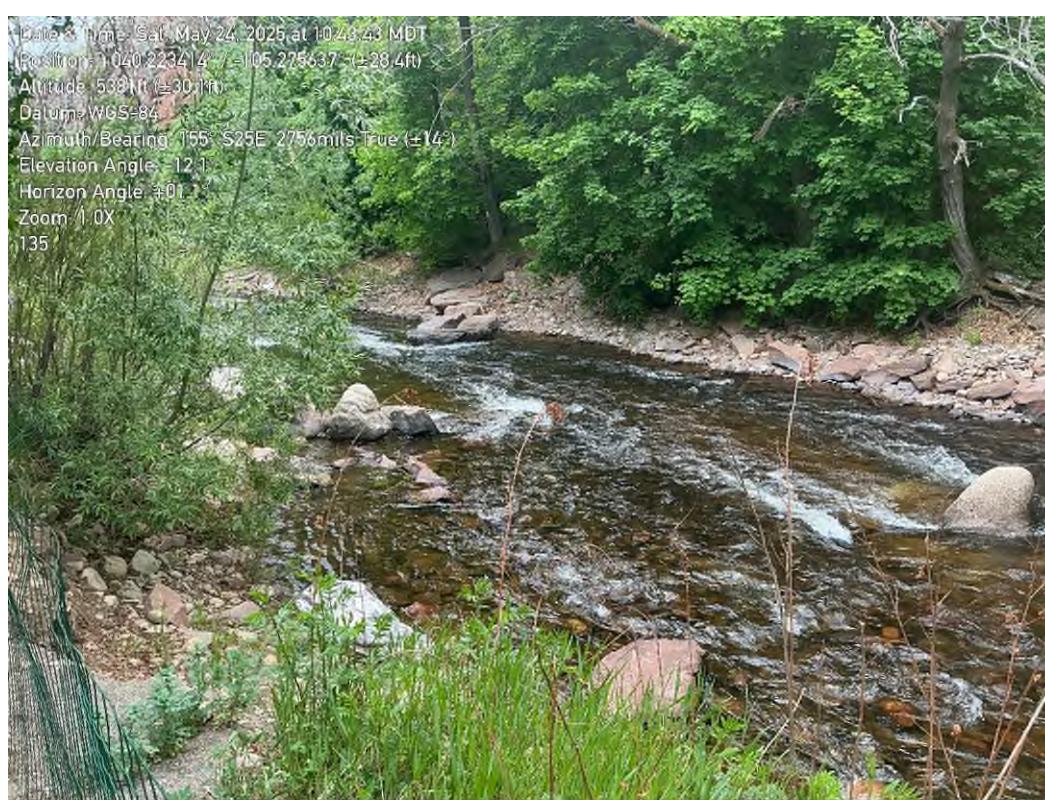
Photograph: 129

Lyons Weir.

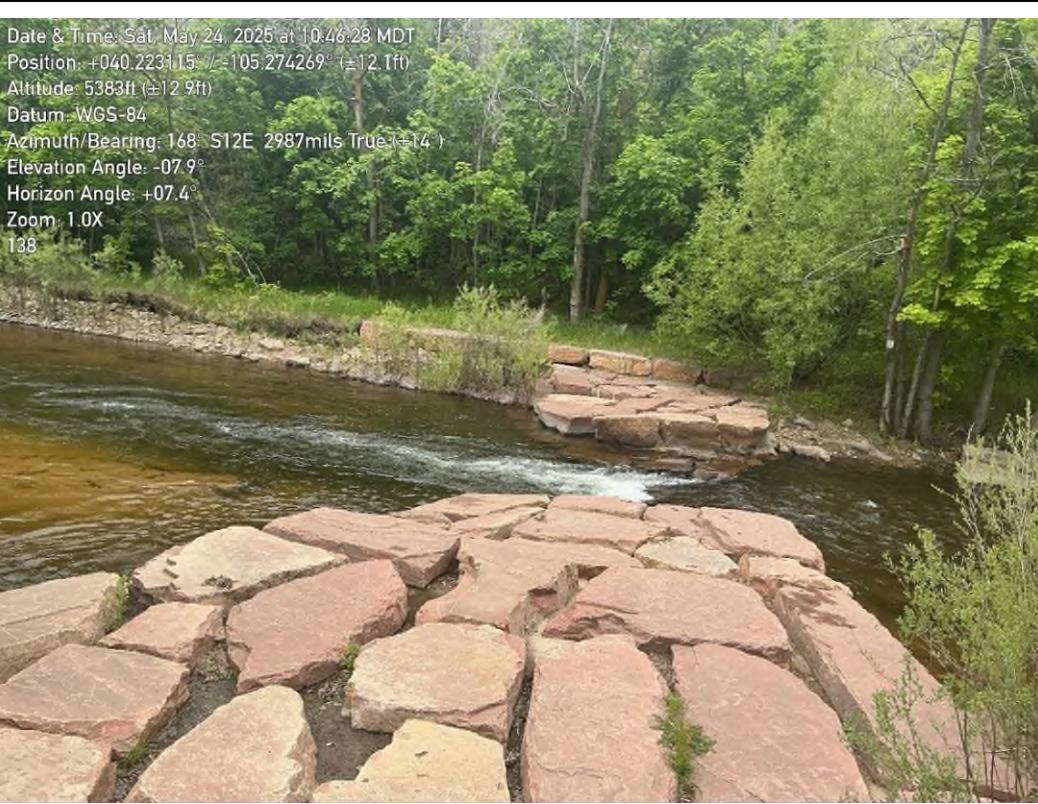
<p>Photograph: 131 Date 5/24/2025 Location: Lyons, CO Description: Lyons Weir.</p>
<p>Date & Time: Sat, May 24, 2025 at 10:47:28 MDT Position: +040.222989° / -105.273936° (±24.8ft) Altitude: 5380ft (±26.5ft) Datum: WGS-84 Azimuth/Bearing: 194° S14W 3449mils True (+14°) Elevation Angle: -22.1° Horizon Angle: +04.2° Zoom: 1.0X 140</p>

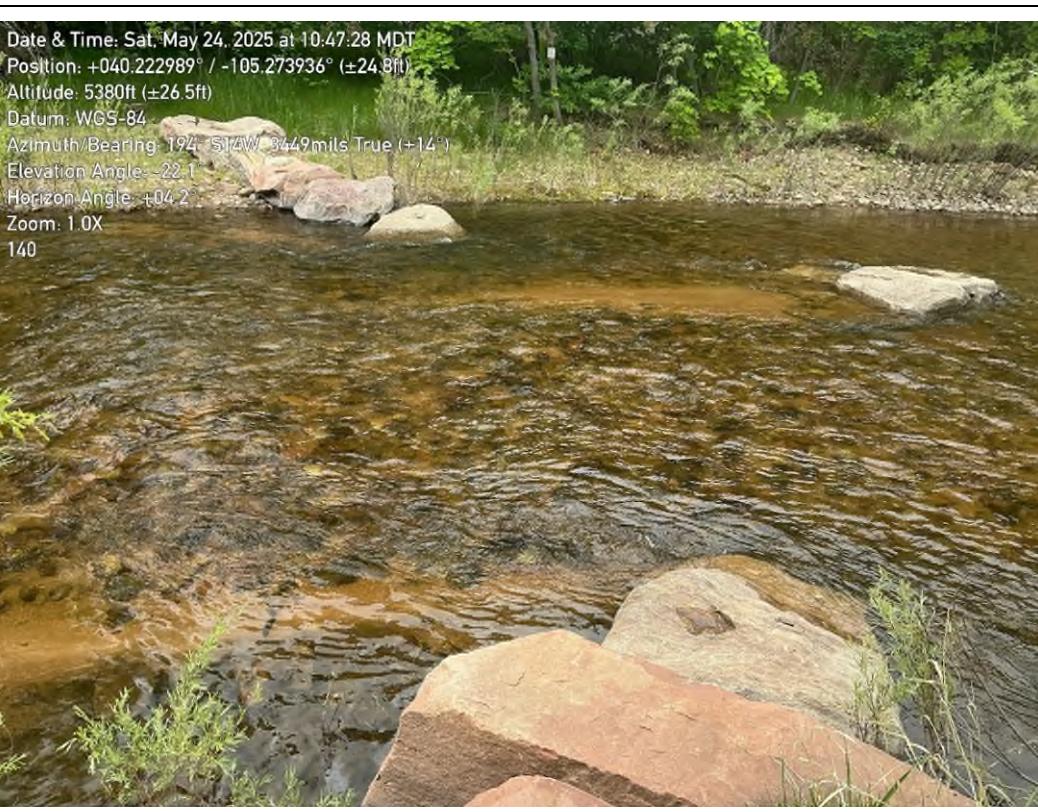
<p>Photograph: 132 Date: 5/24/2025 Location: Lyons, CO Description: Lyons Weir.</p>

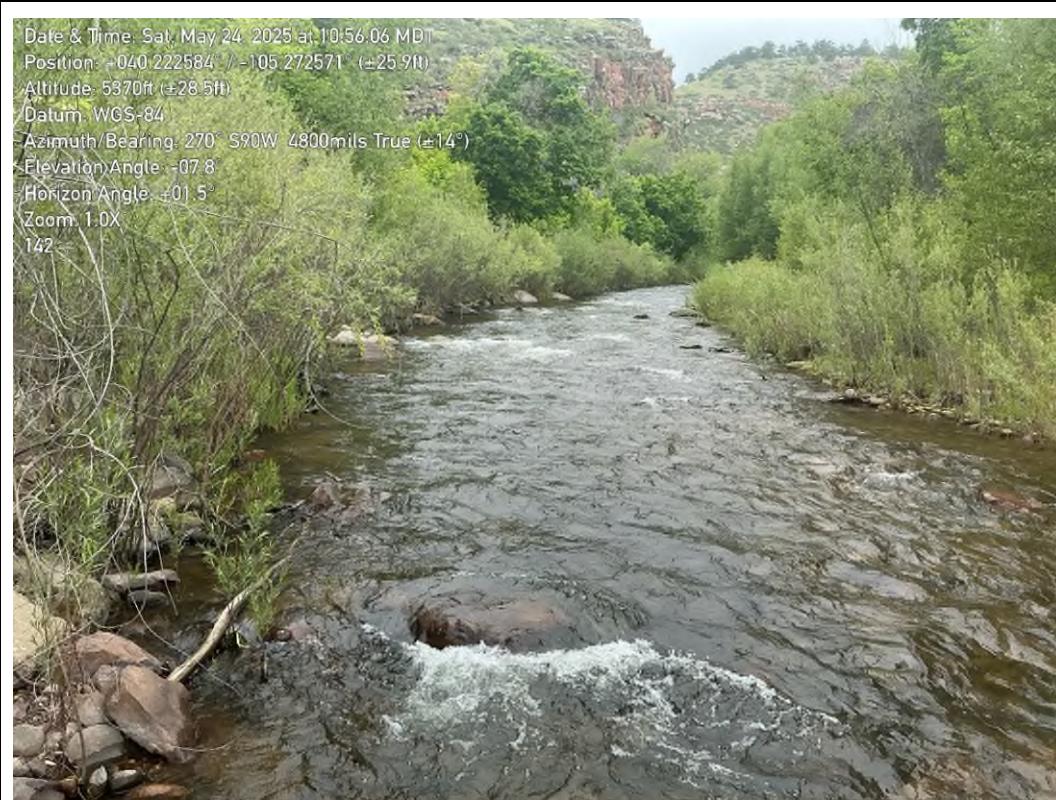
Photograph: 133

Natural - No Concerns

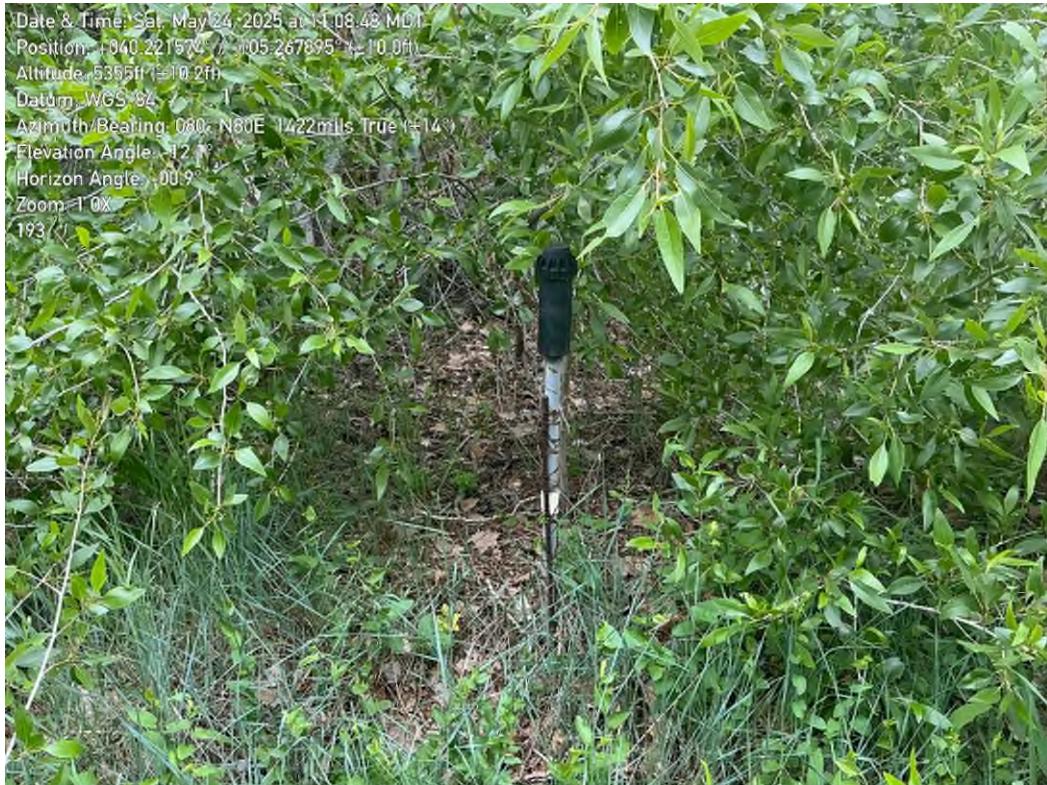
Photograph: 135

Irrigation System by river with a lot of pipes. These are located on the Town of Lyons Section 18 Township 3N Range 70 Block 20 Lot 10. A Thomas pump is associated with this water right- no meter observed. The neighbor who it appears to go to also has a water right associated.

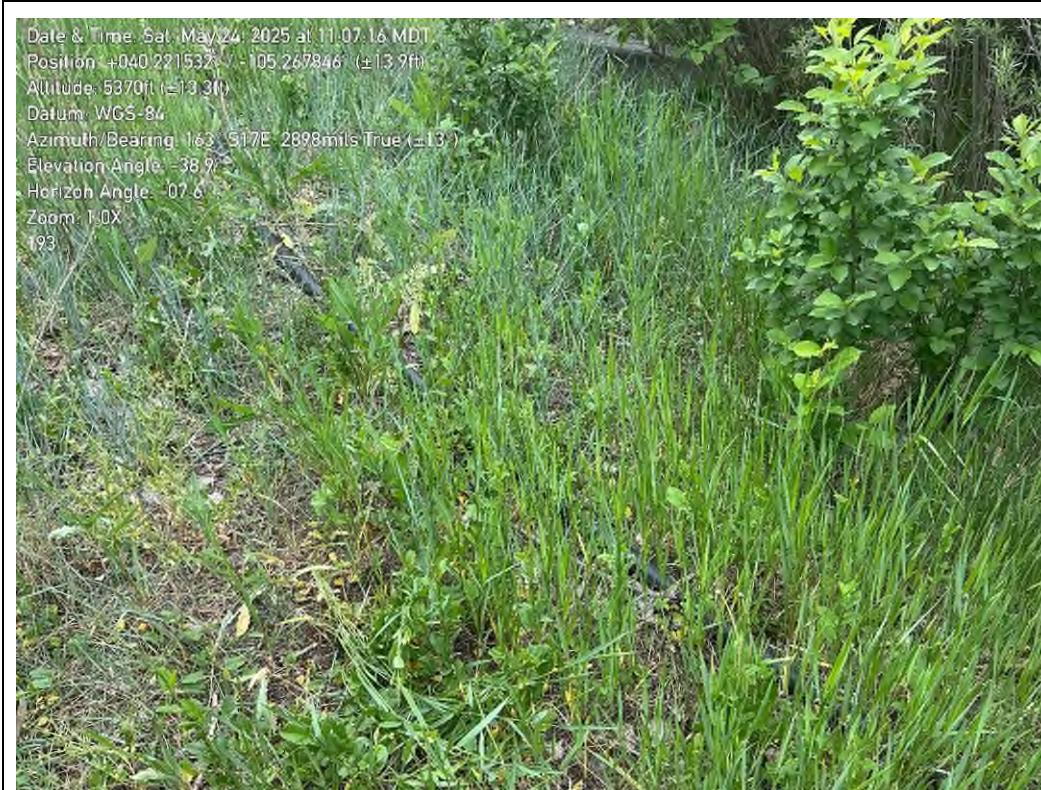
Photograph: 136

More 2.5" pipe on Town of Lyons property.

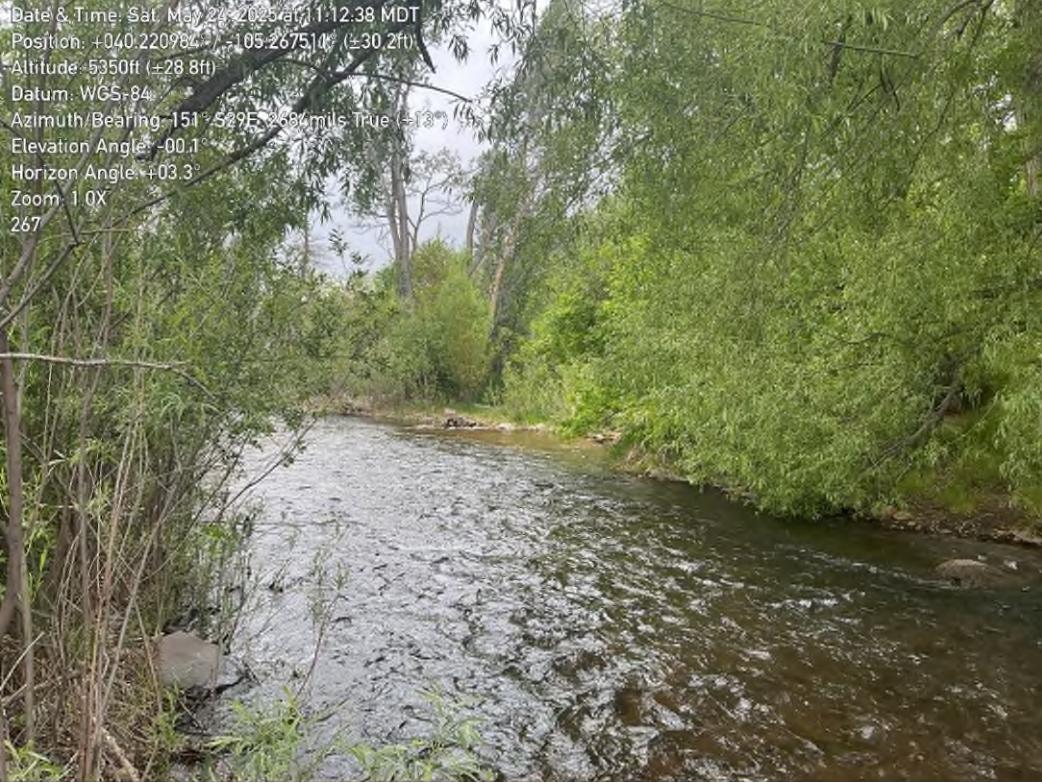
<p>Photograph: 138 Date 5/24/2025 Location: Lyons, CO Description: Lyons Diversion.</p>
<p>Date & Time: Sat, May 24, 2025 at 11:14:55 MDT Position: +040.220906° / -105.267370° ($\pm 28.4\text{ft}$) Altitude: 5370ft ($\pm 16.6\text{ft}$) Datum: WGS-84 Azimuth/Bearing: 128° S 52' E 227° mils True ($\pm 1.4^\circ$) Elevation Angle: -04.6° Horizon Angle: +00.9° Zoom: 1.0X 147</p>

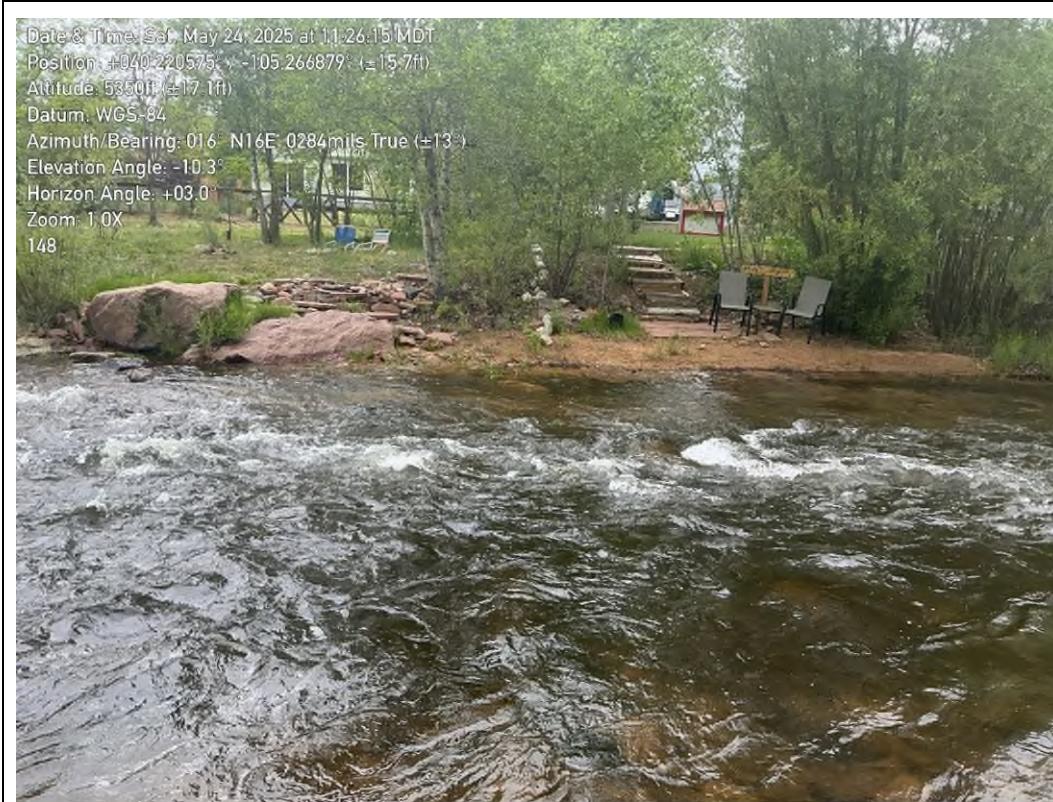
Photograph: 142

No pump observed -
Appears to just be a
beach.

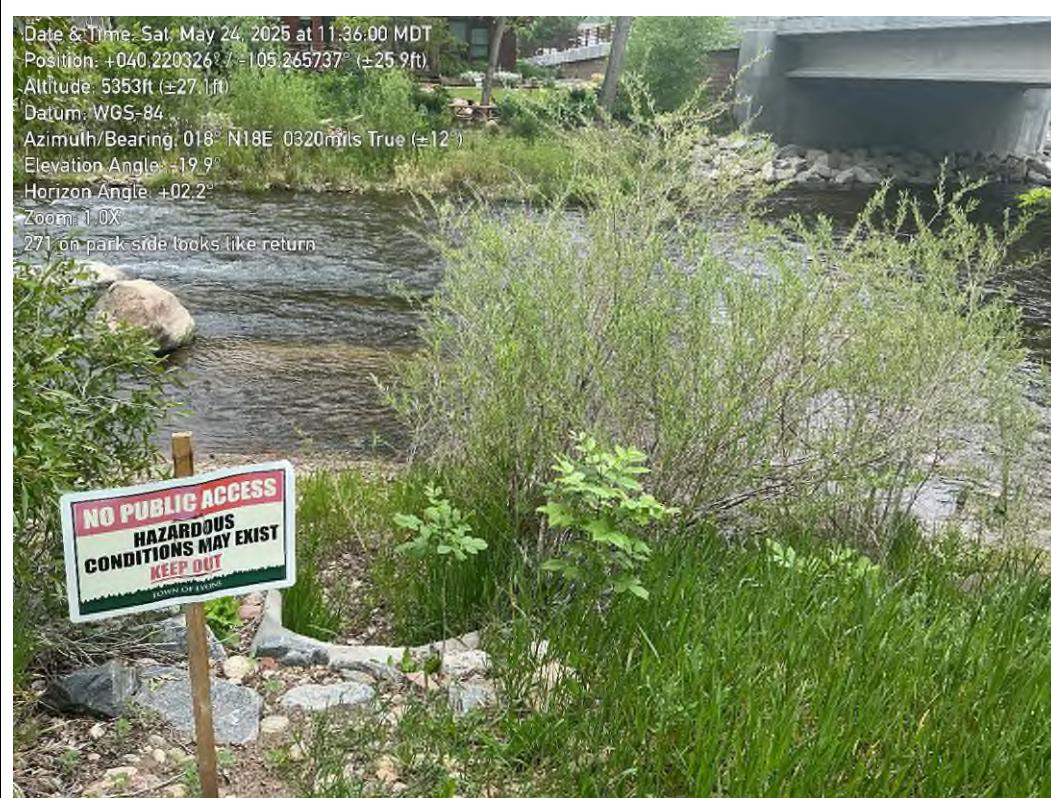
Photograph: 146

Possible old return.

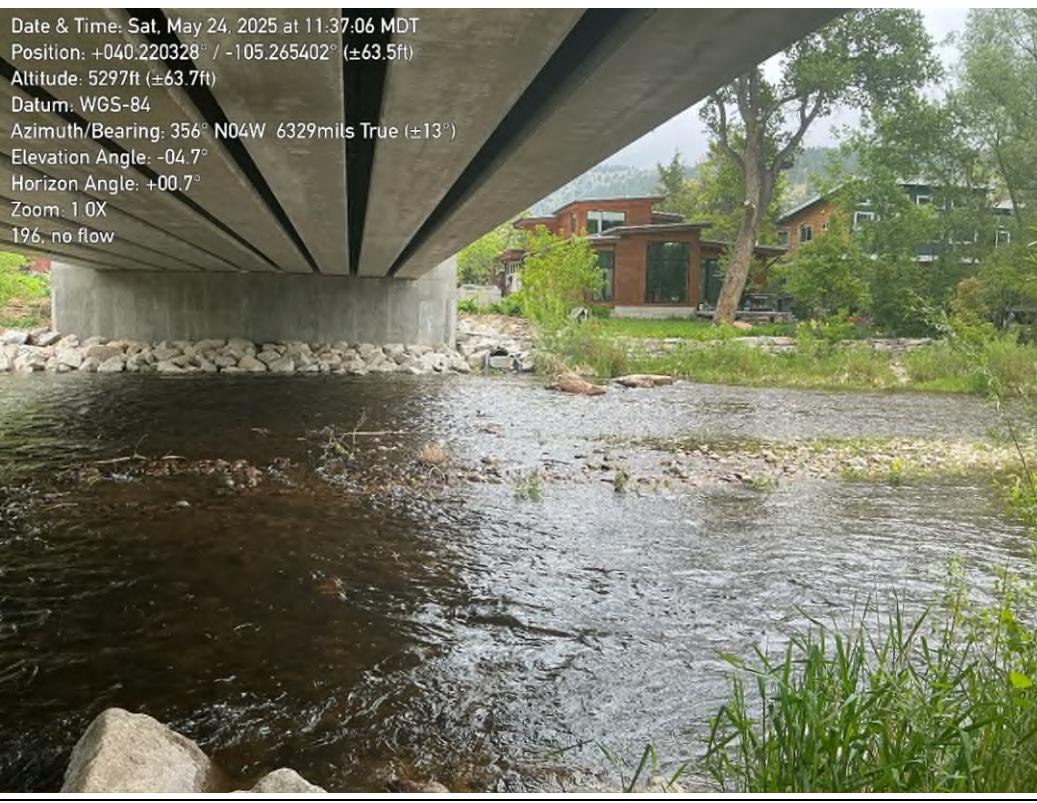
<p>Photograph: 148</p> <p>Date: 5/24/2025</p> <p>Location: Lyons, CO</p> <p>Description: Lyons Return. Associated water rights of who is pulling water is listed here. https://dwr.state.co.us/Tools/Structures/0500910</p> <p>No return was observed. It is unknown what is being diverted as well.</p>
<p>Date & Time: Sat, May 24, 2025 at 11:45:55 MDT Position: +040.220645° / -105.263527° ($\pm 28.6\text{ft}$) Altitude: 5362ft ($\pm 29.3\text{ft}$) Datum: WGS-84 Azimuth/Bearing: 239° S59W 4249mils True ($\pm 14^\circ$) Elevation Angle: -12.3° Horizon Angle: +00.5° Zoom: 1.0X 151</p>

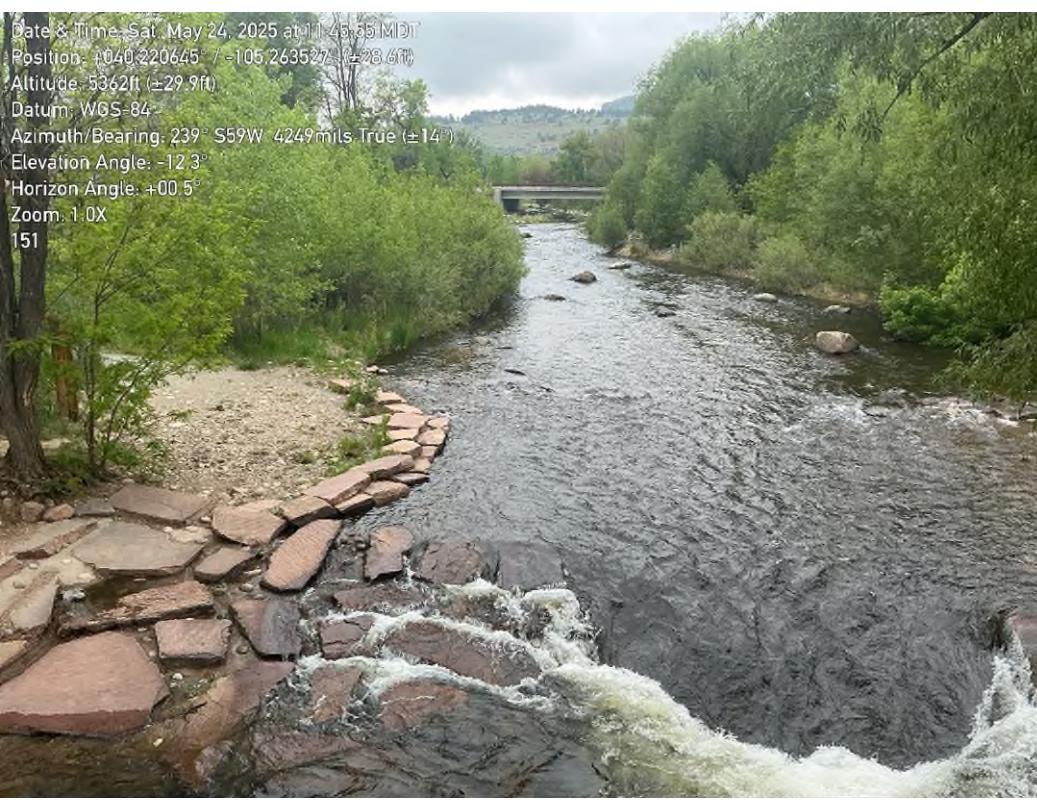
<p>Photograph: 149</p> <p>Date: 5/24/2025</p> <p>Location: Lyons, CO</p> <p>Description: Lyons structures.</p>

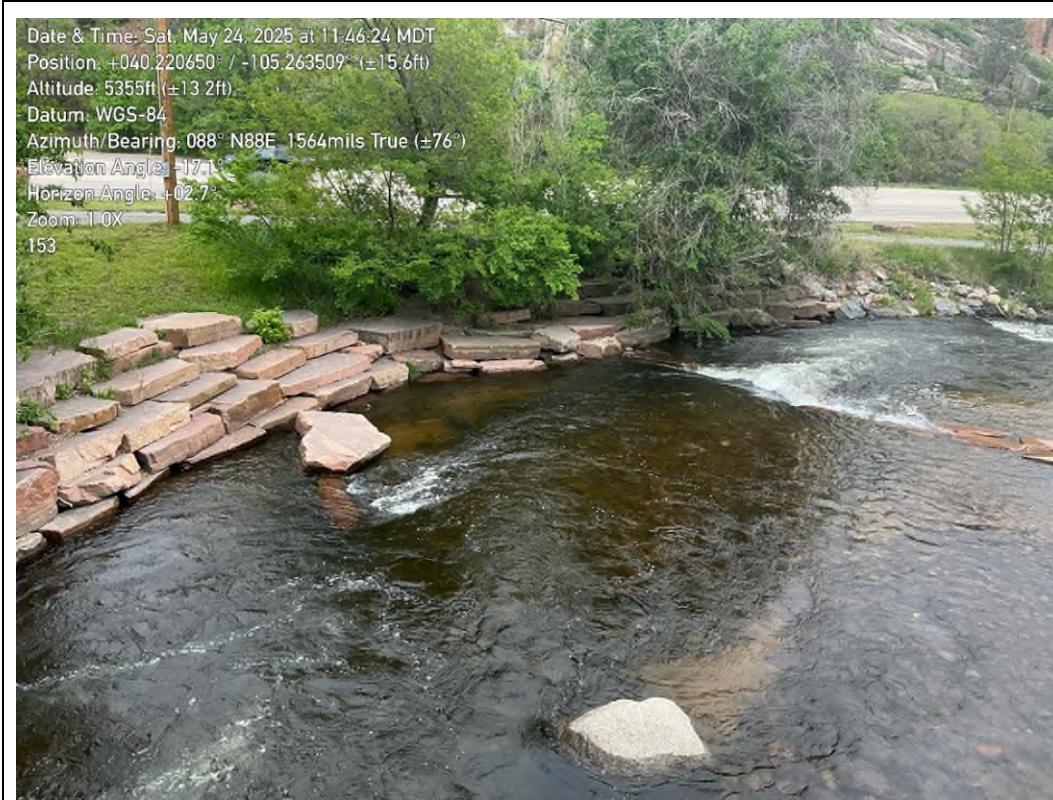
Photograph: 150

Lyons structures.
