STREAM BYPASS FLOW STUDY

25_STRM BYPASS_STUDY_01

*St. Vrain Creek
Ralph Price Reservoir (Button Rock)
to
Supply Irrigating Ditch Diversion*

August 13th, 2025

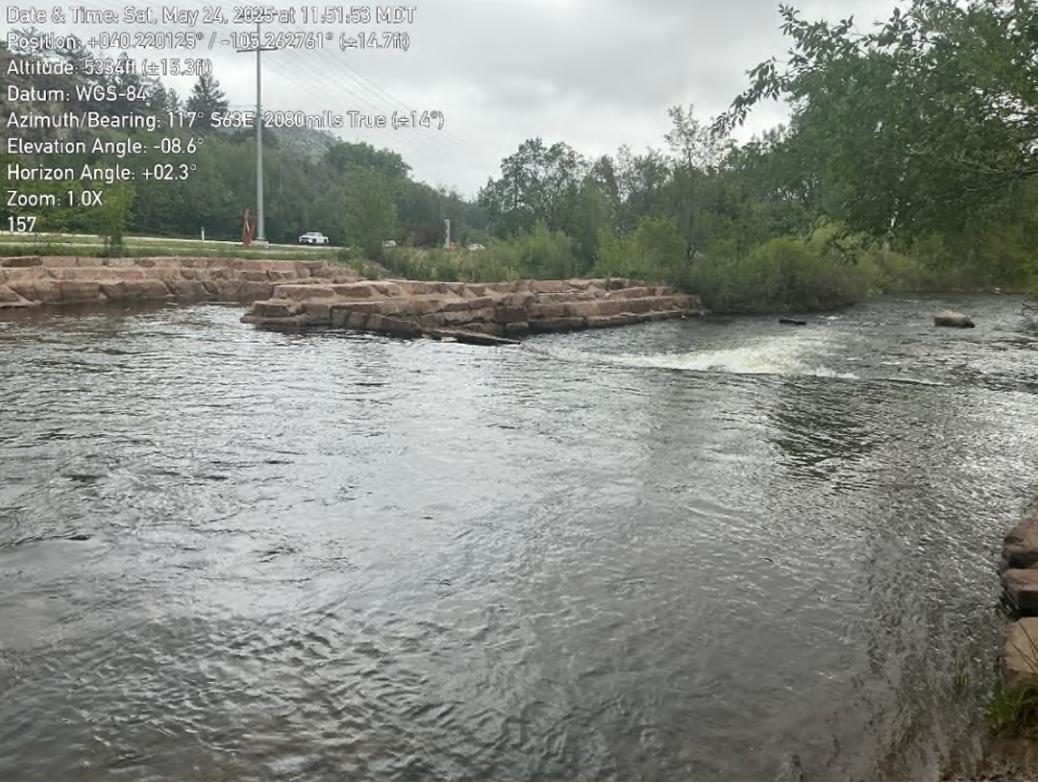
<p>Photograph: 152 Date 5/24/2025 Location: Lyons, CO Description: Lyons structures.</p>
<p>Date & Time: Sat, May 24, 2025 at 12:06:09 MDT Position: +040.217344° / -105.260961° ($\pm 15.0\text{ft}$) Altitude: 5341ft ($\pm 14.6\text{ft}$) Datum: WGS-84 Azimuth/Bearing: 140° S 40E 2489mils True ($\pm 14^\circ$) Elevation Angle: -07.8° Horizon Angle: +01.8° Zoom: 1.0X 198</p>

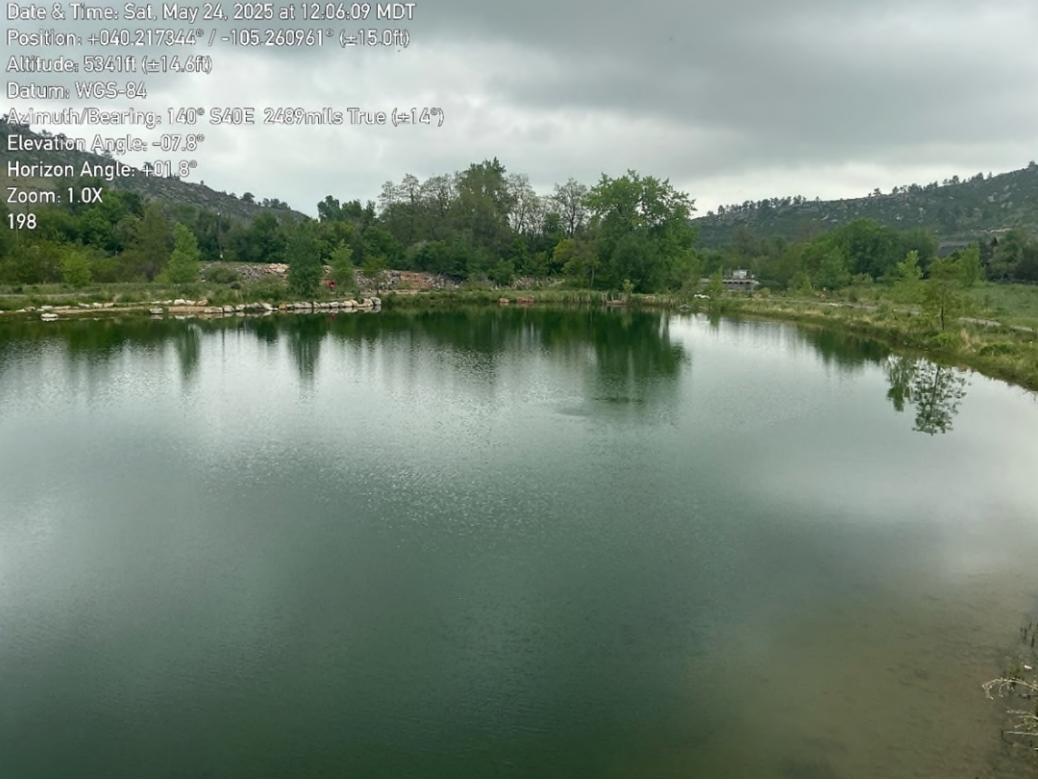
<p>Photograph: 153 Date: 5/24/2025 Location: Lyons, CO Description: Lyons holding pond.</p>

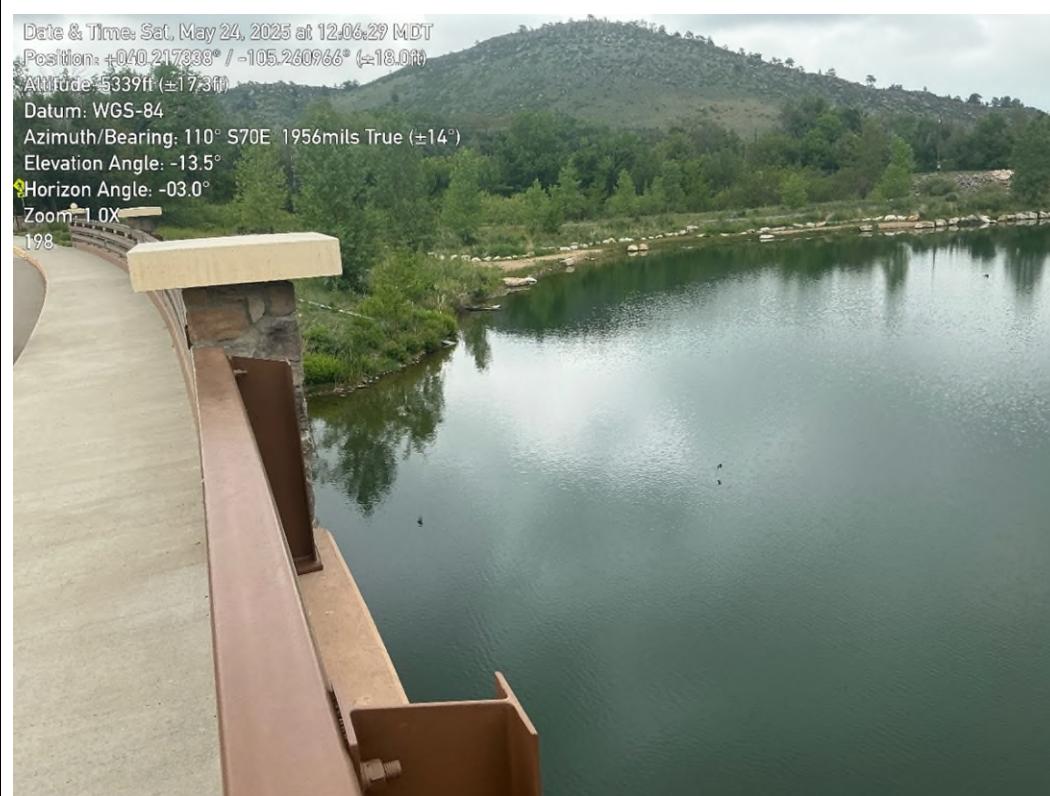
Photograph: 154

Lyons holding pond.

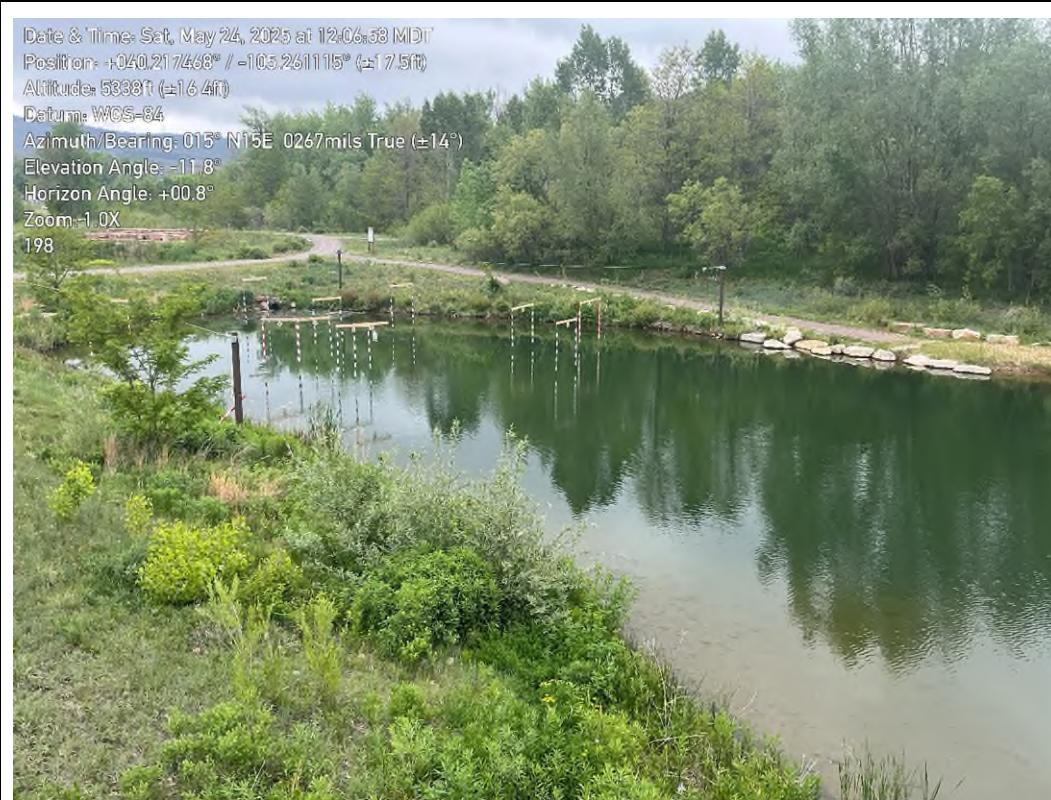
Photograph: 156

Lyons holding pond.

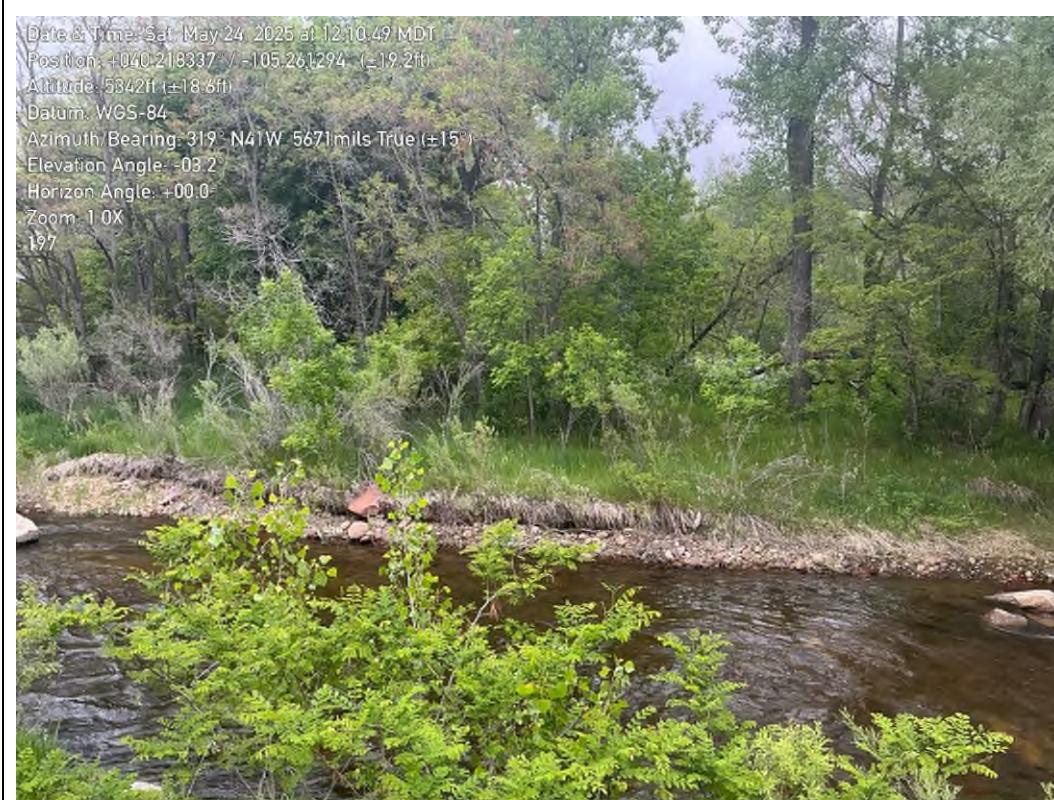
Photograph: 158

Natural

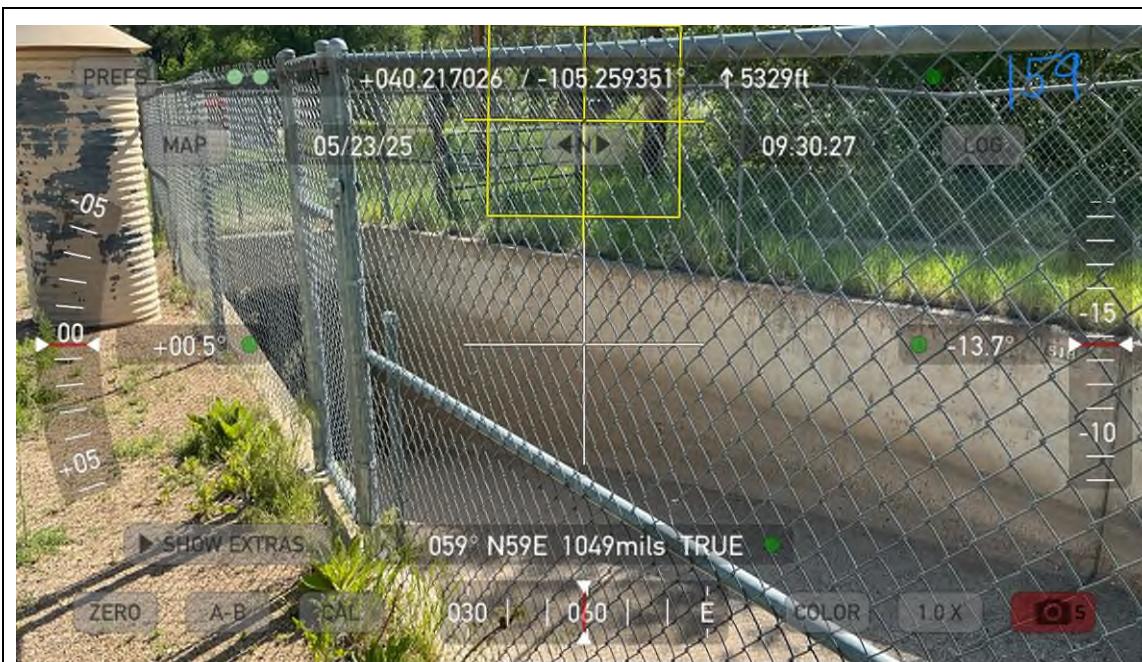
Photograph: 160

Northern Water Release
